NOVA SCOTIA LANDS INC.

## Phase I Environmental Site Assessment (Final)

Lake Enon Former Mill Site, Enon, Nova Scotia, PID Nos: 15551369,  
15340045, and 15340052

October 2022 – 22-3723

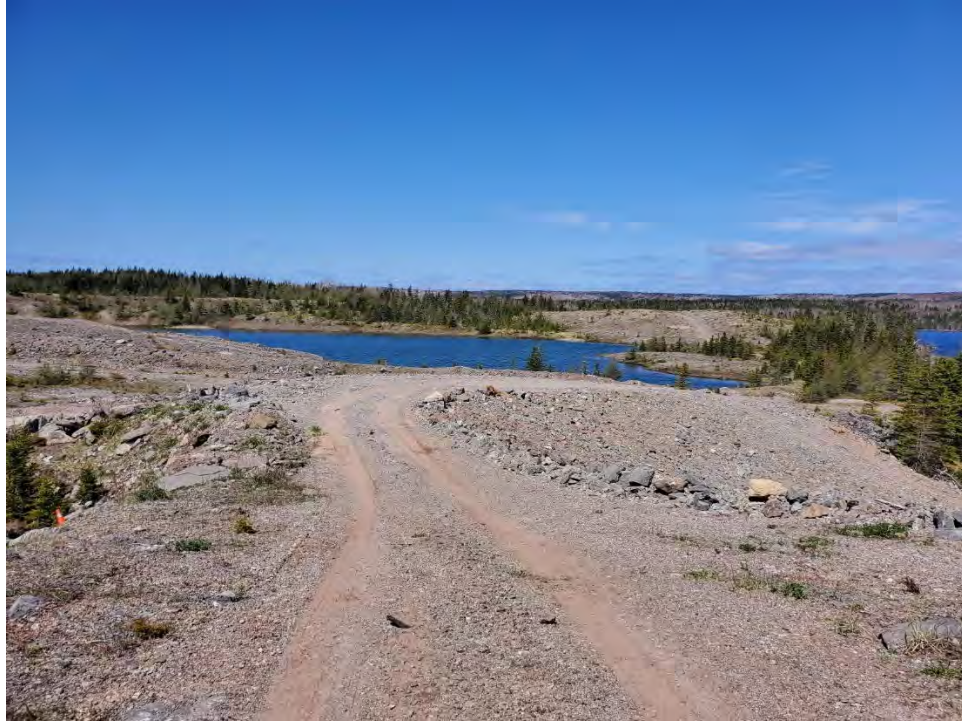
Photo 1. Access Road separating APEC 9 from APECs 3 and 4, facing northwest (May 2022).

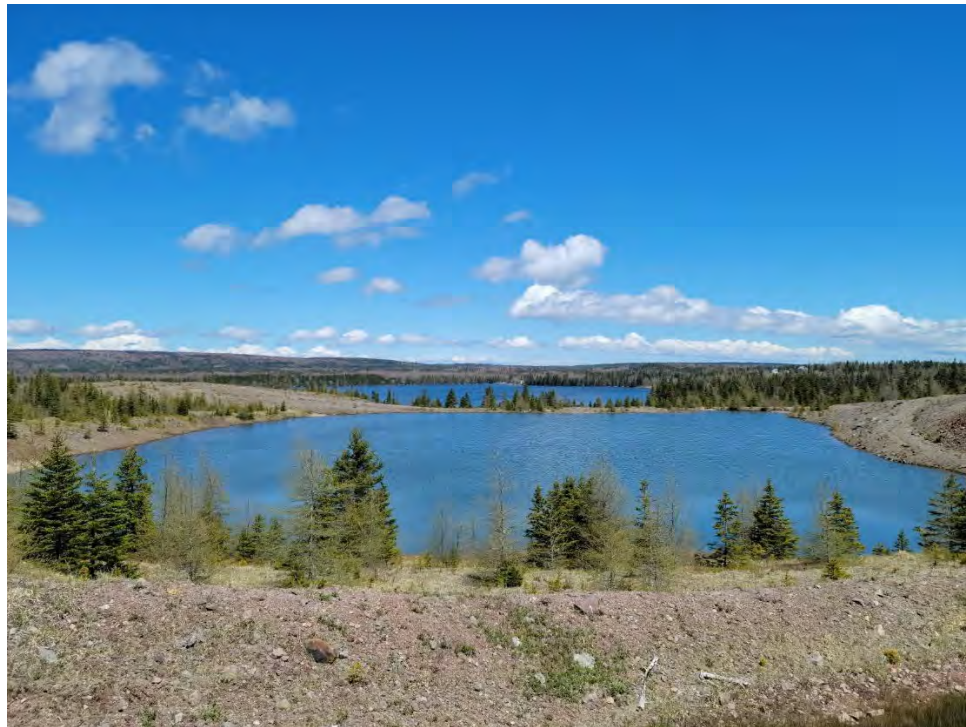
Photo 2. Settling pond (APEC 6) facing north towards Enon Lake (captures APEC 8), shown in background (May 2022).

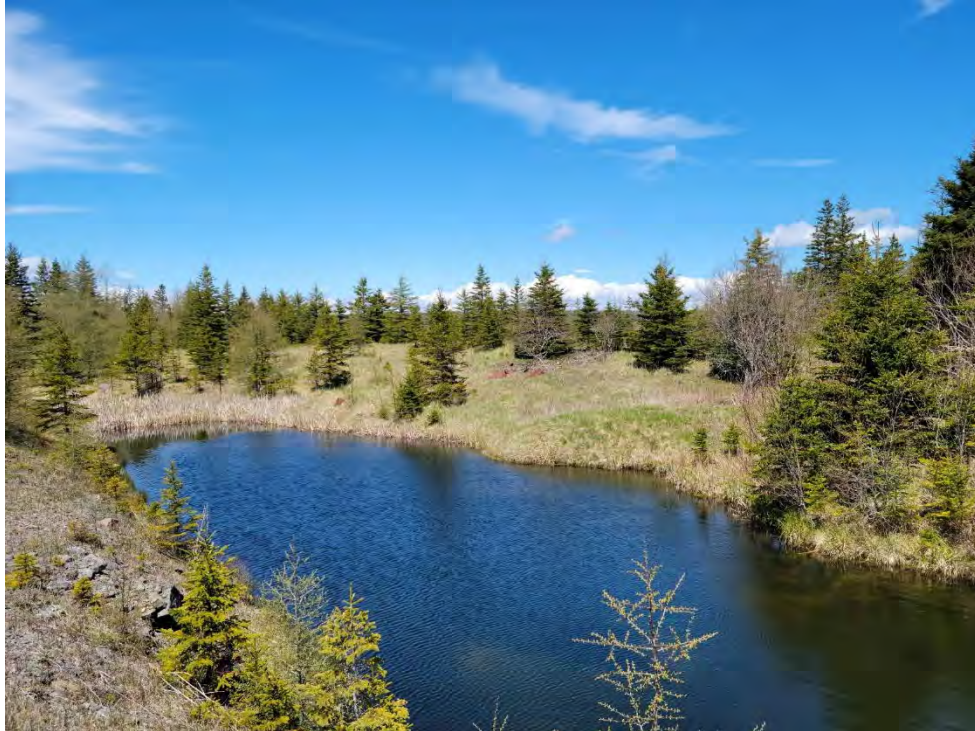
Photo 3. View of APEC 1 facing northwest (May 2022).

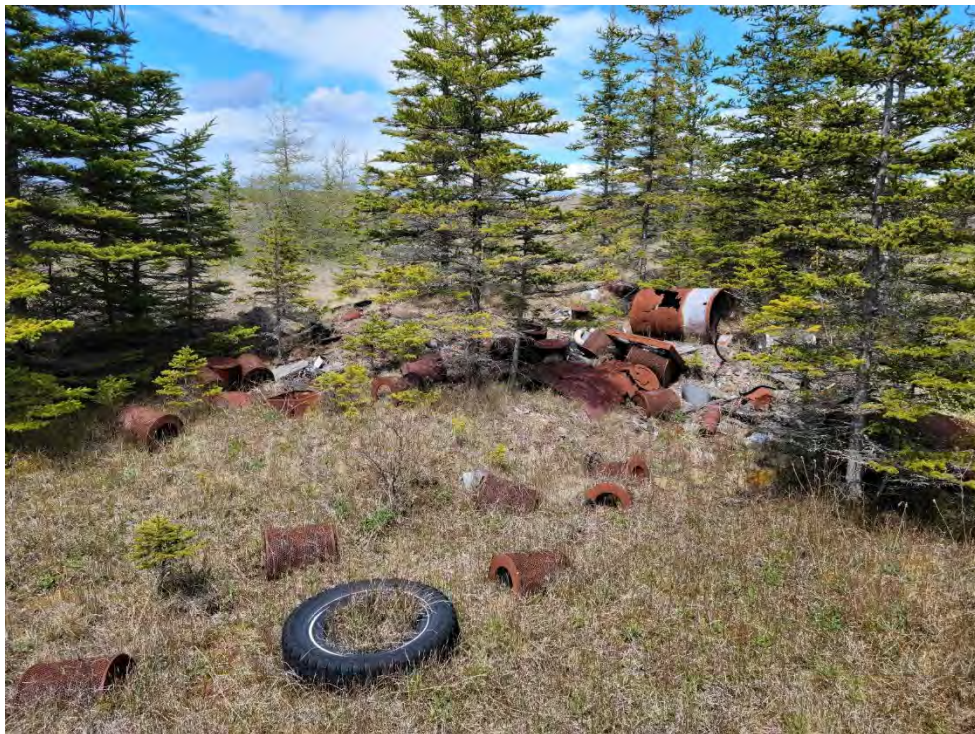
2. Waste Management	No current waste generation was observed at the subject property. Miscellaneous debris, including abandoned drums and tires, were observed on-site east and west of Loch Lomond Road. Some of the drums were observed to be partially buried. The contents of partially buried drums are unknown.	Yes

Photo 4. Miscellaneous debris (i.e., drums, tires) in APEC 1, situated north of pond (May 2022).

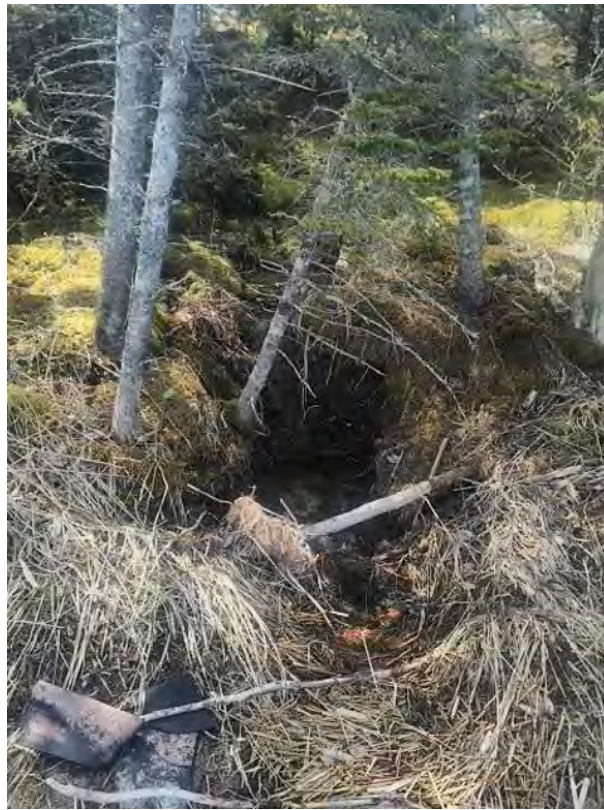
Photo 5. Discharge point “A” to Enon Lake (May 2022).

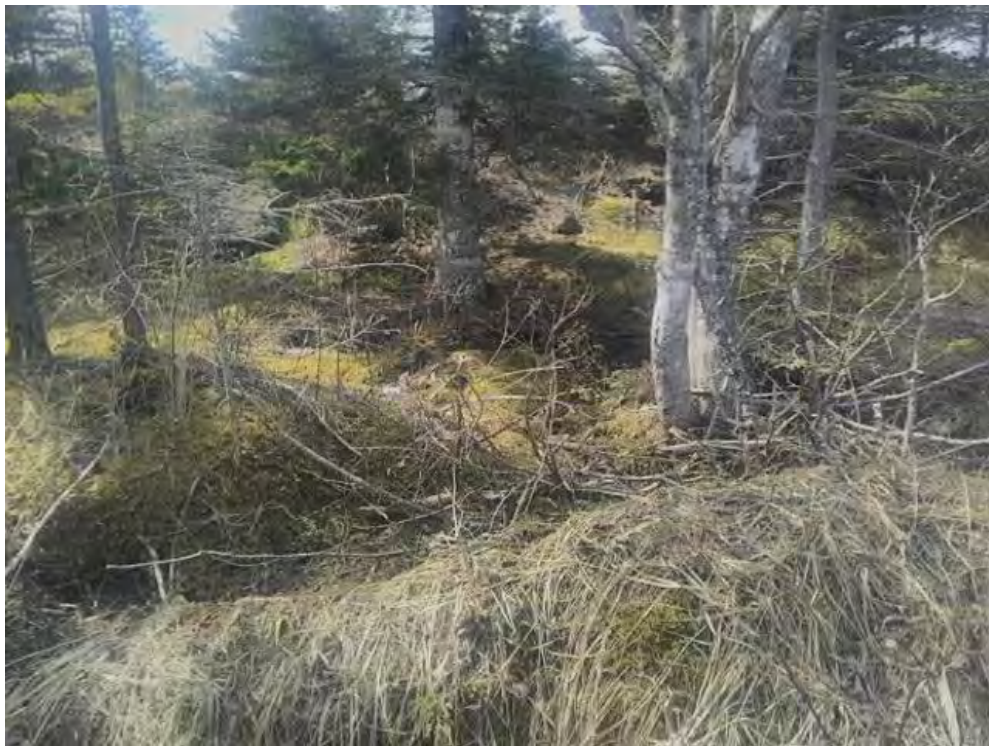
Photo 6. Discharge point “B” to Enon Lake (May 2022).

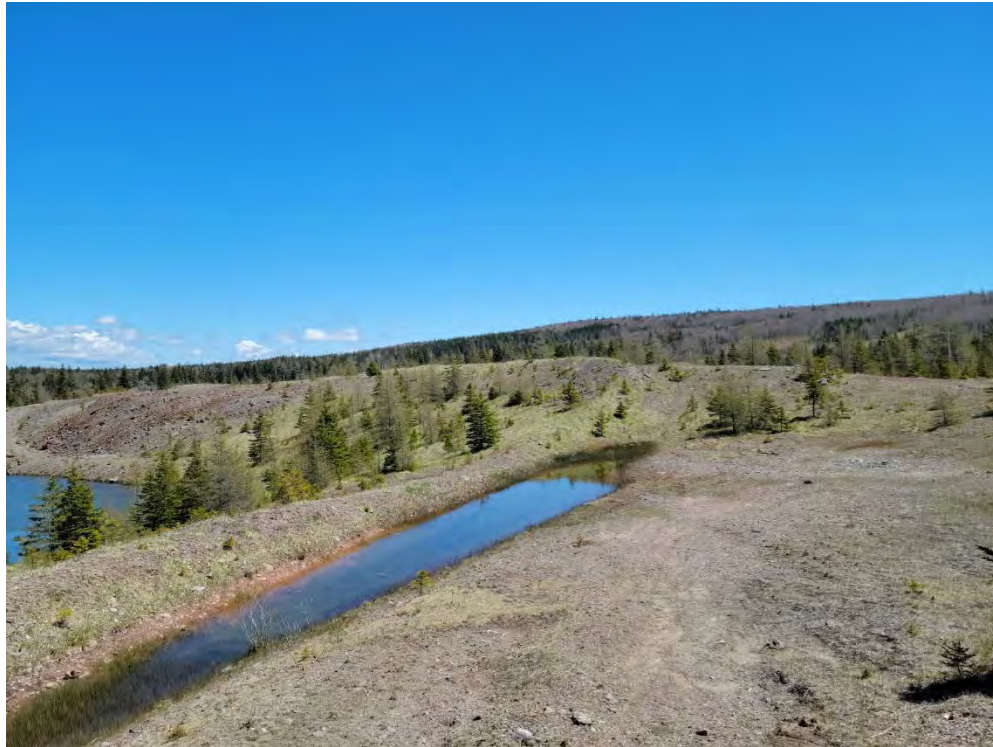
Photo 7. Ponded water between APEC 10 and APEC 9, south of APEC 6 (May 2022).

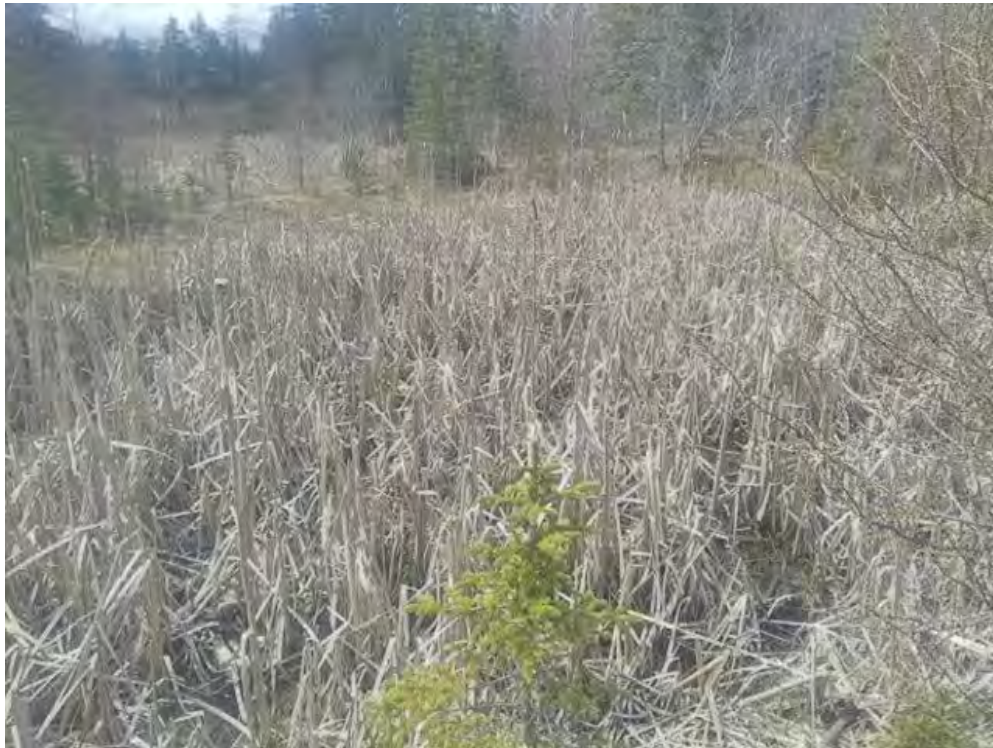
Photo 8. Northwest portion of APEC 1 (May 2022).

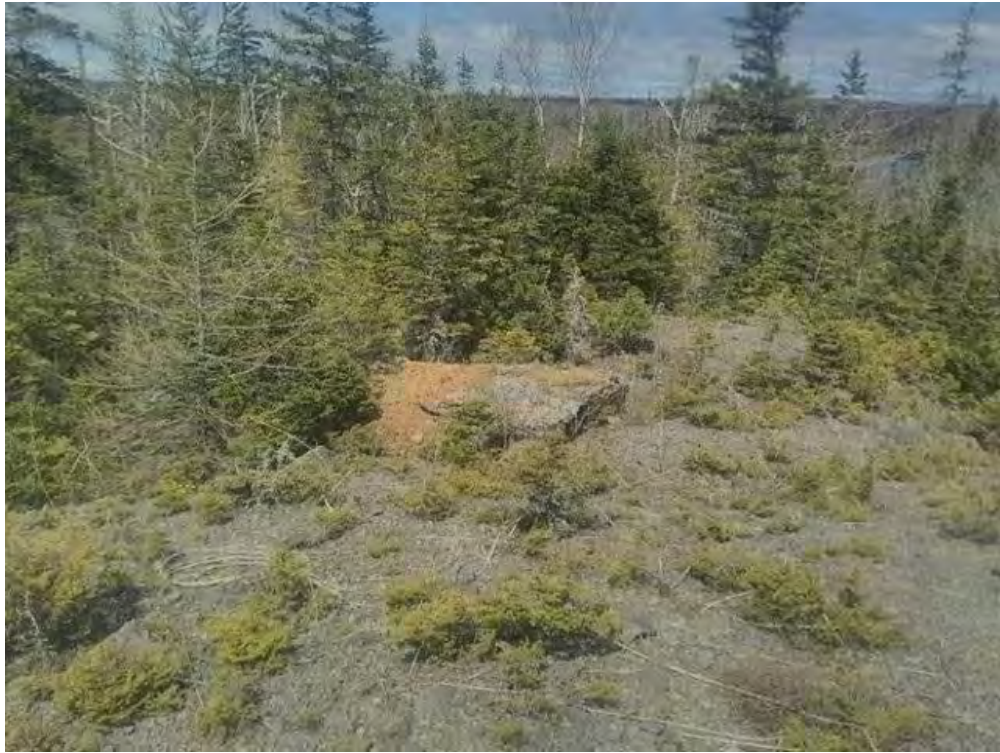
Photo 9. Northwest corner of APEC 2 showing potential iron staining (May 2022).

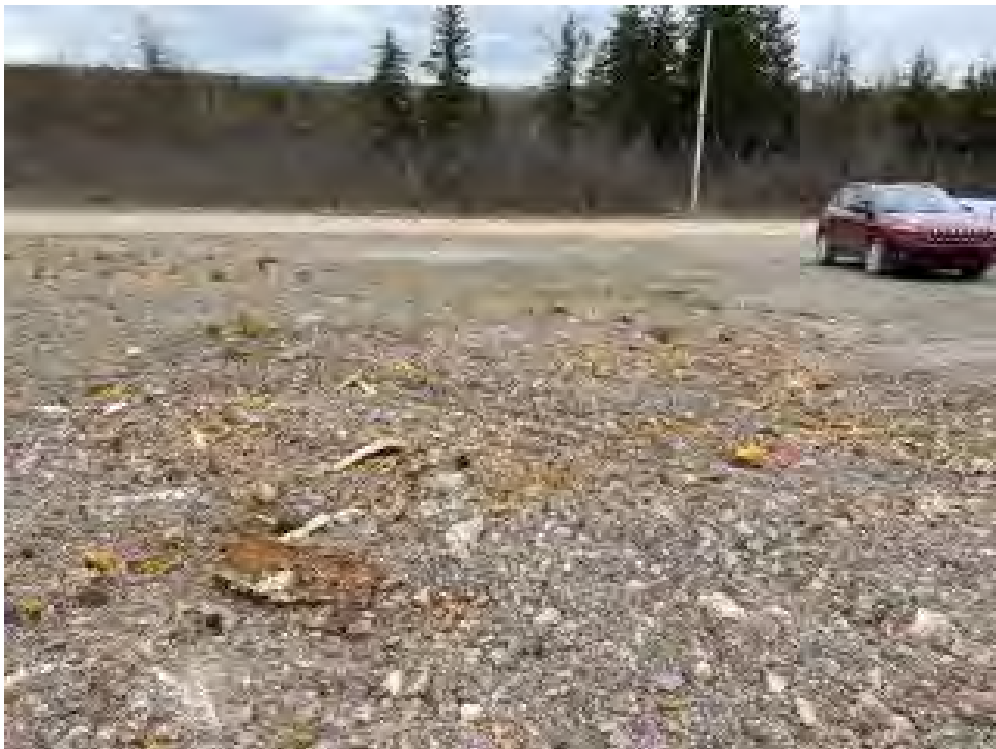
- Potential petroleum hydrocarbon impacts resulting from fuel containers observed in an abandoned trailer at the site (noting that this trailer was not observed during the 2022 Phase I ESA site visit); and

Photo 10. Area of a former abandoned trailer in APEC 4, facing Loch Lomond Road (May 2022).

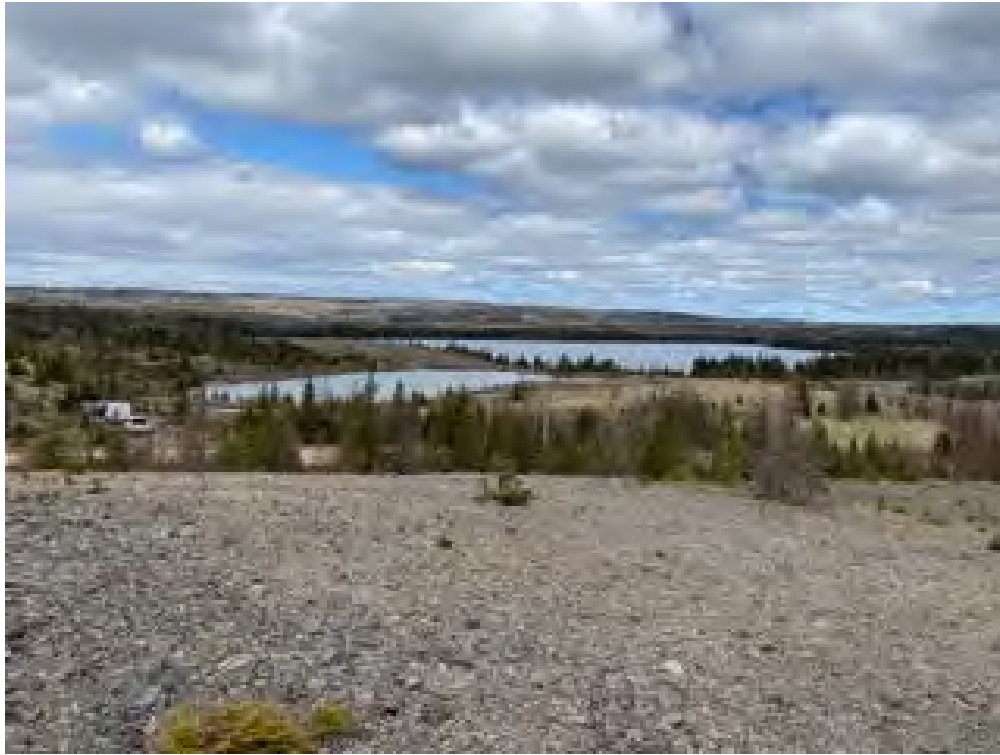
Photo 11. View from the top of APEC 5 overlooking site, facing northwest (May 2022).

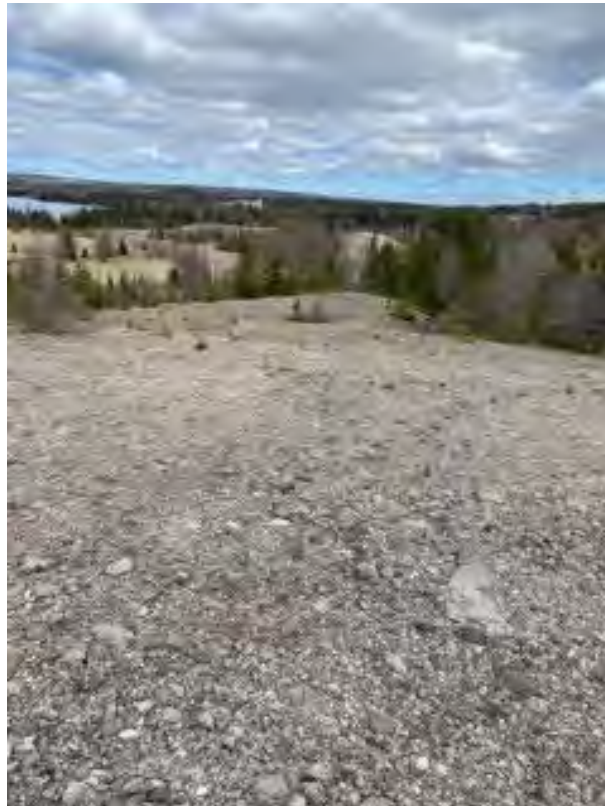
Photo 12. View of APEC 5, facing northeast (May 2022).

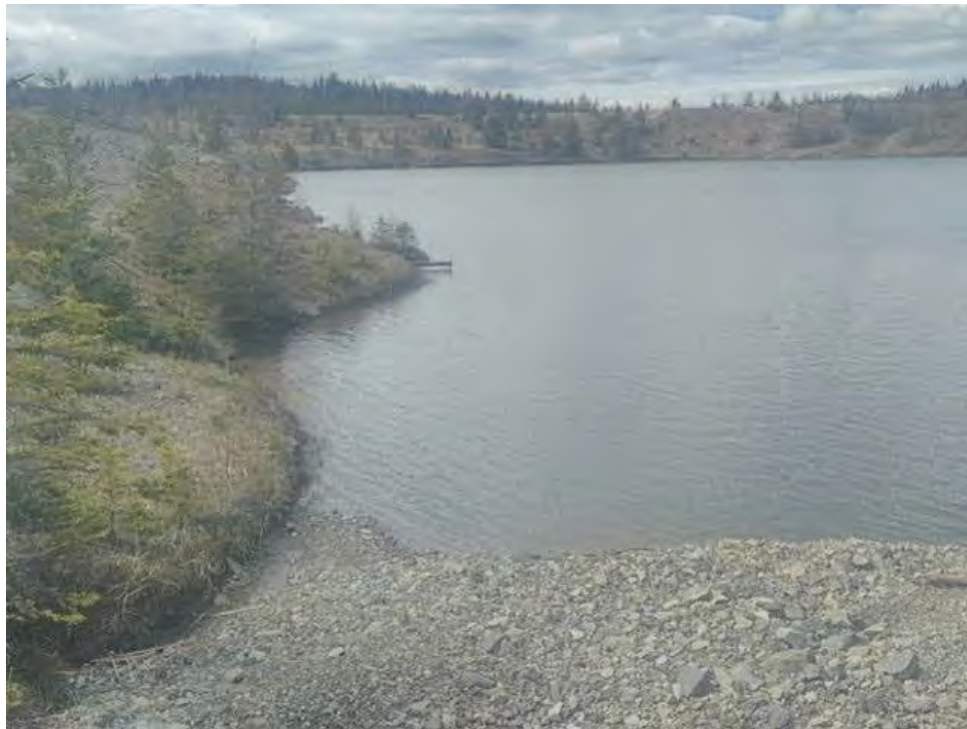
Photo 13. Culvert situated on the east side of APEC 6 (May 2022).

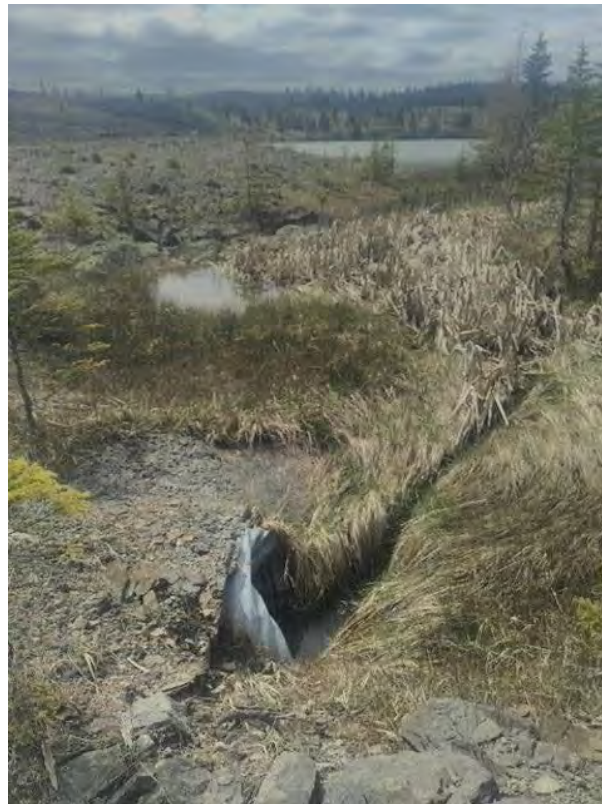
Photo 14. Western end of a culvert northeast of APEC 6, situated east to west (May 2022).

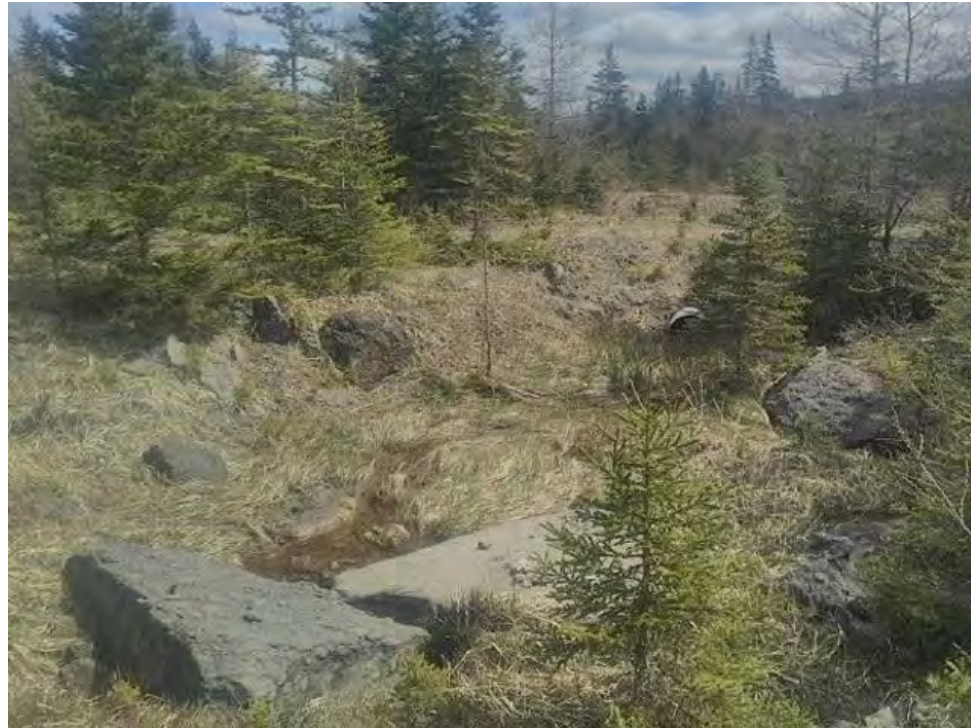
Photo 15. Culvert situated between APEC 6 and APEC 7 (May 2022).

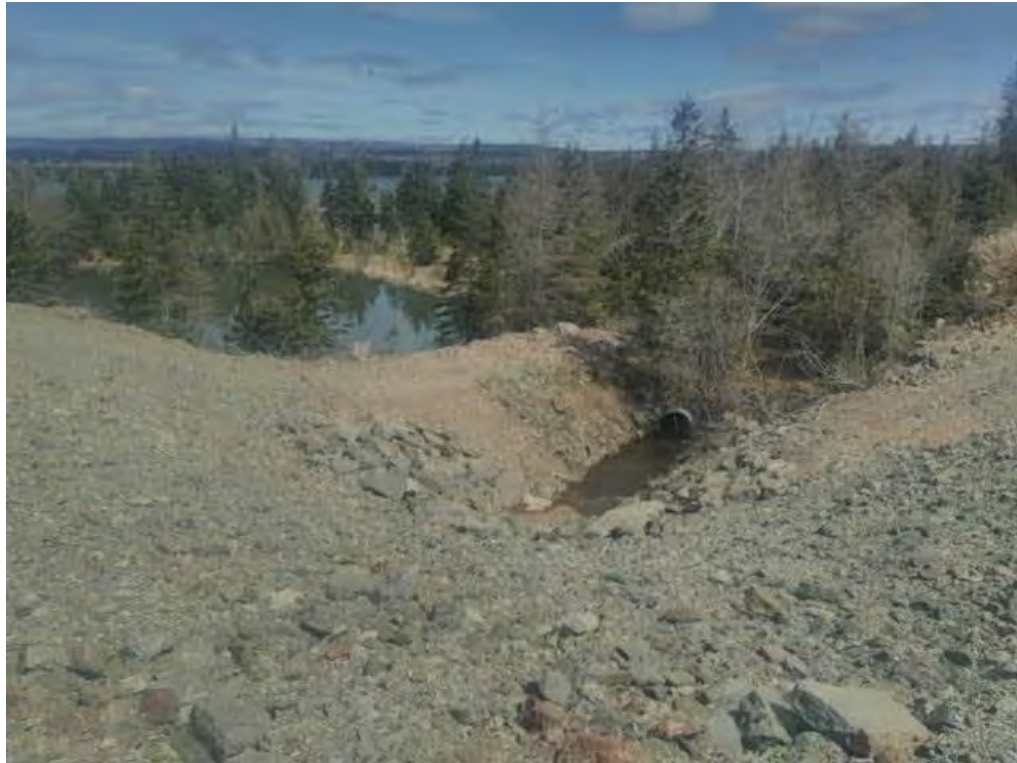
Photo 16. Culvert situated southeast of APEC 7, potential iron staining near culvert inlet (May 2022).

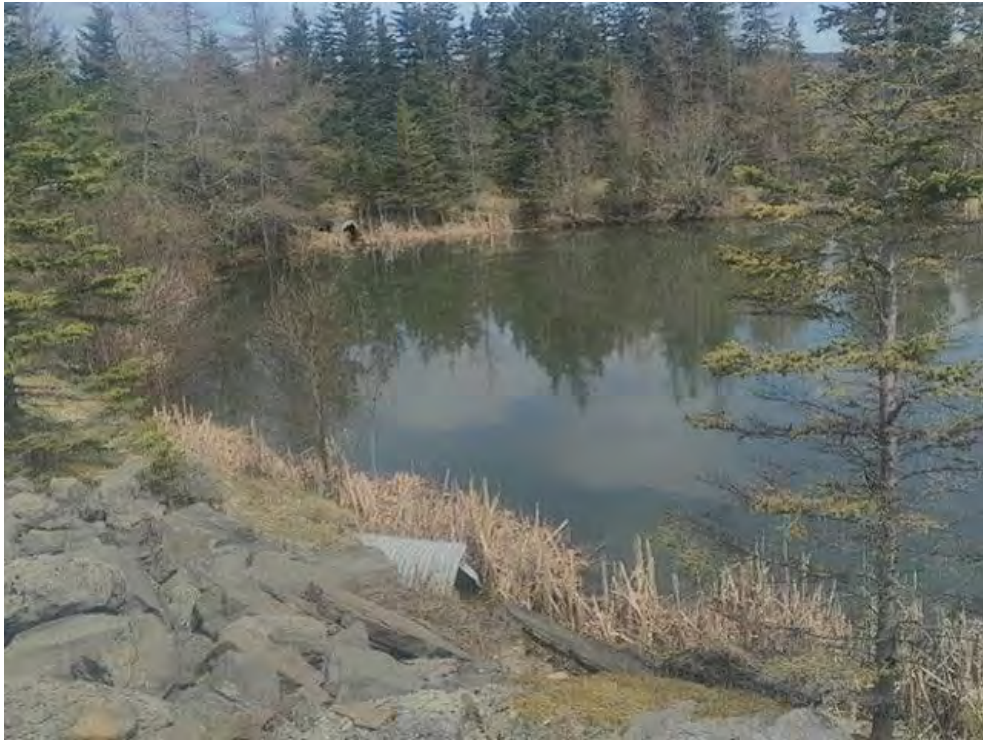
Photo 17. Culverts located at the northeast end of APEC 7 (May 2022).

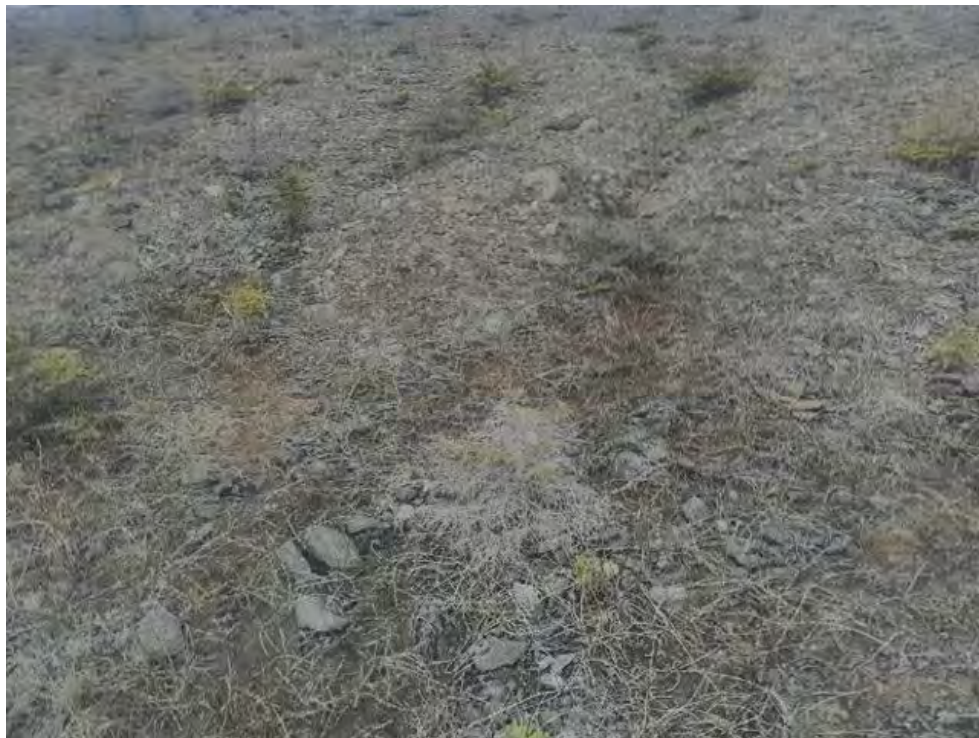
Photo 18. Precipitate observed near the northeast corner of APEC 1 (May 2022).

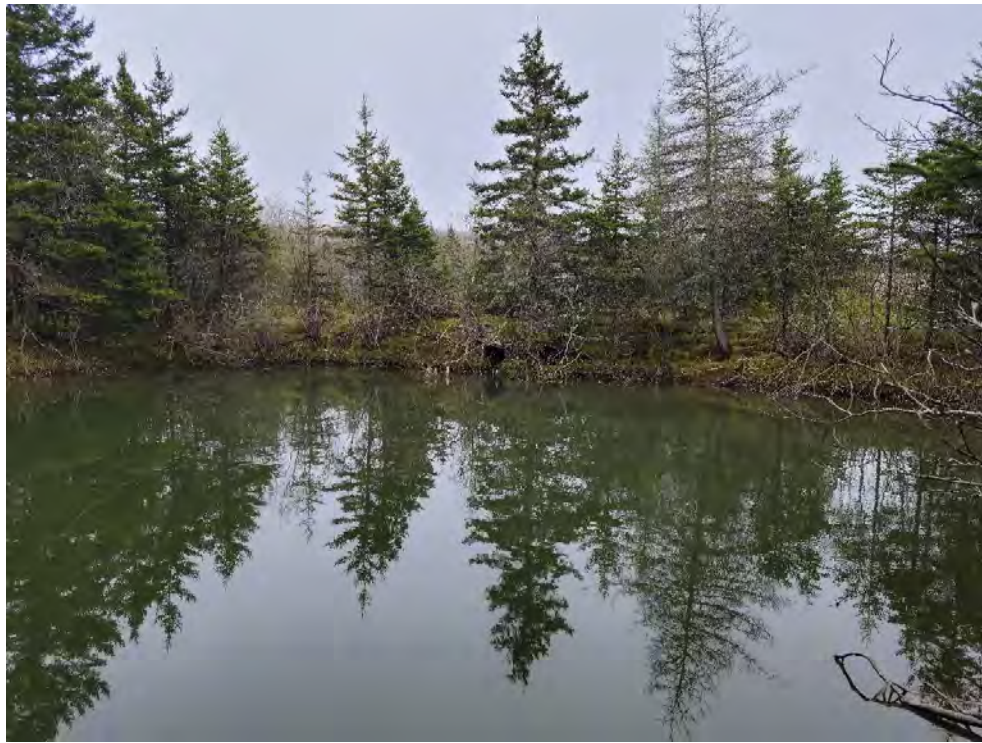
Photo 19. View of APEC 7, facing northwest (May 2022).

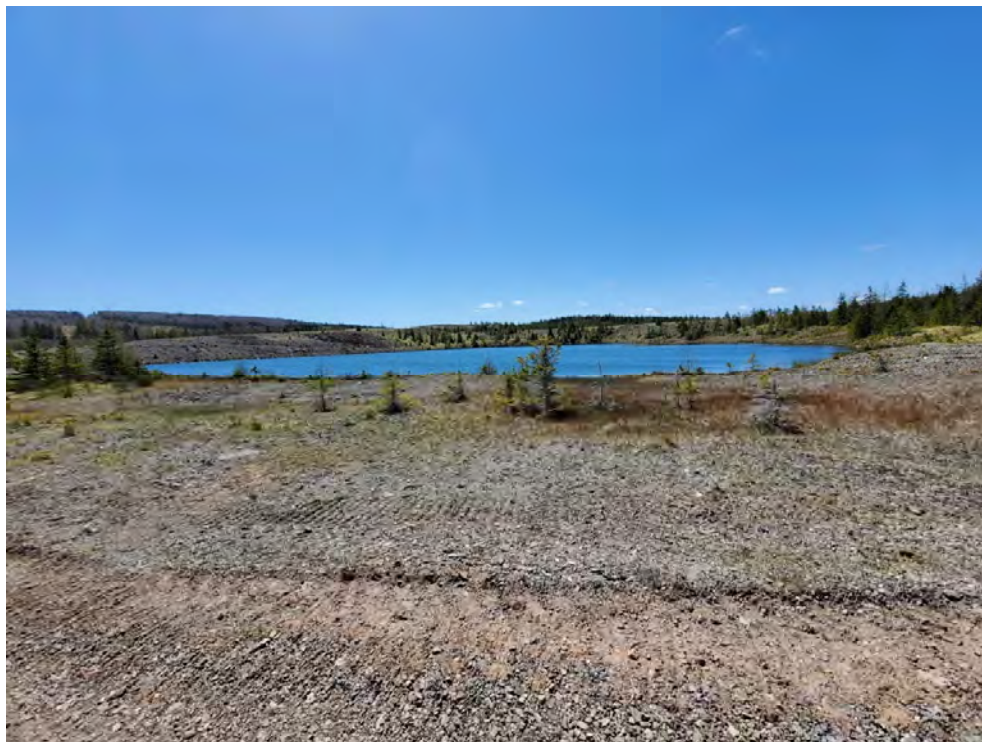
Photo 20. View of APEC 6, facing south (May 2022).

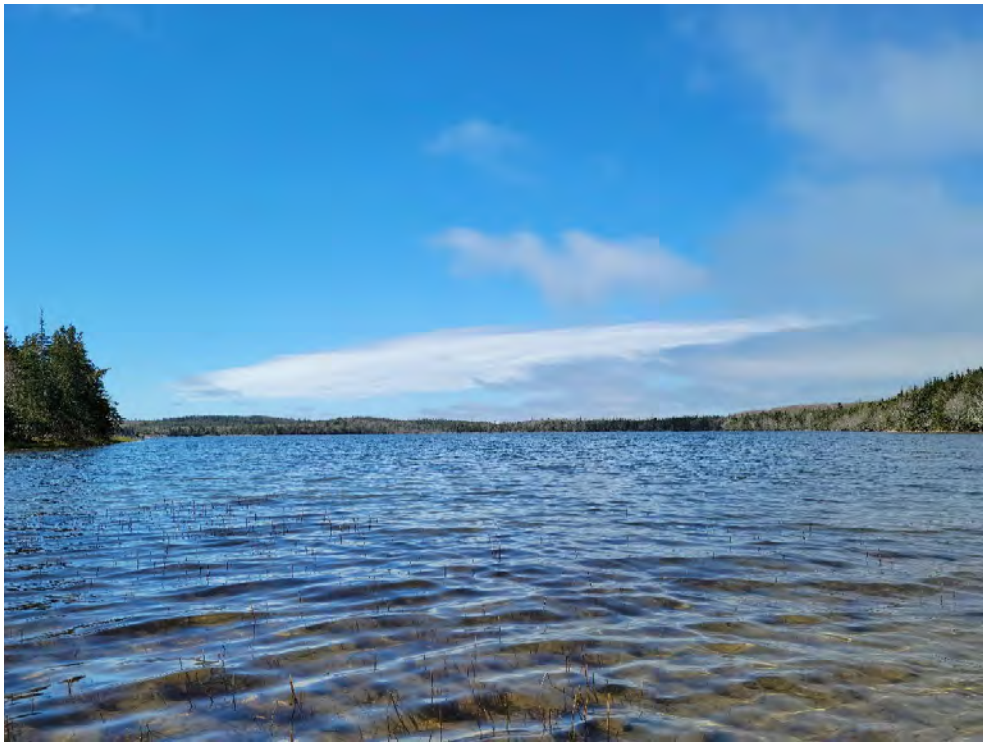
Photo 21. View of Enon Lake from the north shore, facing south (May 2022).

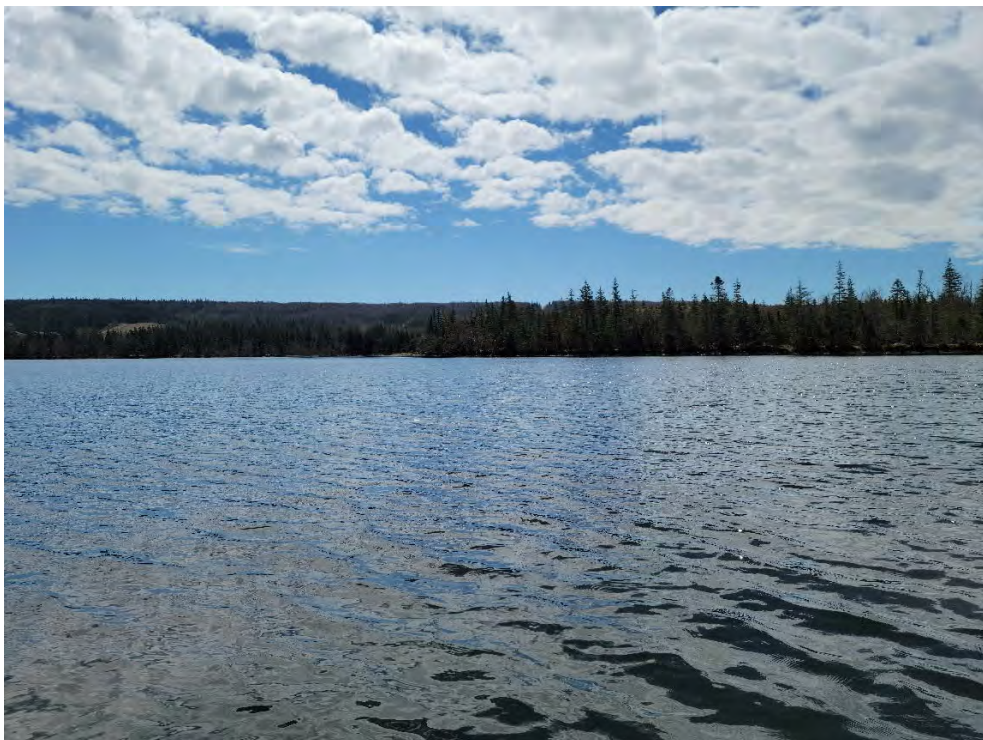
Photo 22. View of Enon Lake, facing south (May 2022).

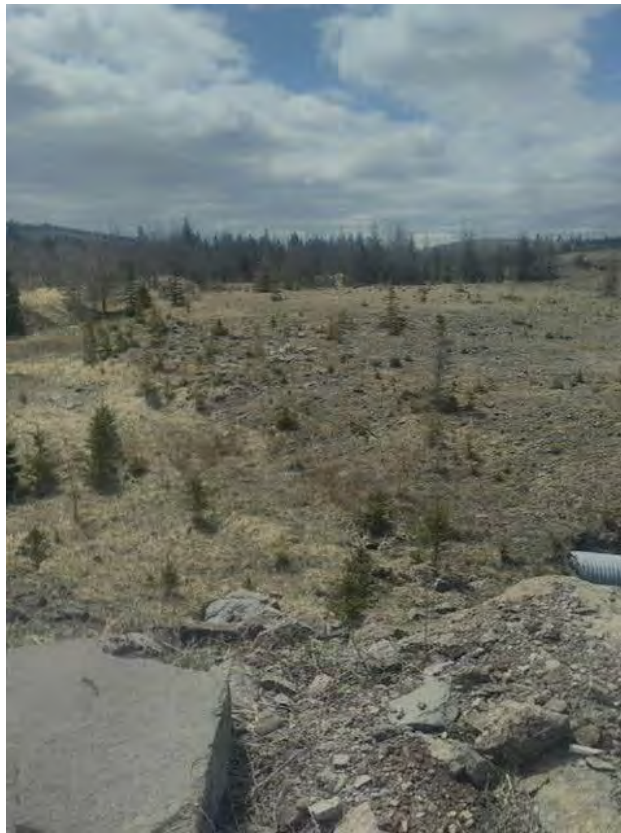
Photo 23. View of the northeastern portion of APEC 9, with discarded culvert on the right, facing south (May 2022).

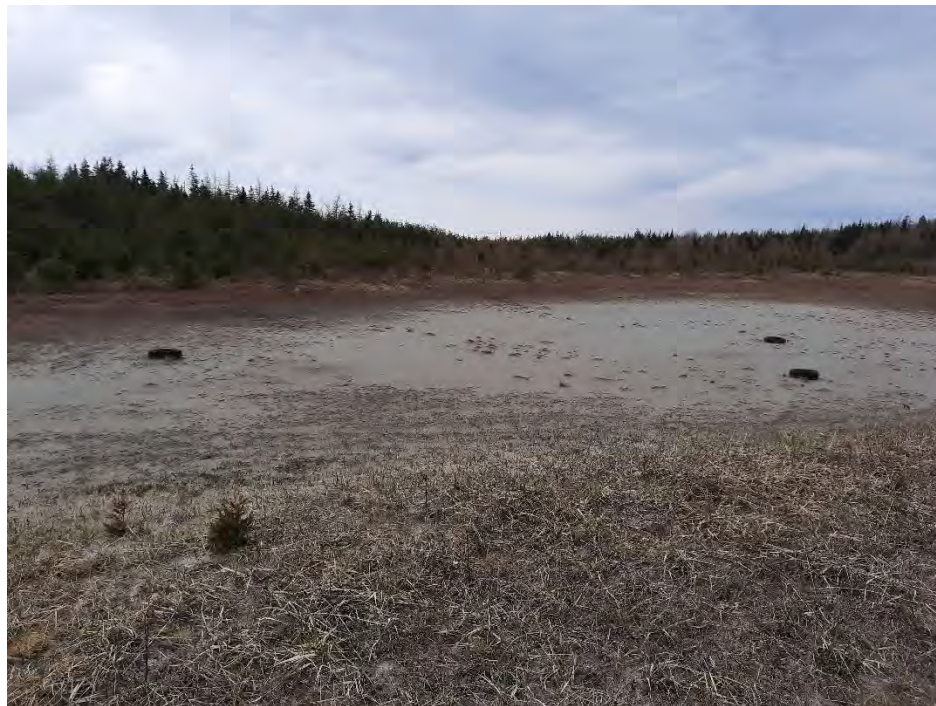
Photo 24. View of APEC 10, facing southwest (May 2022).

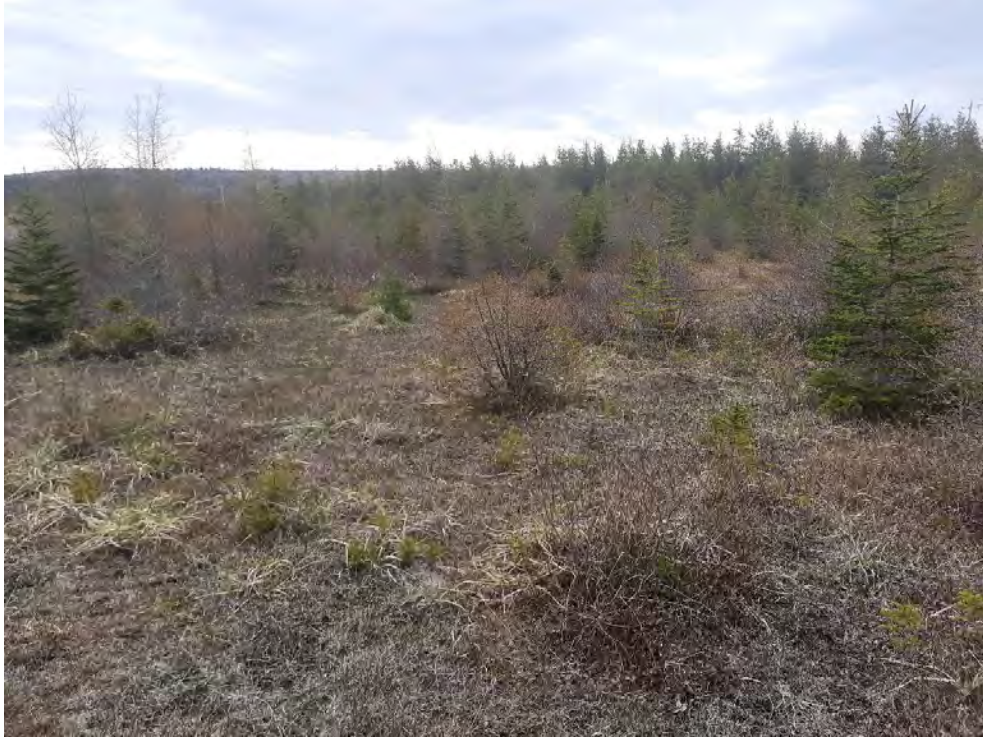
Photo 25. View of APEC 10, facing southeast (May 2022).

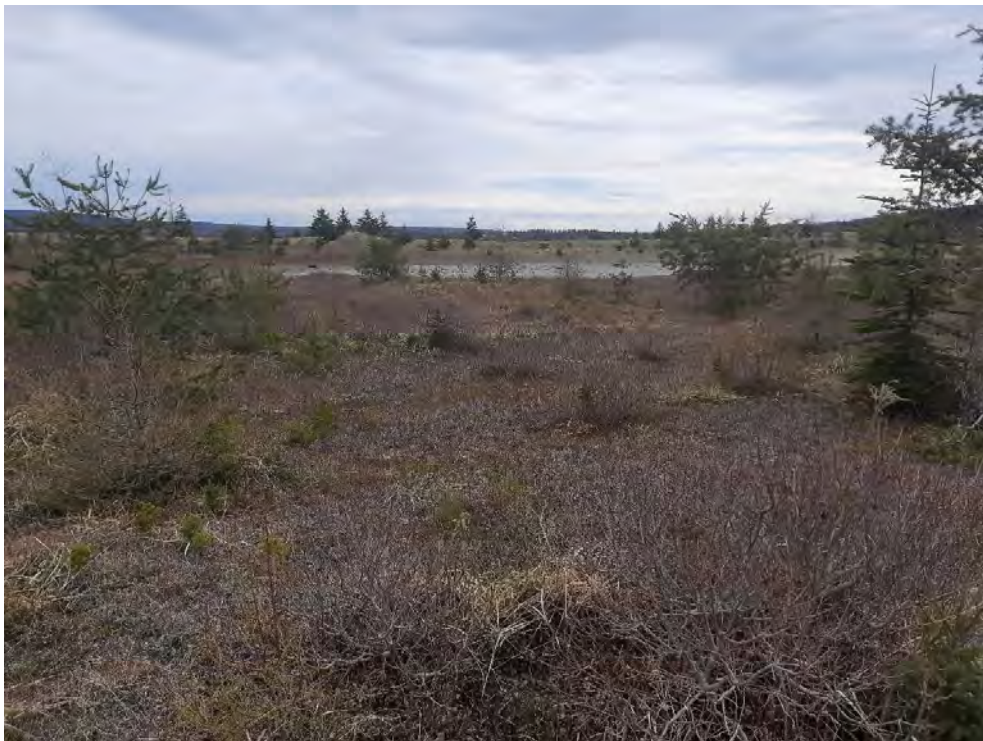
Photo 26. View of APEC 10, facing northeast (May 2022).

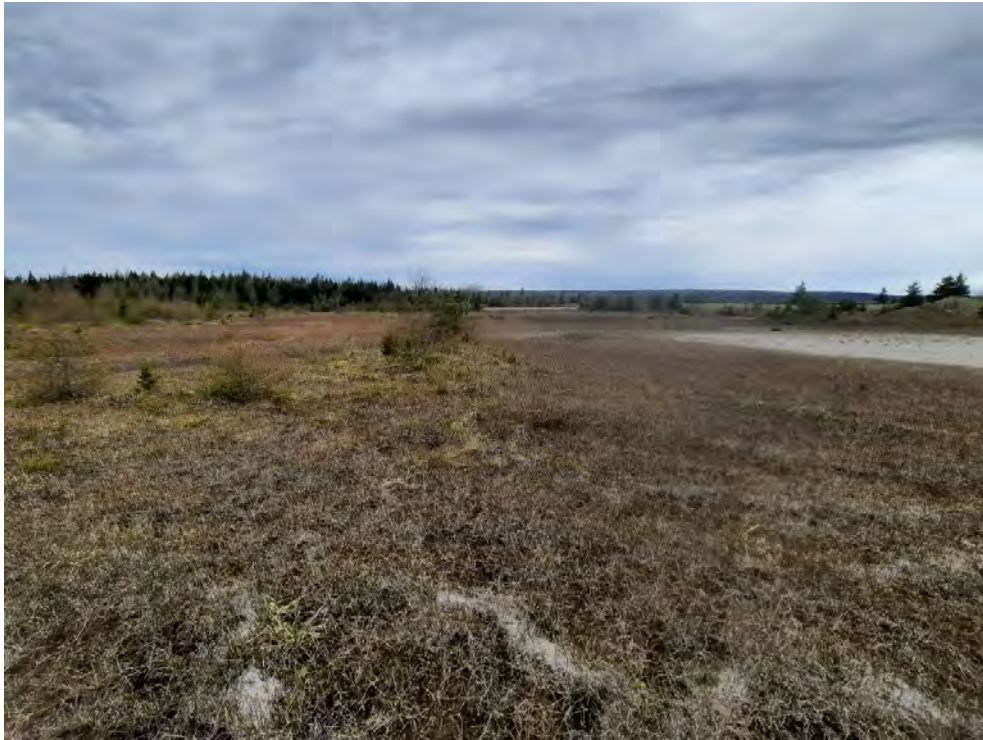
Photo 27. View of APEC 10 (foreground and right) and APEC 11 (background on left), facing north (May 2022).

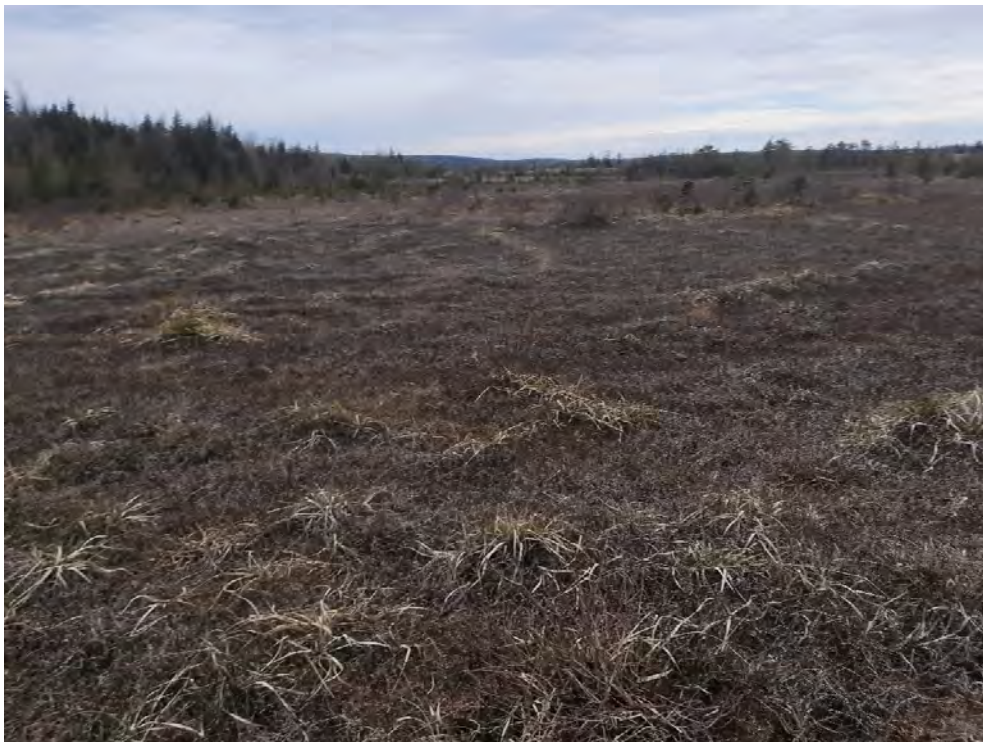
Photo 28. View of APEC 11, facing north (May 2022).

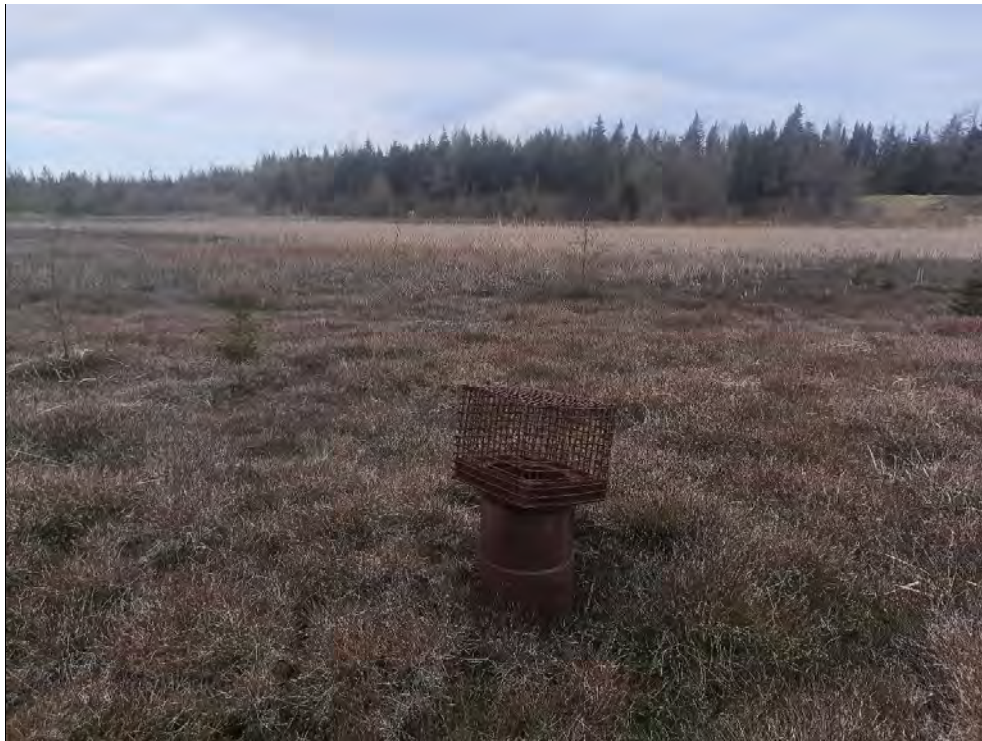
Photo 29. Drain located in APEC 11, facing west (May 2022).

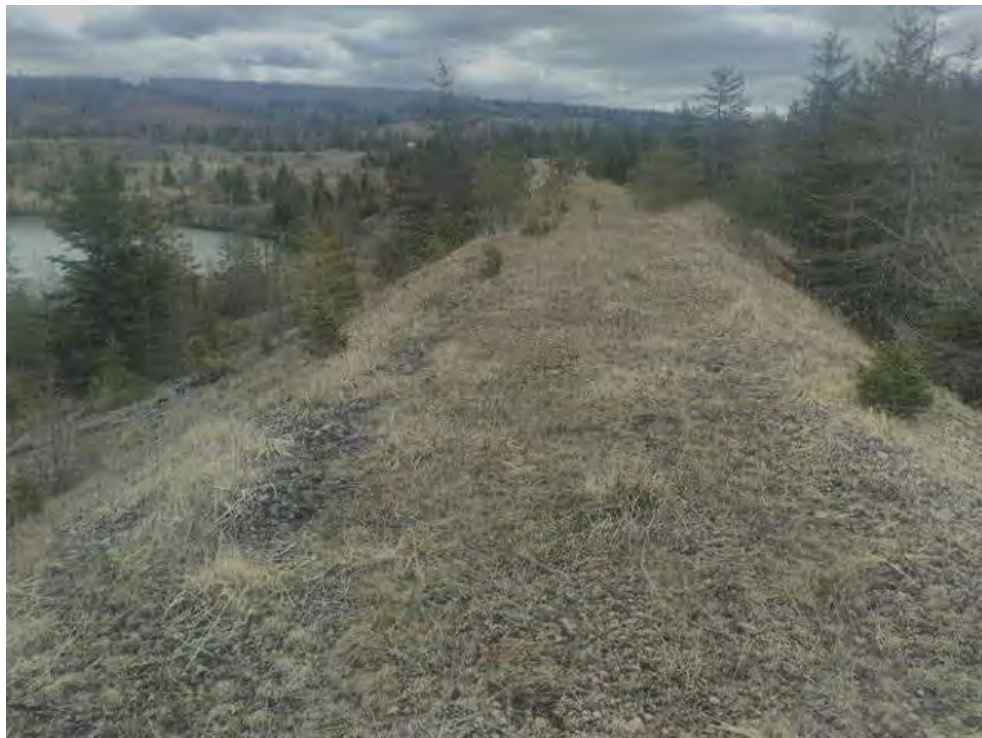
Photo 30. View of access road facing southeast towards Loch Lomond Road. APEC 6 visible to the left (May 2022).

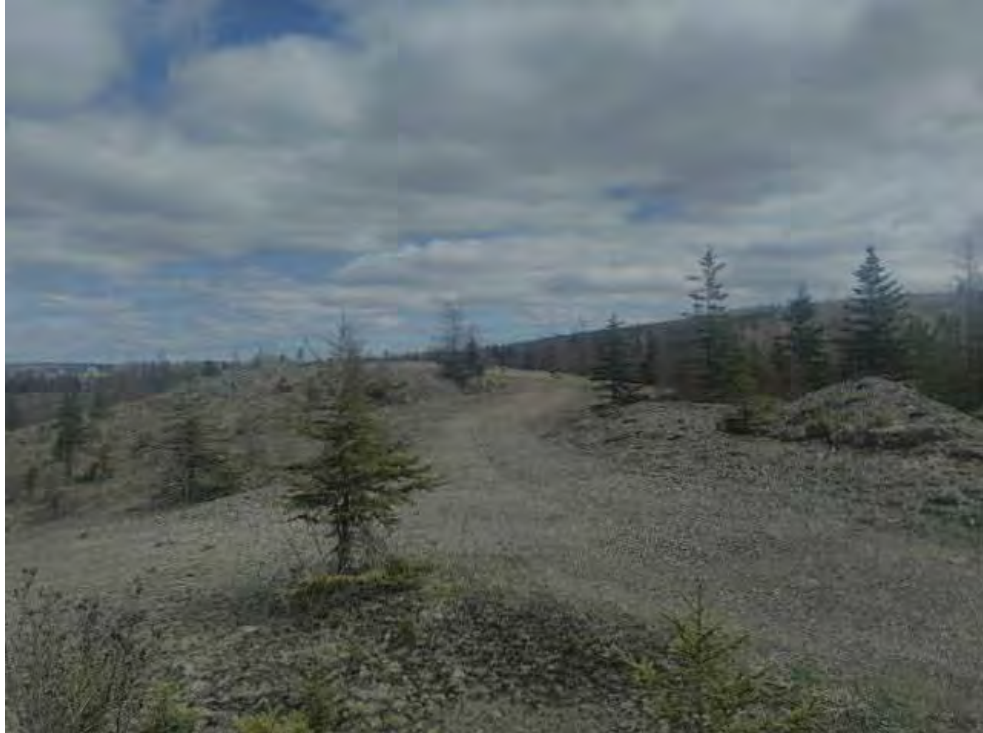
Photo 31. View of APEC 9 from access road, facing northeast (May 2022).

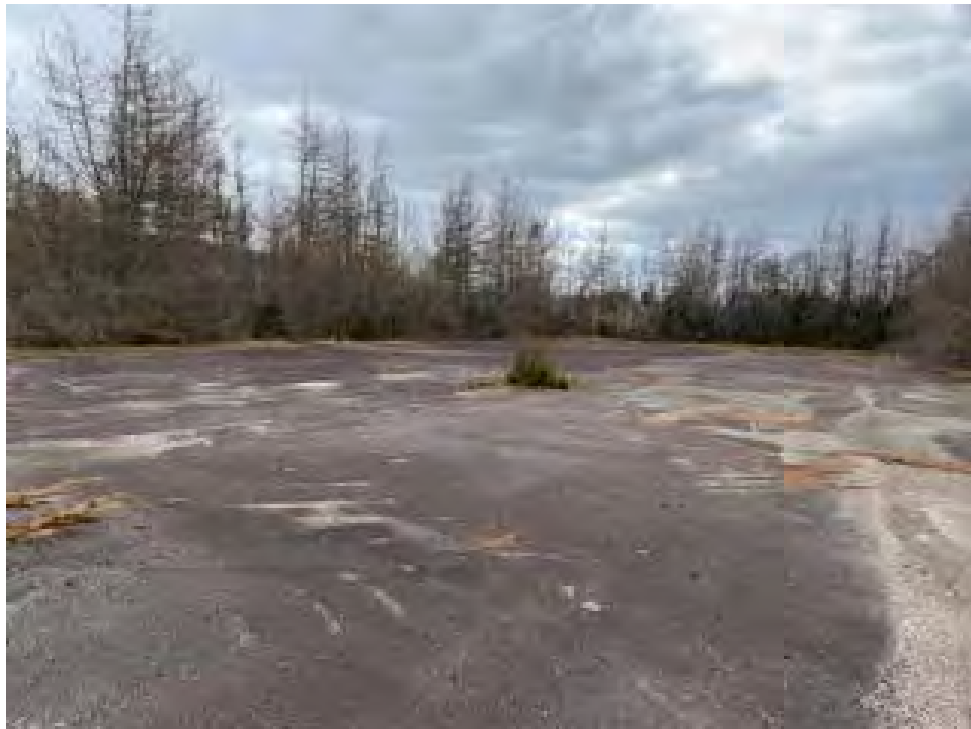
Photo 32. View of APEC 12, facing south (May 2022).
