NOVA SCOTIA LANDS INC.

## Phase I Environmental Site Assessment (Final)

Lake Enon Former Mill Site, Enon, Nova Scotia, PID Nos: 15551369,  
15340045, and 15340052

October 2022 – 22-3723

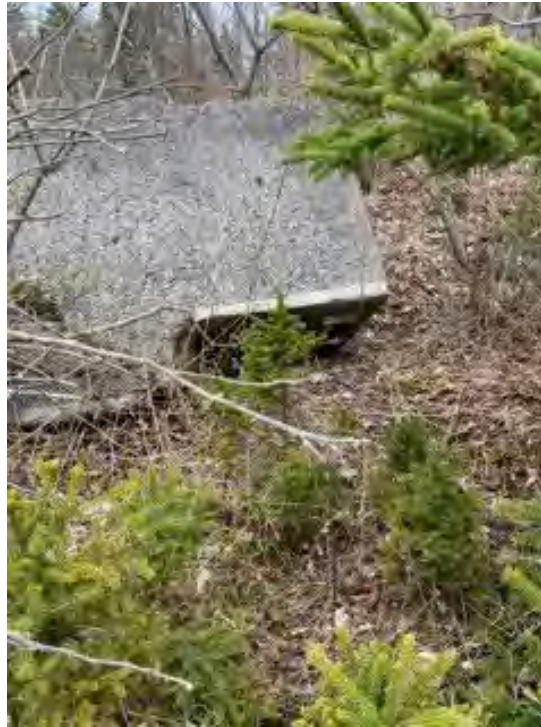
Photo 32. Concrete container situated near the northern boundary of APEC 12 (May 2022).

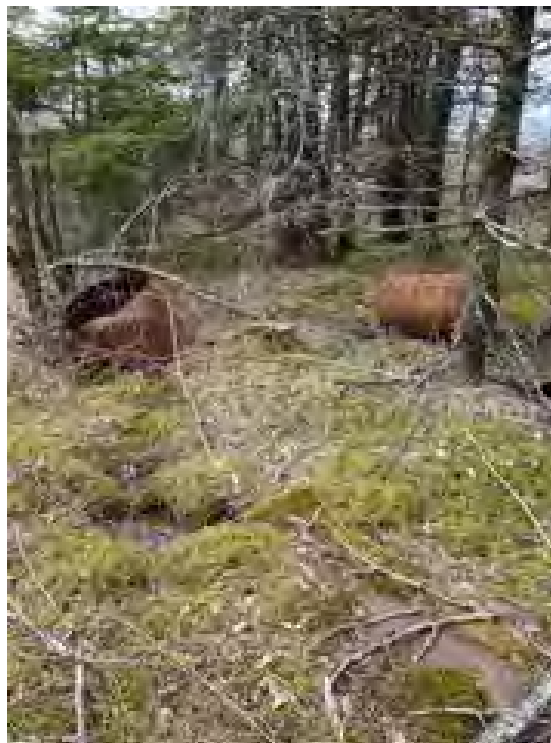
3. Hazardous Waste Management	Abandoned drums were observed on-site east and west of Loch Lomond Road. Some of the drums were observed to be partially buried. The contents of partially buried drums are unknown.	Yes

Photo 32. Drums situated north of APEC 12 (May 2022).

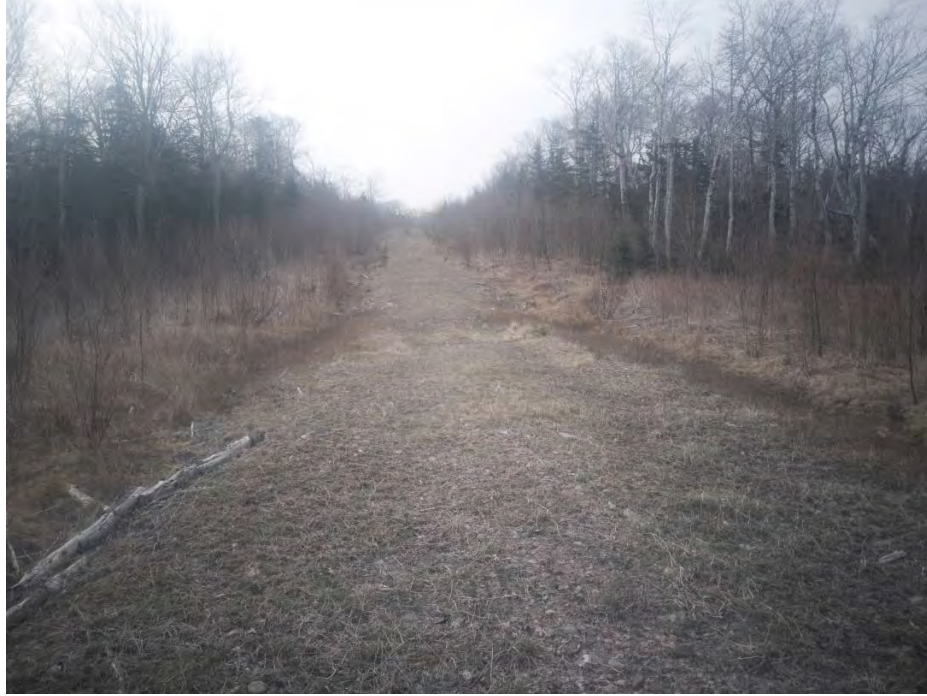
Photo 33. Pathway extending southeast from Loch Lomond Road, south of APEC 12, facing southeast (May 2022).

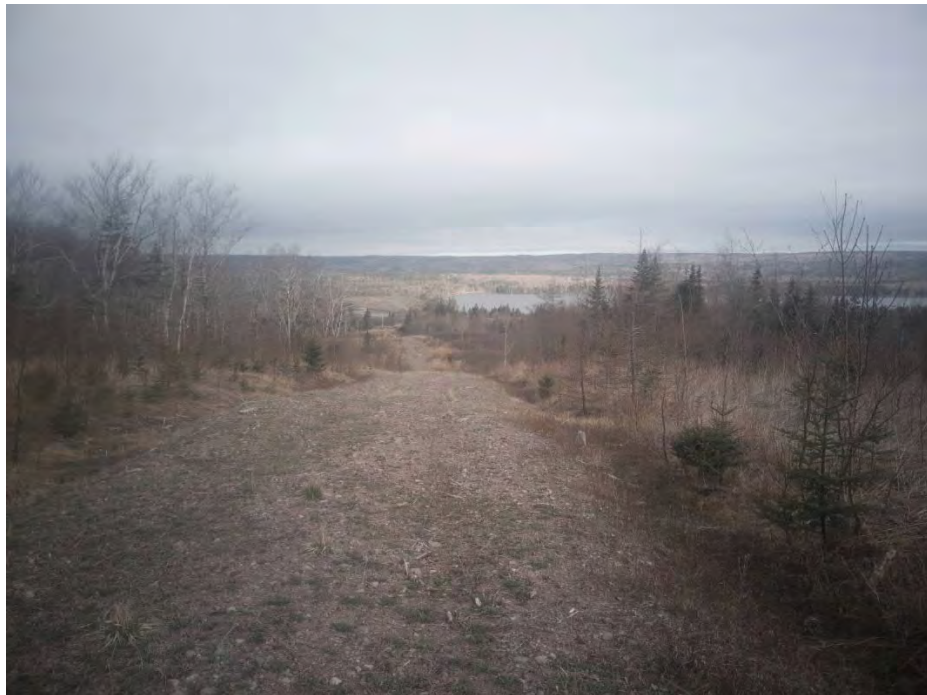
Photo 32. Pathway extending southeast from Loch Lomond Road, south of APEC 12, facing northwest (May 2022).

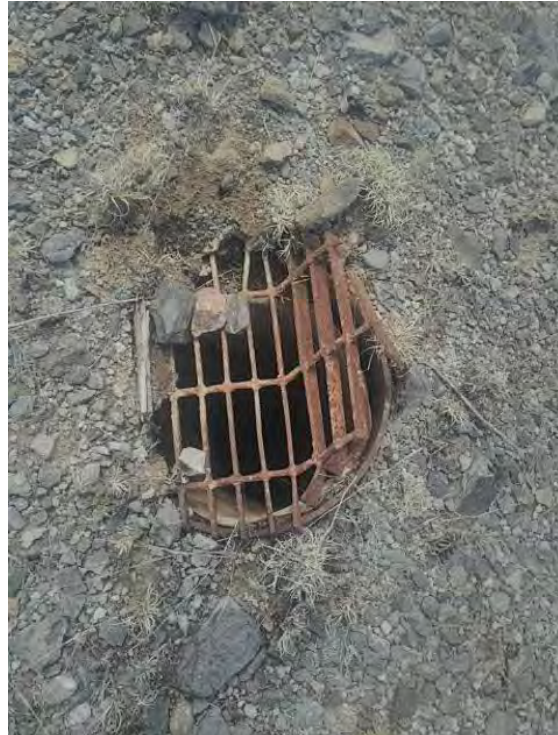
Photo 35. In-ground drain located north of APEC 6 and southeast of APEC 2 (May 2022).

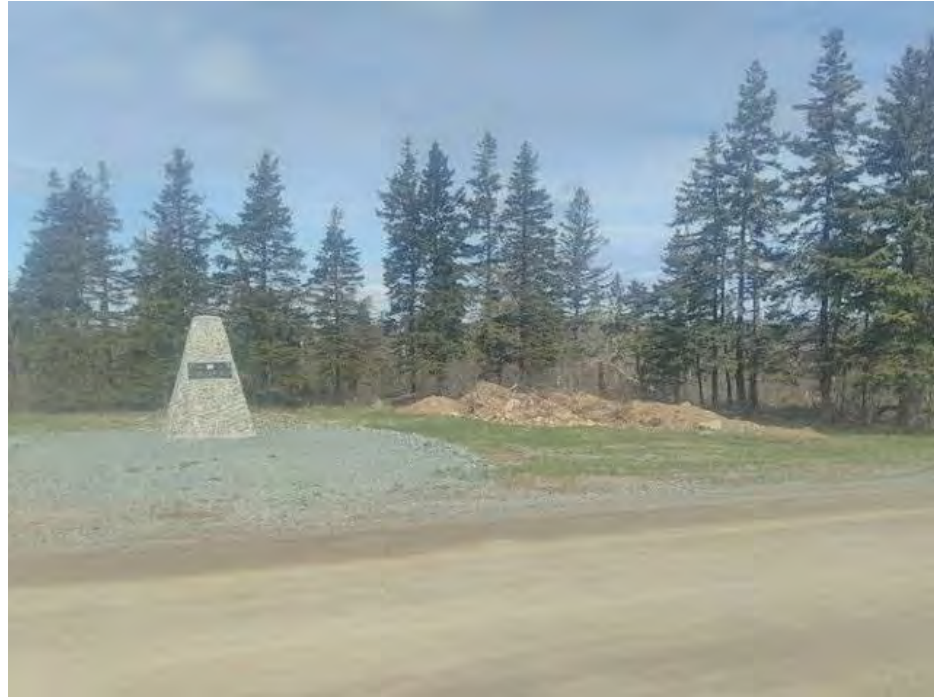
Photo 32. Memorial cairn located on PID No. 15340029, located adjacent to the site's northern boundary, and west of Loch Lomond Road (May 2022).
