Phase I Environmental Site Assessment (Final)

Former Frenchvale Mine Site, Frenchvale, Nova Scotia

Property Identification Designation Number: 15845167

April 2025 – 24-8606

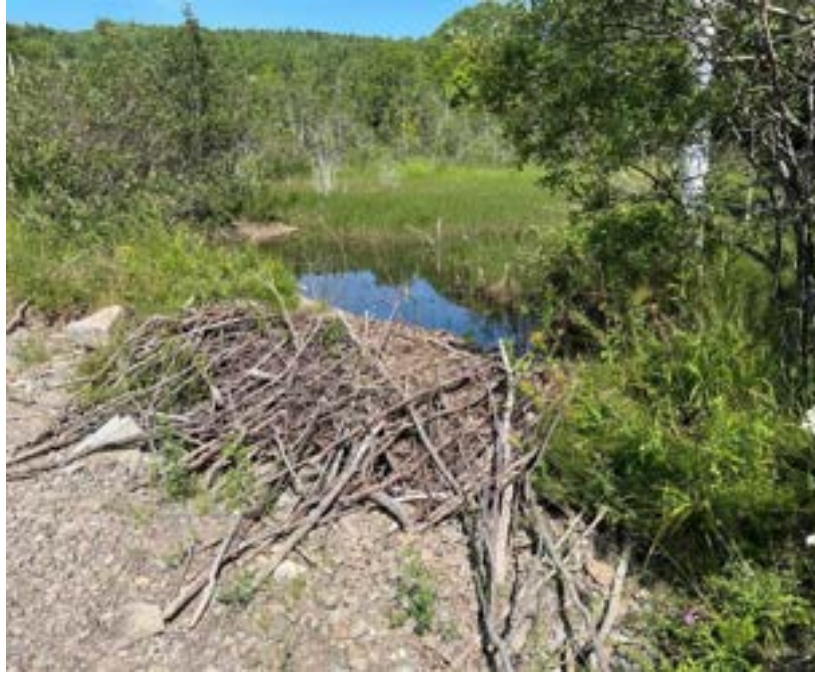
Photo 1: View of an on-site pond with apparent beaver activity, facing northwest. (July 25, 2024)

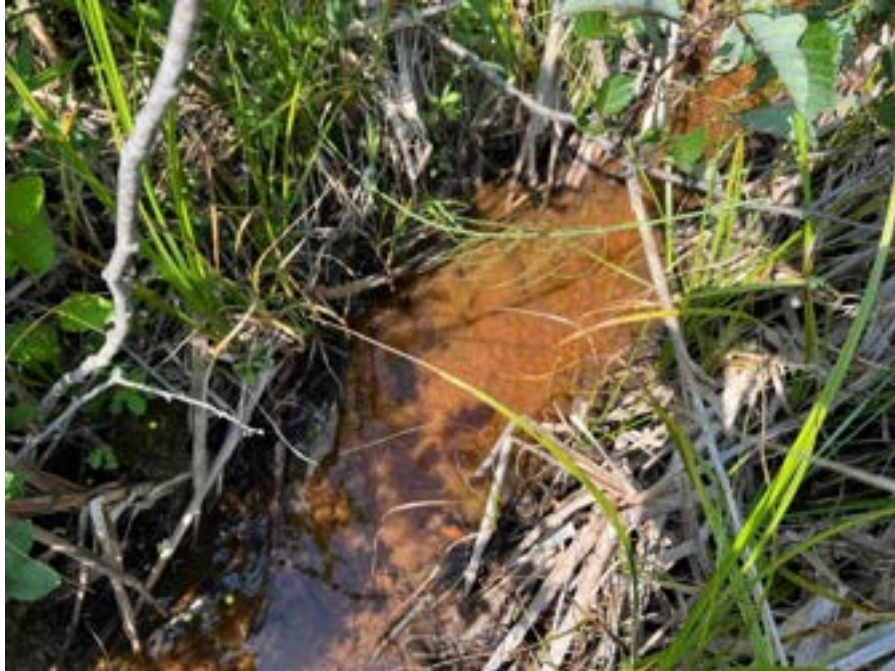
- Suspected overburden covers an area of approximately 11,000 square meters (m²) and may vary in thickness. Precipitate staining, typically associated with iron, was identified in a ditch that drained from a small ponded area near the entrance of the former mine site to a watercourse, which flows south to Gouthro Lake.

Photo 3: View of possible iron precipitate observed in an on-site watercourse that discharges to Gouthro Lake. (July 25, 2024)

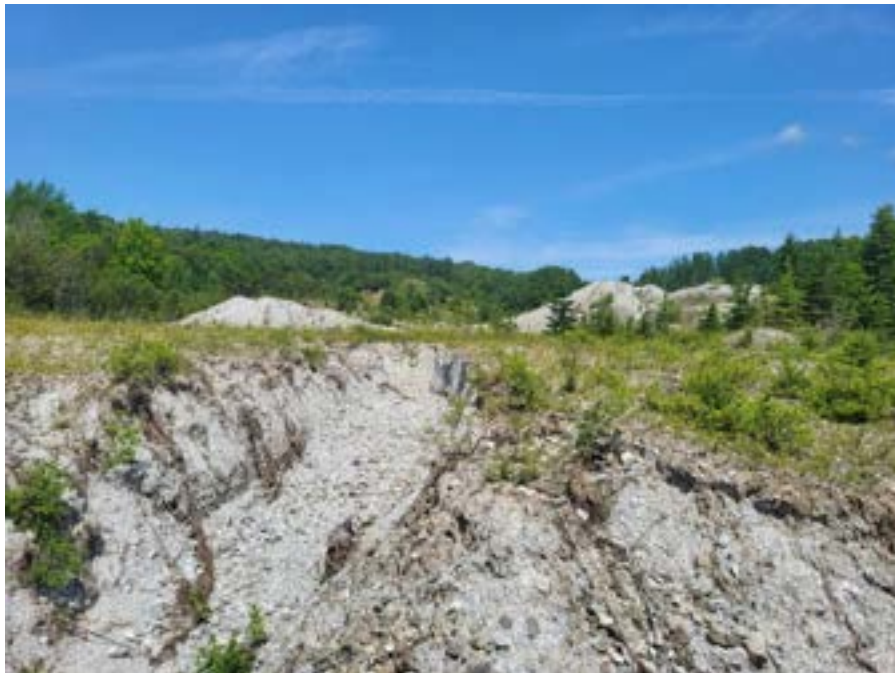
Photo 4: View of stockpile washout to the shore of Gouthro Lake, facing north. (July 25, 2024)

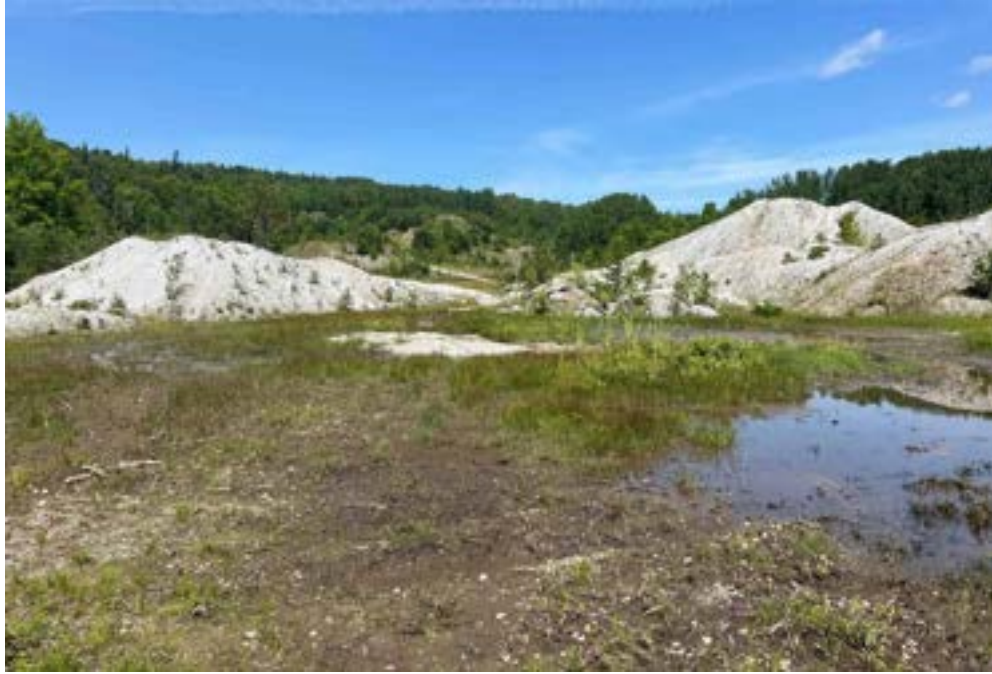
Photo 5: View of on-site stockpiles and ponded water, facing east. (July 25, 2024)

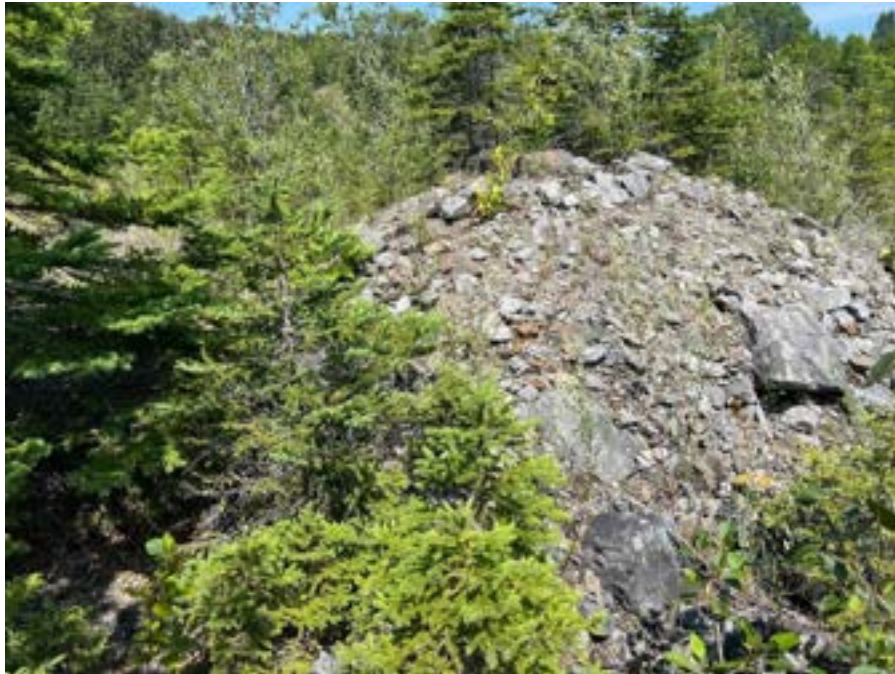
4	Waste-Rock Pile	<ul style="list-style-type: none"> Metals pH PHCs PAHs Gross Alpha Beta for NORM ARD 	Soil, SW, Sediment	Waste rock pile with iron staining and seep identified during the Phase I ESA site visit.
5	Former off-site and upgradient quarry operations	<ul style="list-style-type: none"> Metals pH PHCs PAHs Gross Alpha Beta for NORM ARD 	Soil, SW, Sediment	Partially buried debris identified at site boundary during the Phase I ESA site visit; unknown demolition/decommissioning practices.

Photo 6: View of an on-site waste rock pile with iron staining observed. (July 25, 2024)

Based on the identified APECs and corresponding COPCs, assessment of relevant media of concern (i.e., soil, surface water, and sediment) is recommended to include metals (including mercury and sulphur), PHCs, PAHs, PCBs, pH, conductivity, and general chemistry. Potential NORM can be initially assessed for by collection of one sample for gross alpha beta analysis. It is recommended that ARD be pre-screened by assessing concentrations of sulphur, chloride, electrical conductivity, sodium adsorption ratio, and pH at select surface soil and sediment sample locations in areas where overburden piles and waste rock have been identified (i.e., APECs #1 and #4).

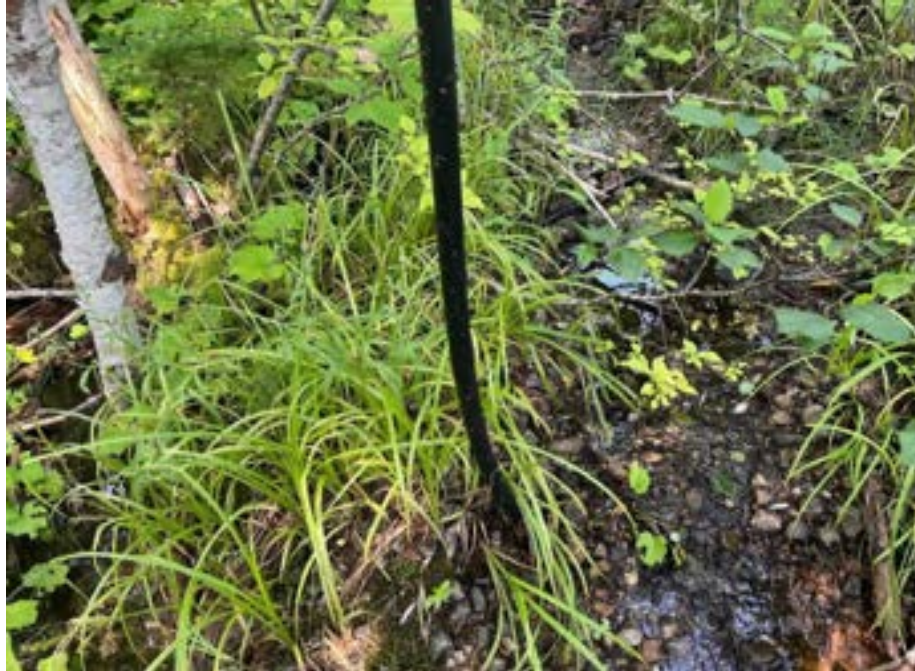
Photo 7. View of a pipe observed on-site, use unknown. (July 25, 2024)

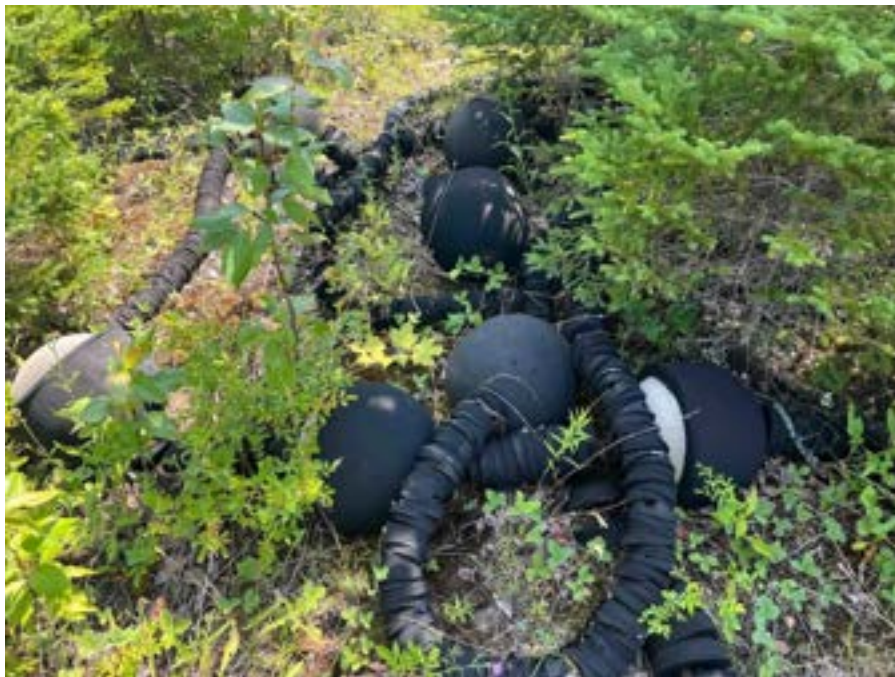
Photo 8: View of discarded fishing gear observed on-site near northeast property boundary. (July 25, 2024)

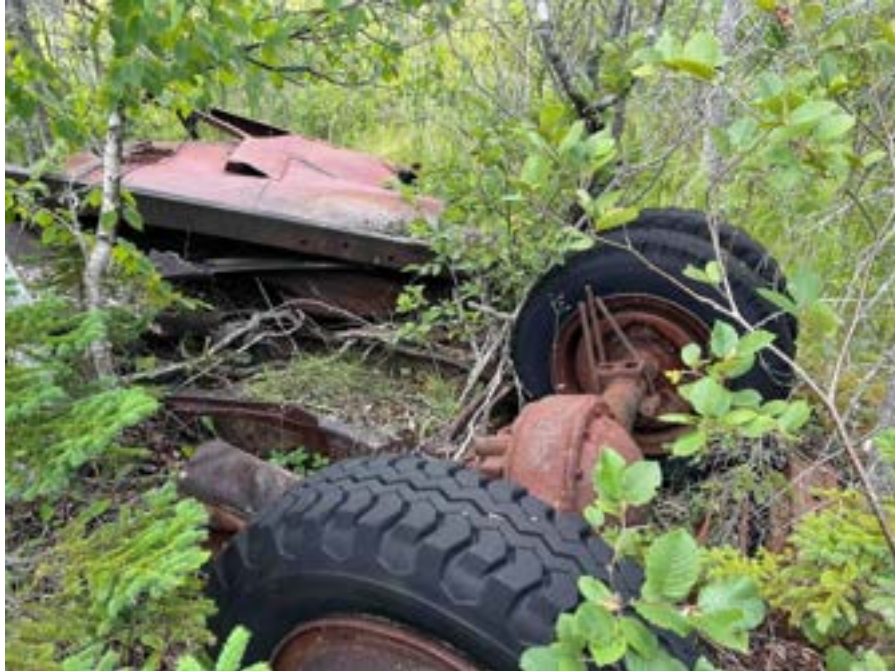
- Heavily rusted equipment debris was observed at the northern portion of the site. This equipment has the potential to contain fluids. No staining or odours were observed in the area of the equipment.

Photo 9: View of rusted vehicle/equipment debris. (July 25, 2024)

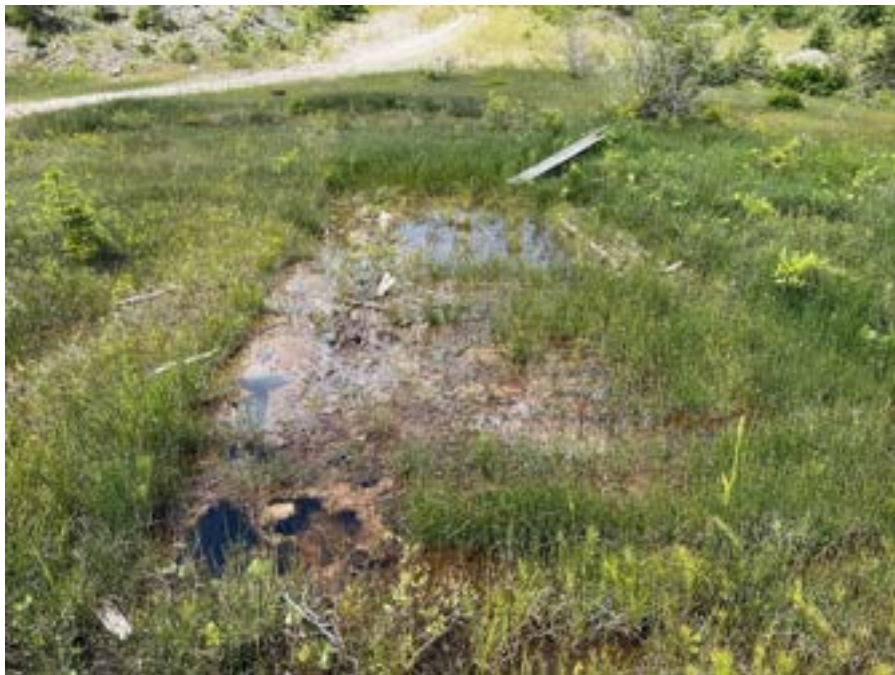
12.	Pesticides/Herbicides	No known sources of pesticides/herbicides used on-site.	No
13.	Pits/Lagoons	No lagoons were observed on the subject property. Remnants of a weigh scale foundation are present on the northwest portion of the site and is currently holding water,	No (Safety hazard)

Photo 10: View of weigh scale remains. (July 25, 2024)

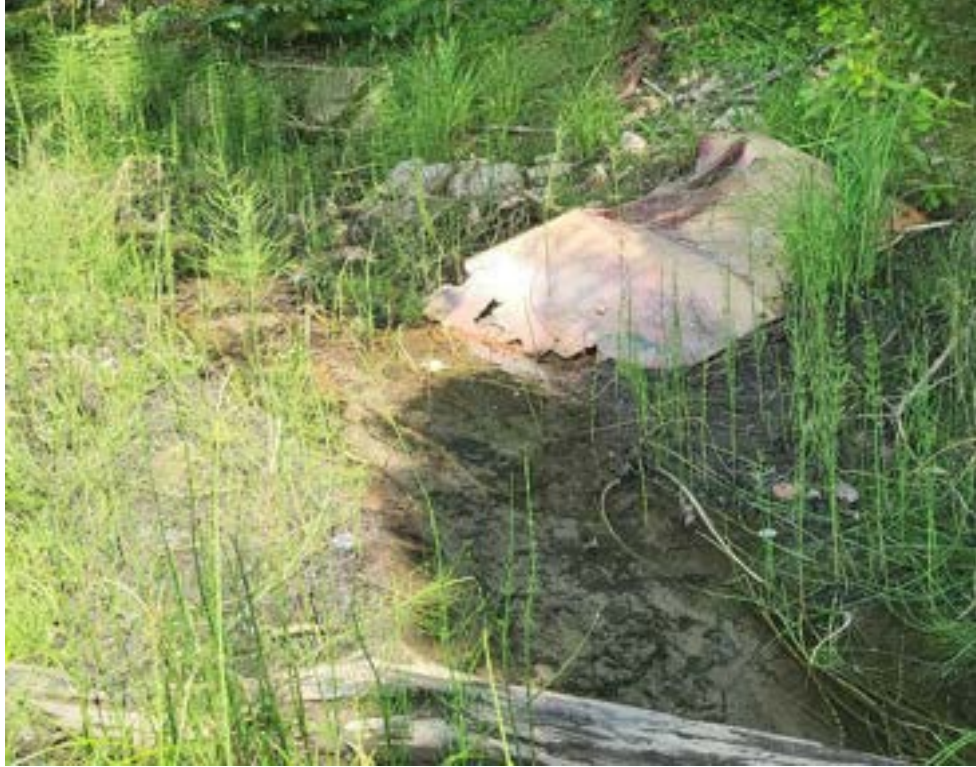
- Metal debris was identified throughout the site, the majority of which was observed to be within the northern portion of the site. Metal debris was observed within a watercourse at the northern portion of the site, and also within the water body situated north of the access road. The majority of on-site metal debris was observed to be heavily rusted.

Photo 11: View of rusted metal debris observed within an on-site watercourse; located upgradient of an on-site pond. (July 25, 2024)

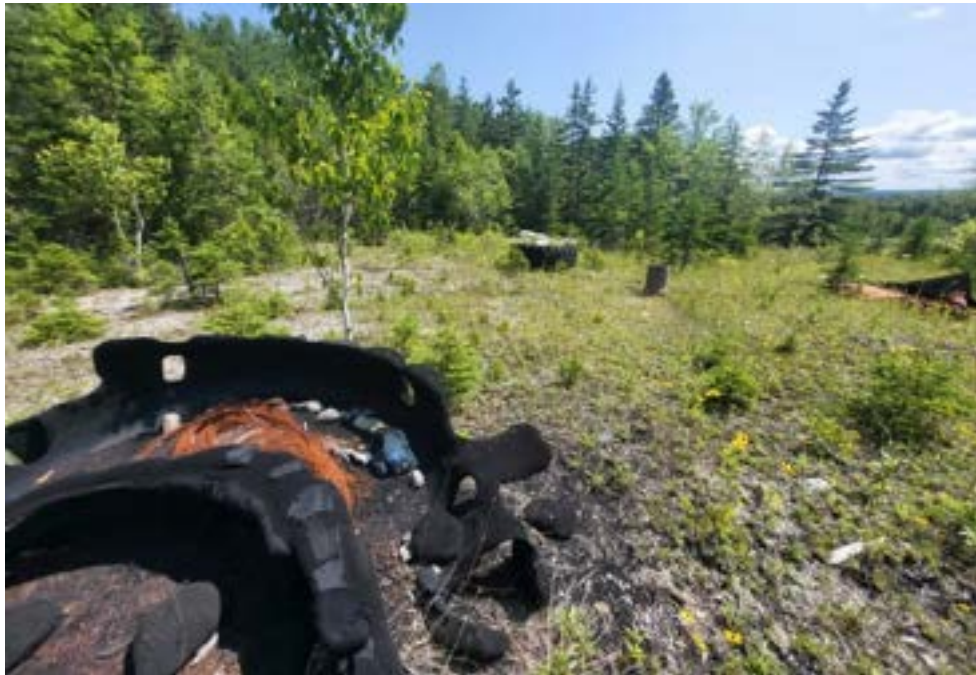
- Burned tires were observed at the northern portion of the site. No obvious signs of accelerants were observed; however, soil surrounding burned tires was observed to be discoloured.

- Rolls of geotextile were observed near the burned tires and also partially buried under stockpiles within the central portion of the site. This material is inert and does not represent an environmental concern to the site; however, it represents the potential for other materials and/or debris to be buried on-site.

Photo 12: View of burned heavy equipment, tires, metal, geotextiles, and concrete debris. (July 25, 2024)
