**BNS MILLER LAKE
PHASE I ESA REPORT**

Site Visit Photo Log

Report Name
Miller Lake Mine Sites

Client:	Build Nova Scotia
Project:	Phase I Environmental Site Assessment of Miller Lake
Project Number:	60711967

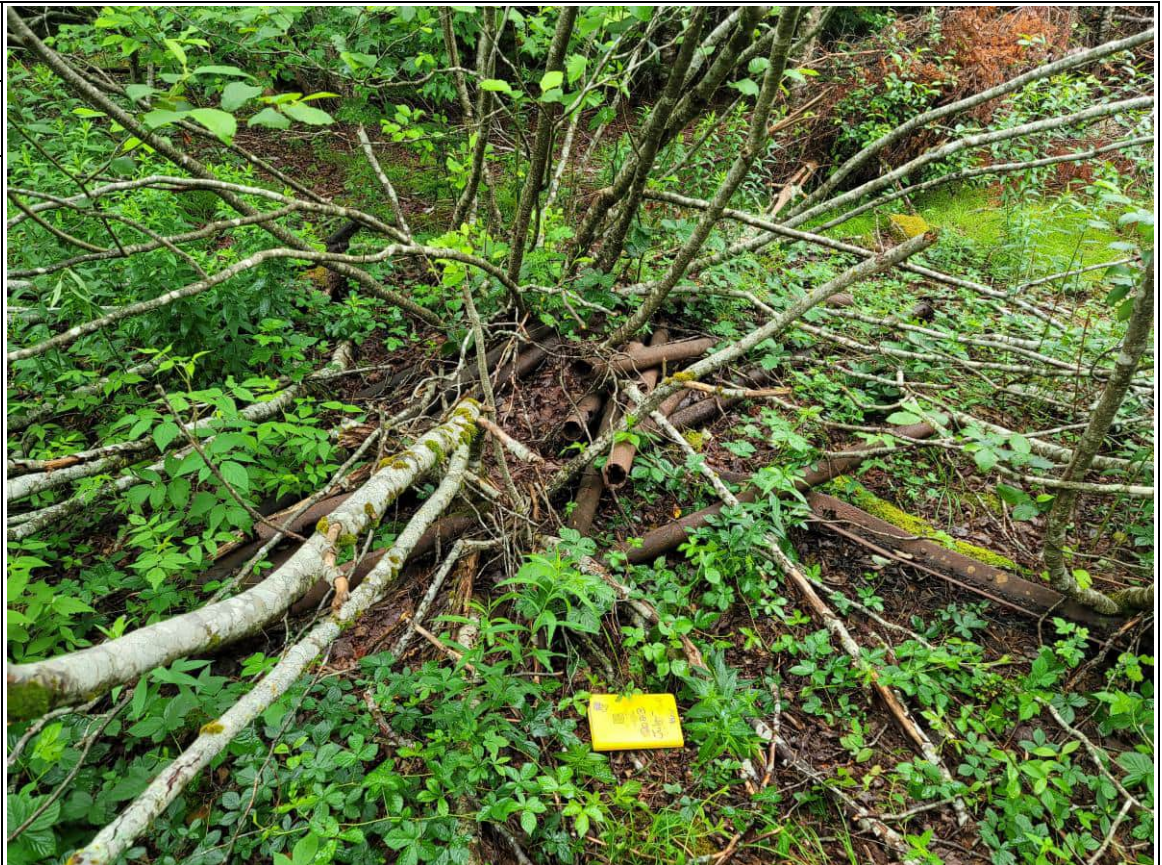
Photo No.	Date
1-01	7/18/2023
Subsite	
01 (West)	
Description	
Discarded metal pipes.

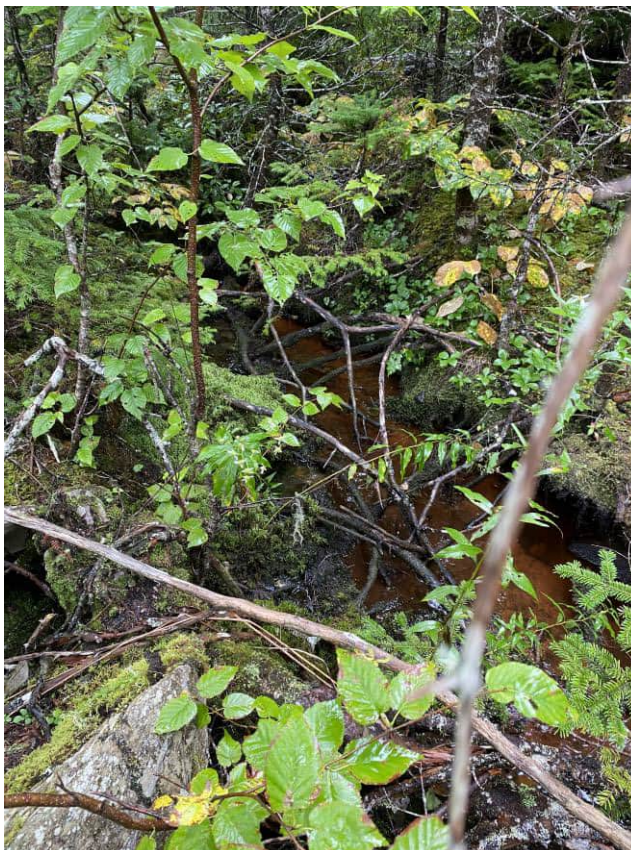
Photo No.	Date
1-02	9/7/2023
Subsite	
01 (West)	
Description	
Downstream water course.	
Sediment sampling location at Subsite 01.

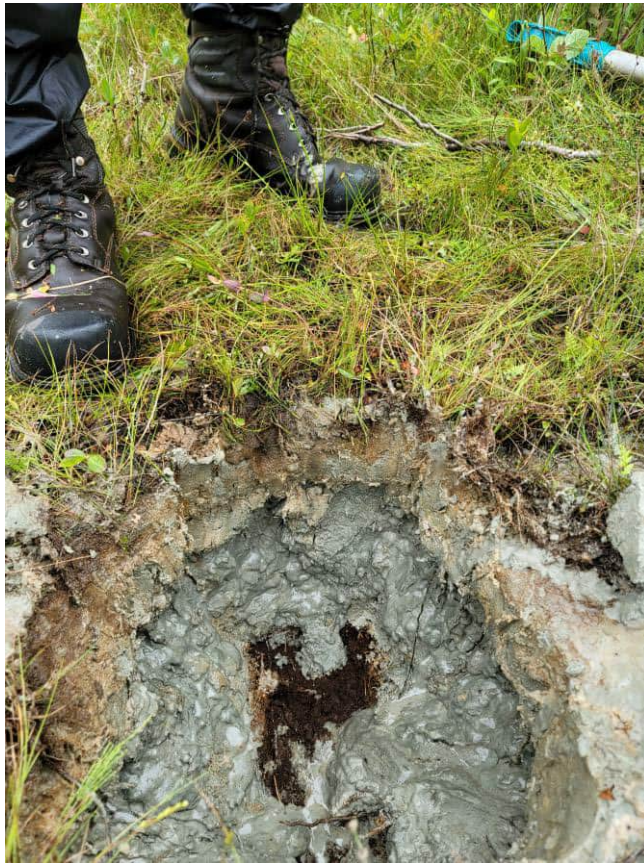
Photo No. 1-03	Date 7/18/2023
Subsite 01 (West)	
Description Site 01 tailings deposit. Sampled.

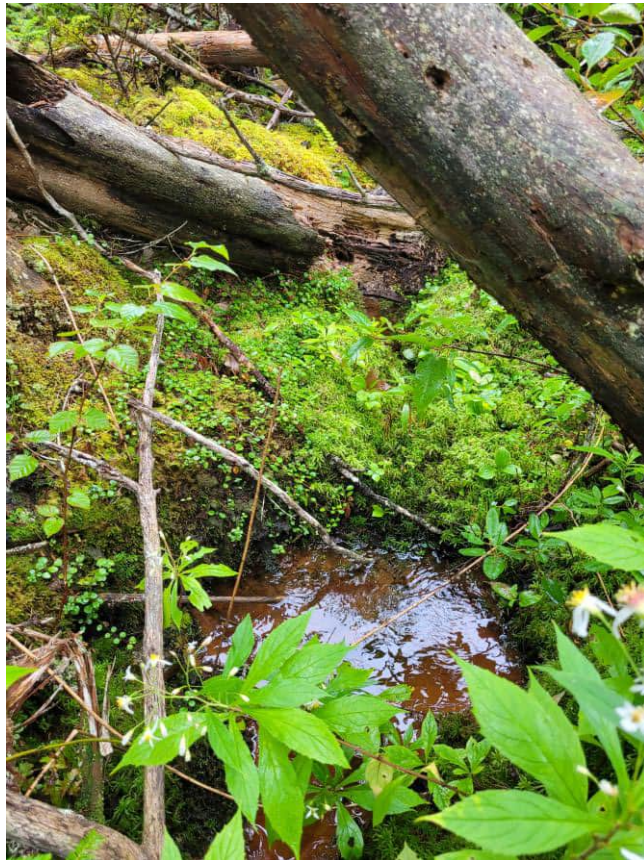
Photo No. 1-04	Date 7/18/2023
Subsite 01 (West)	
Description Ponded water at Subsite 01

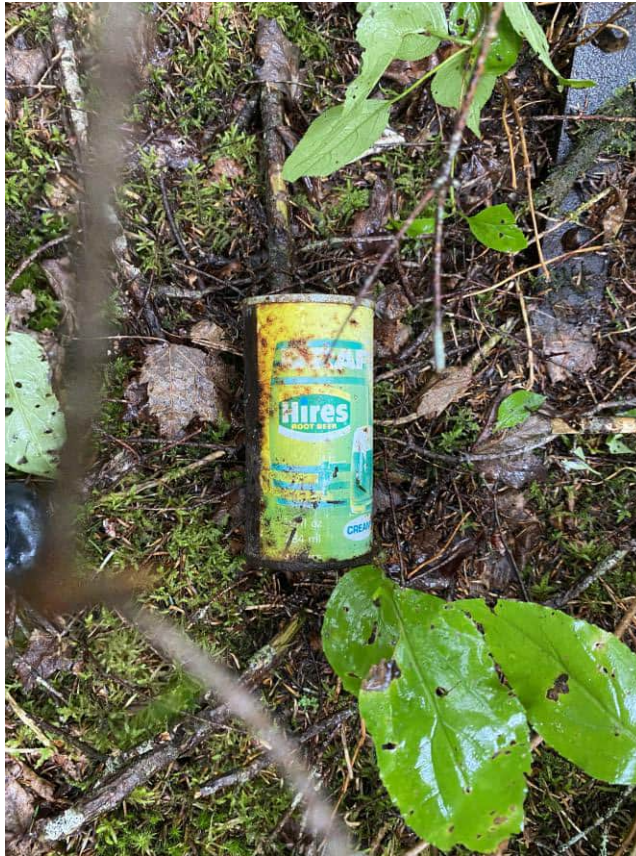
Photo No. 1-05	Date 9/7/2023
Subsite 01 (West)	
Description Can found near the office location at Subsite 01

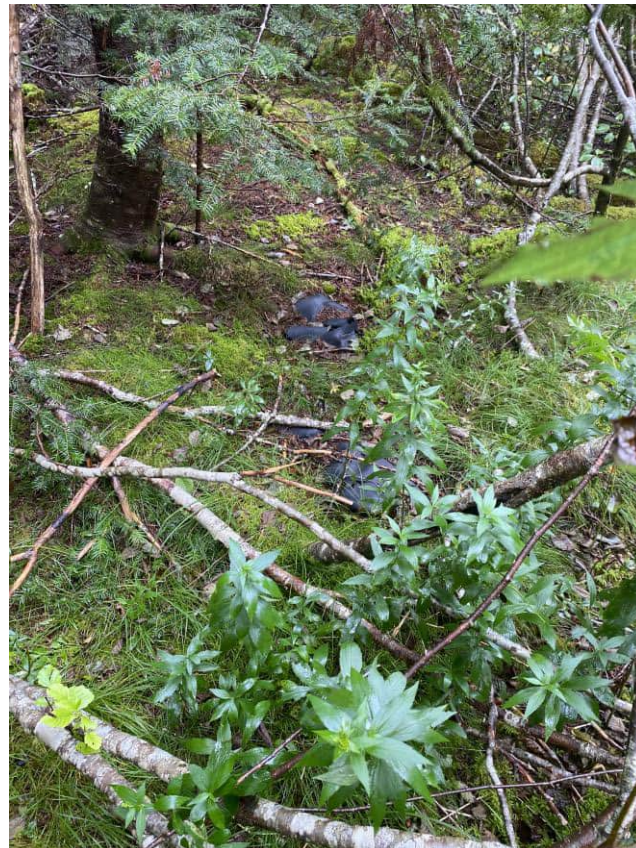
Photo No. 1-06	Date 9/7/2023
Subsite 01 (West)	
Description Discarded fabric materials near the office location at Subsite 01

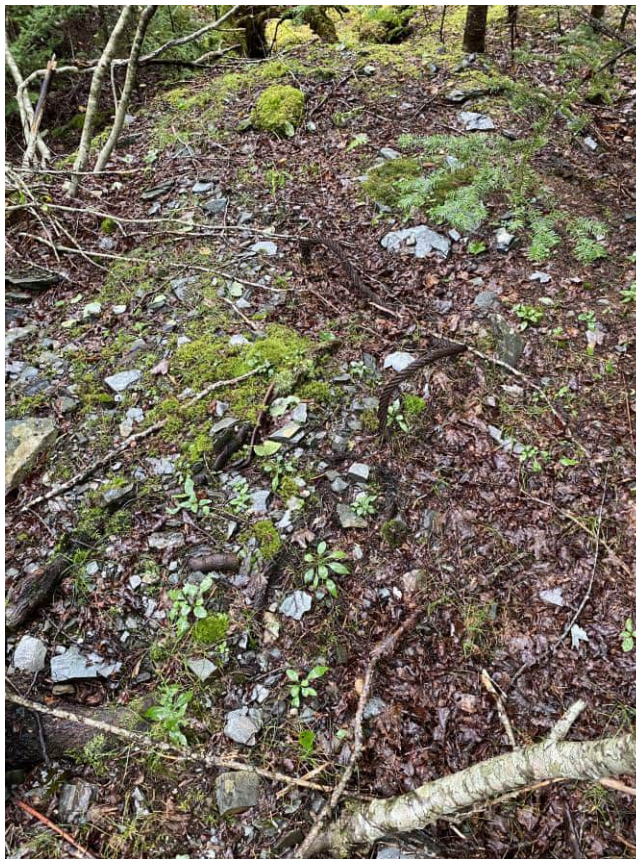
Photo No. 1-07	Date 9/7/2023
Subsite 01 (West)	
Description Hoist cable at the Hoist location at Subsite 01

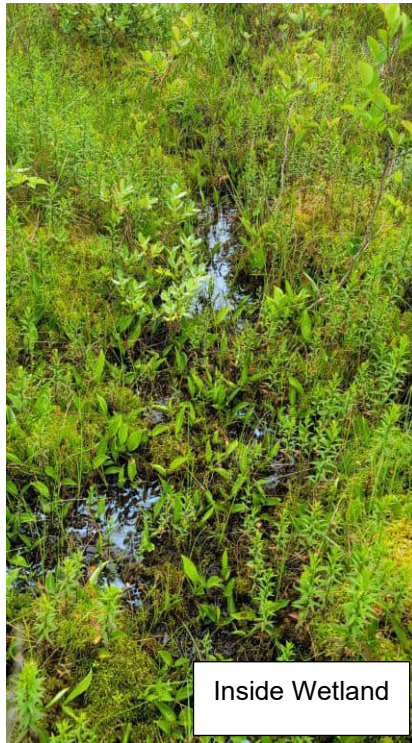
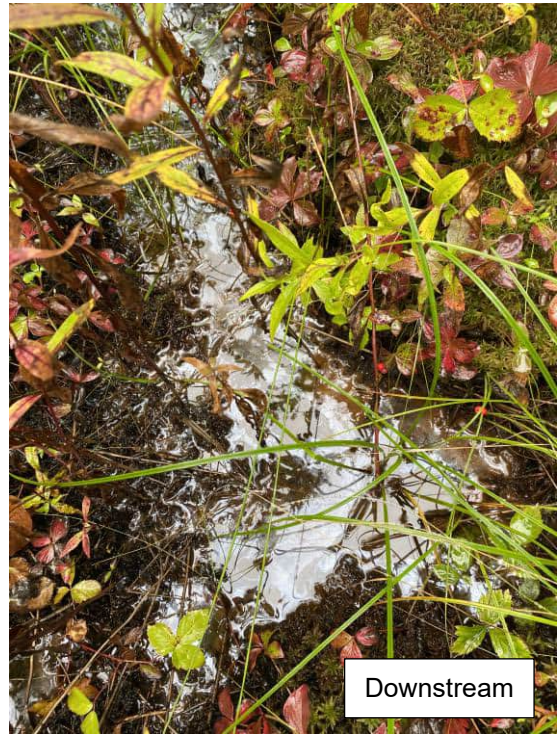
Photo No. 1-09	Date 9/7/2023
Subsite 01 (West)	
Description Standing water with white/blueish tint (sheen) at surface found downstream and in wetland where tailings were deposited.

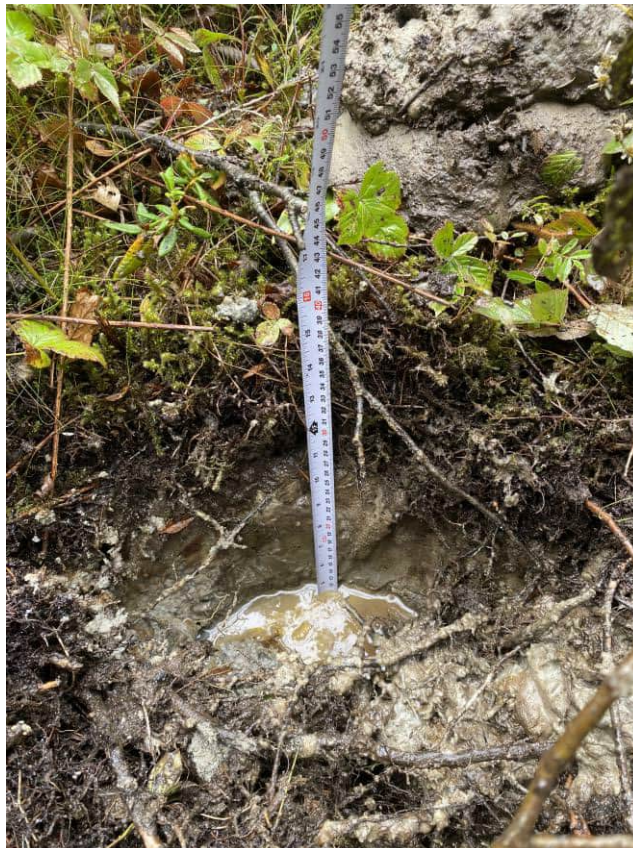
Photo No. 1-10	Date 9/7/2023
Subsite 01 (West)	
Description Soil profile at the tailing sample at Subsite 01

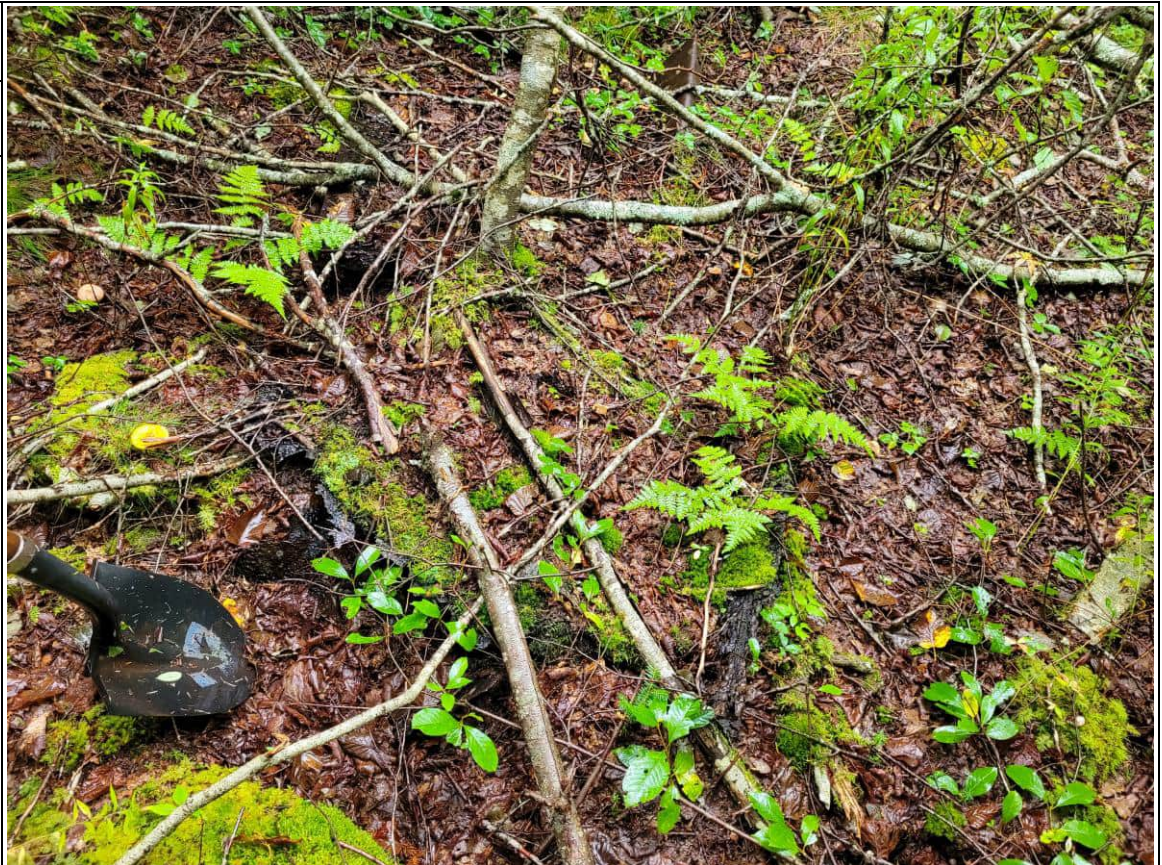
Photo No. 1-11	Date 9/7/2023
Subsite 01 (West)	
Description Scrap metal found at the Mill location

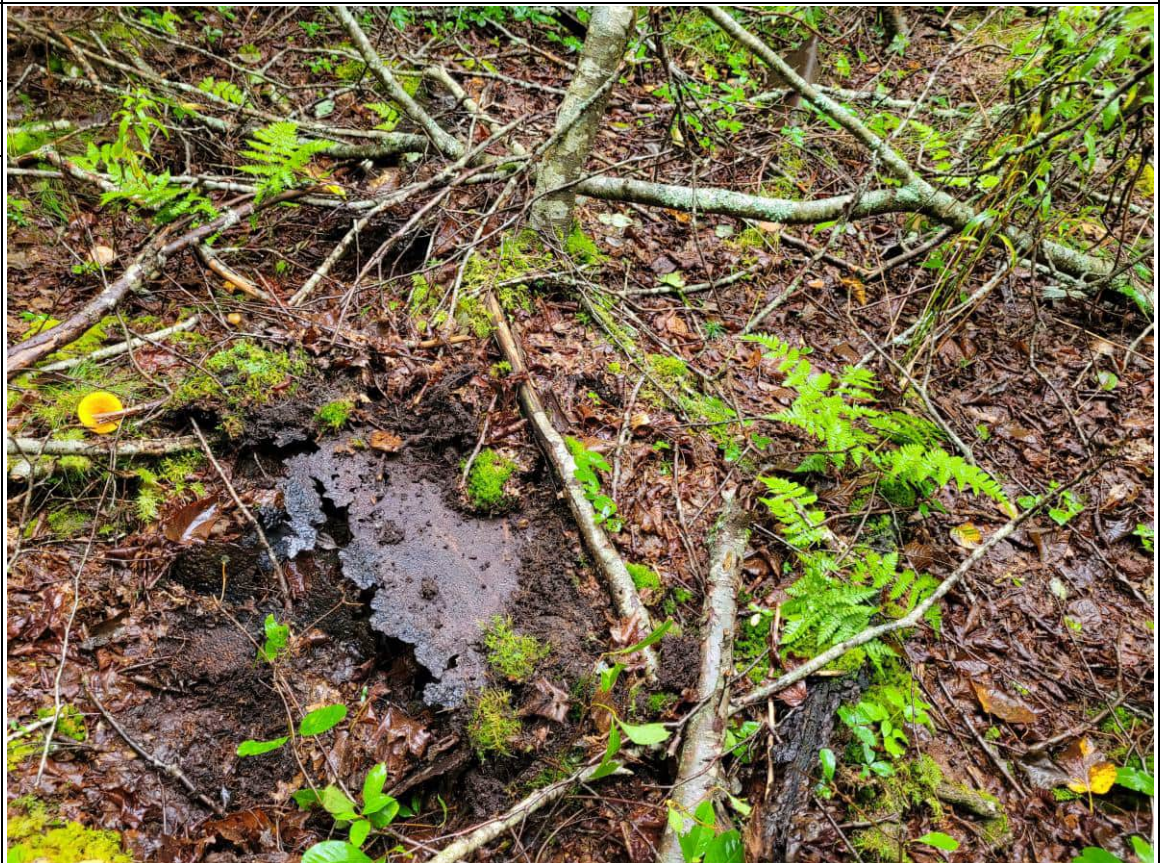
Photo No. 1-12	Date 9/7/2023
Subsite 01 (West)	
Description Scrap metal found at the Mill location

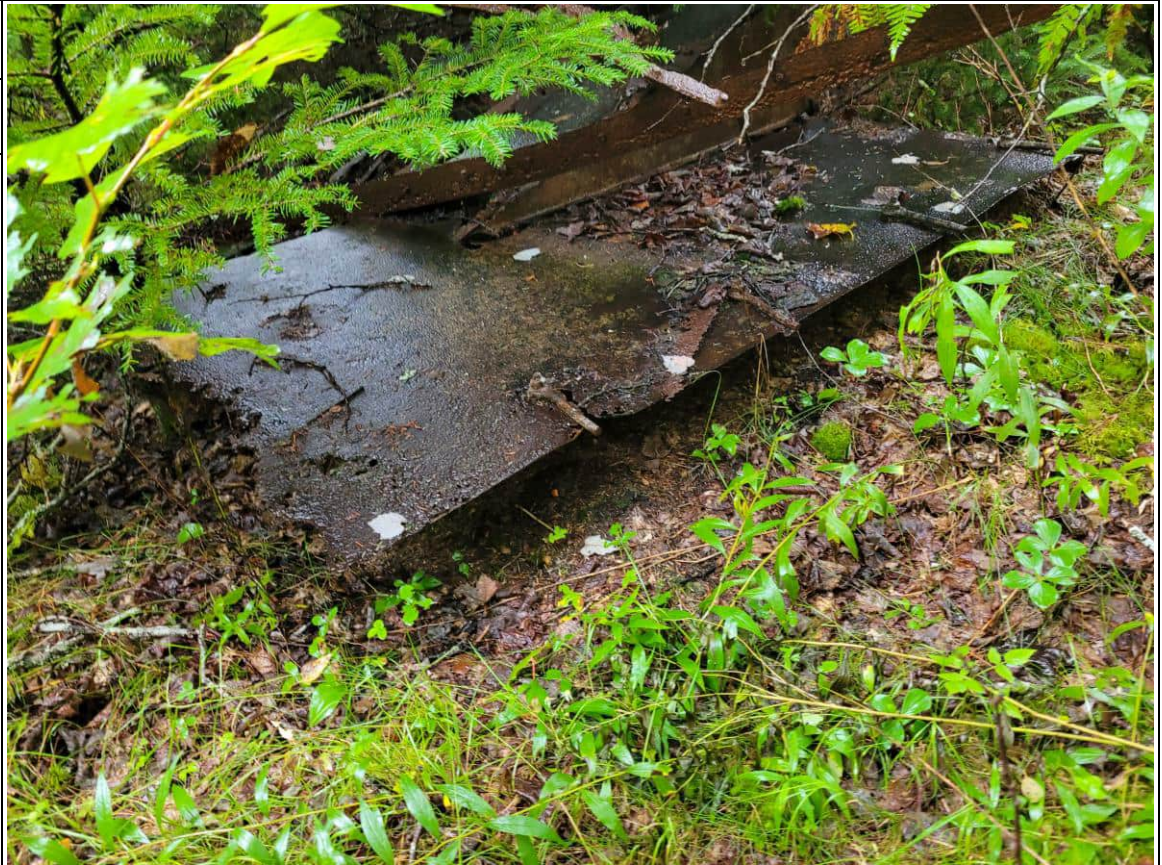
Photo No. 1-13	Date 9/7/2023
Subsite 01 (West)	
Description Debris Area: S01-DA-003.2 (Mill)	
Remains of a structure found at the Mill location

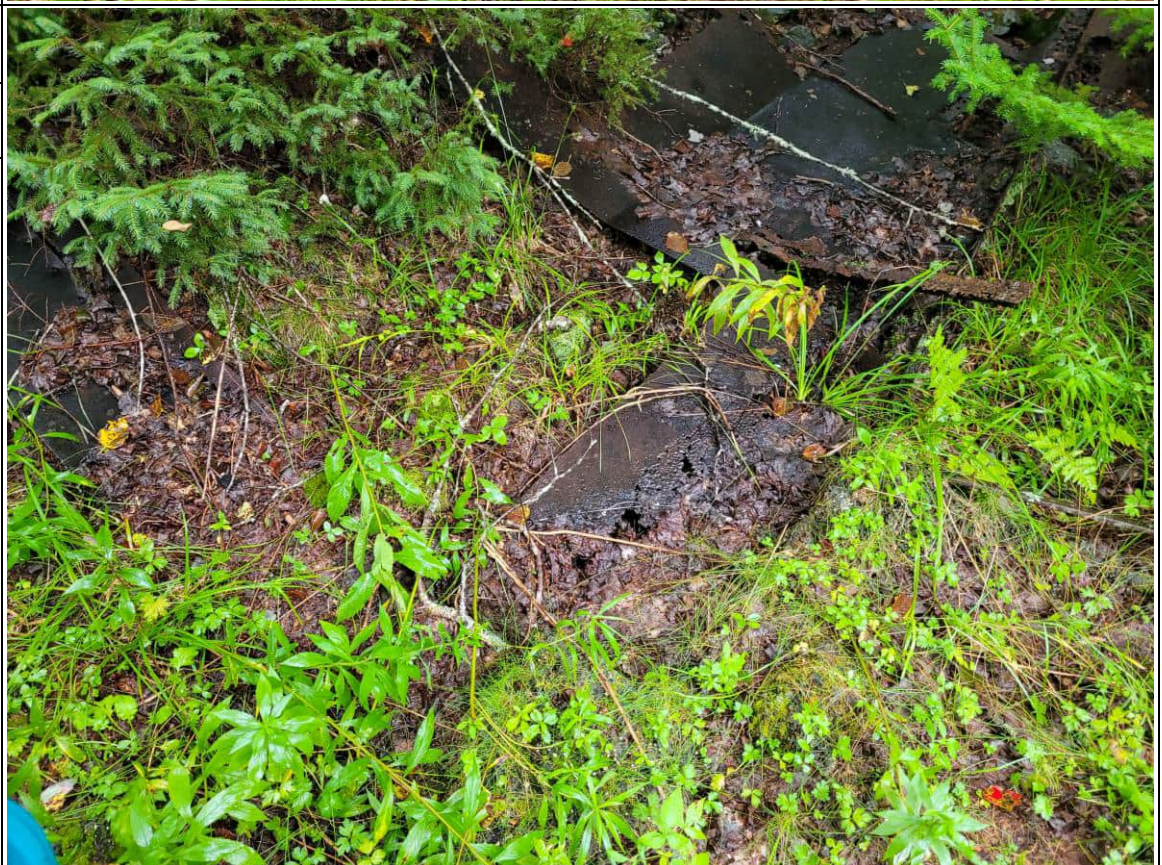
Photo No. 1-14	Date 9/7/2023
Subsite 01 (West)	
Description Debris area: S01-DA-003.2 (Mill) (cont...)

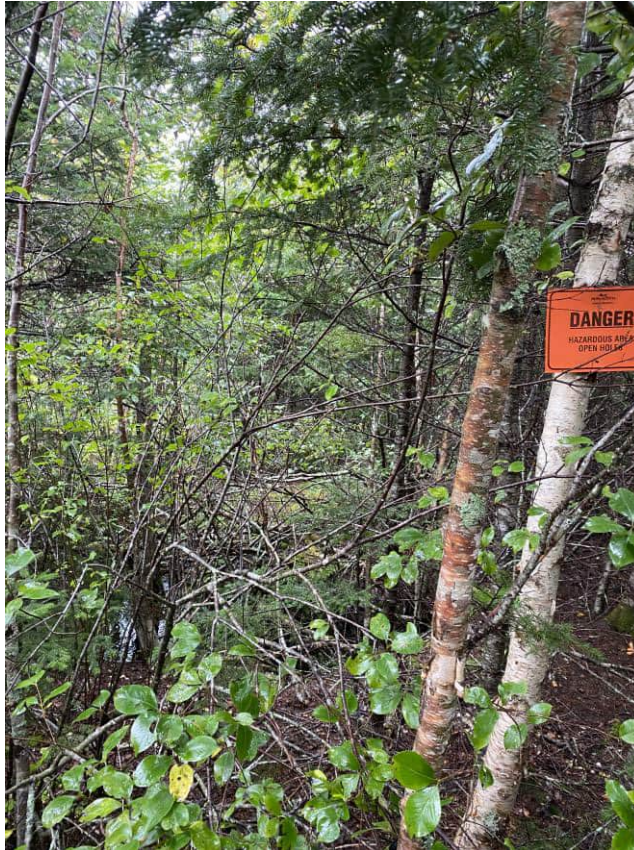
Photo No. 1-15	Date 9/7/2023
Subsite 01 (West)	
Description A warning sign for a mine opening at Subsite 01. Mine opening can be seen in the foreground.

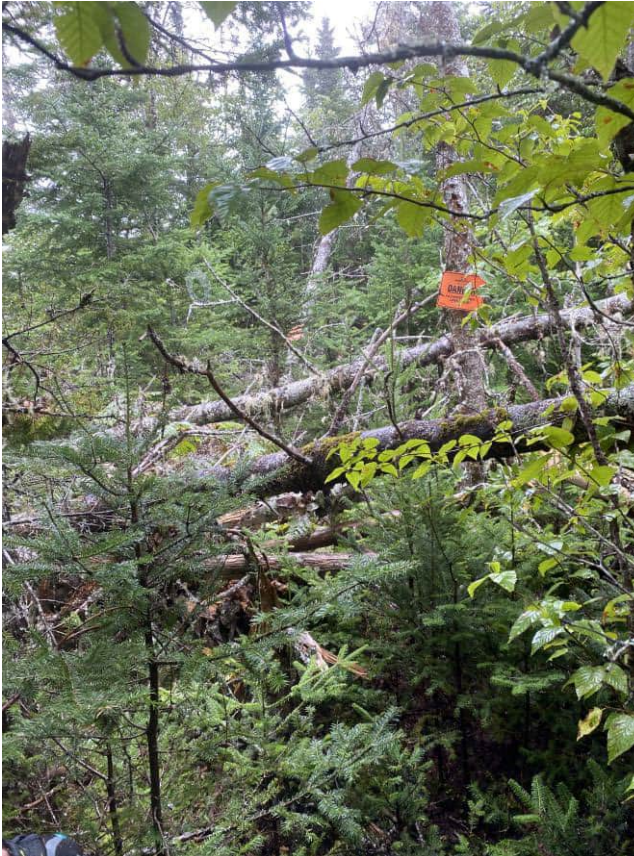
Photo No. 1-16	Date 9/7/2023
Subsite 01 (West)	
Description A warning sign for a mine opening at Subsite 01. Downed trees blocked the view for the mine opening.

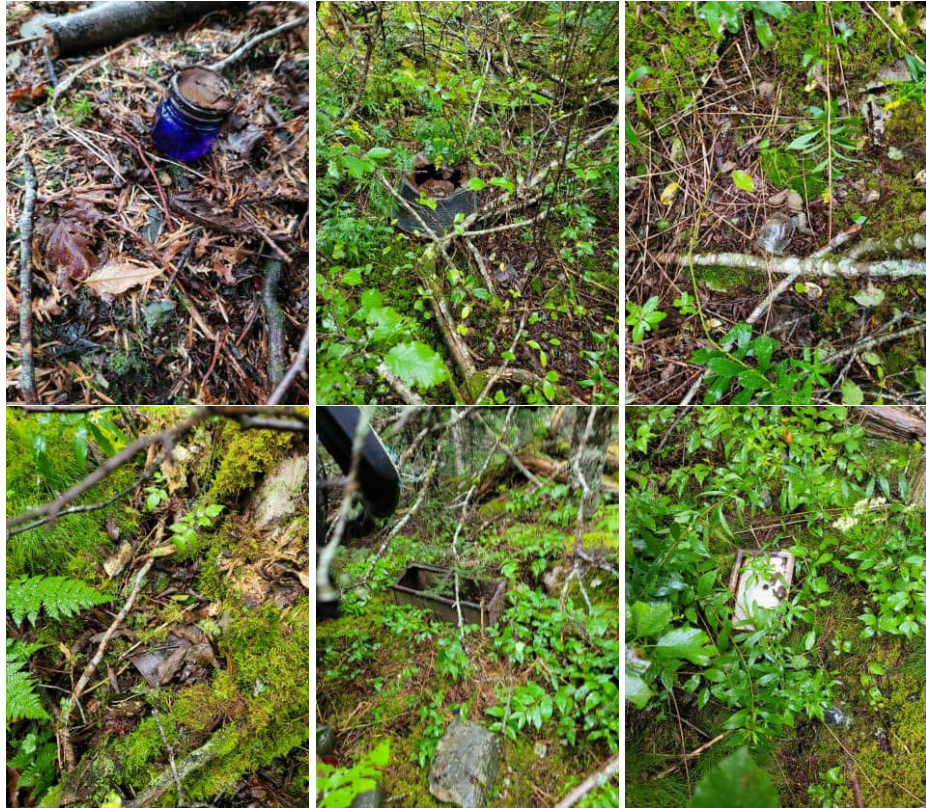
Photo No. 1-17	Date 9/7/2023
Subsite 01 (West)	
Description Debris area: (S01-DA-002 (Office)) Near former Office

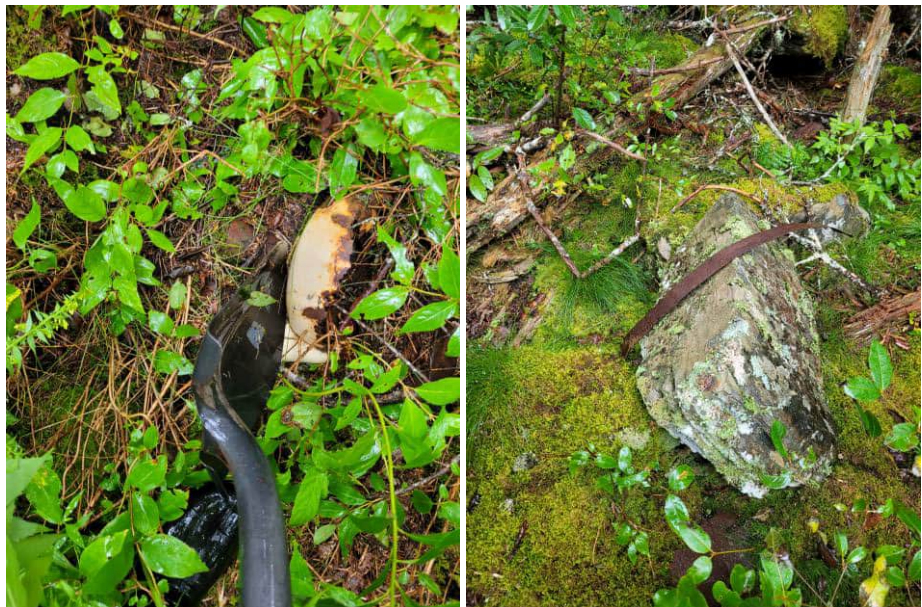
Photo No. 1-18	Date 9/7/2023
Subsite 01 (West)	
Description Debris area: (S01-DA-002 (Office)) Cont...

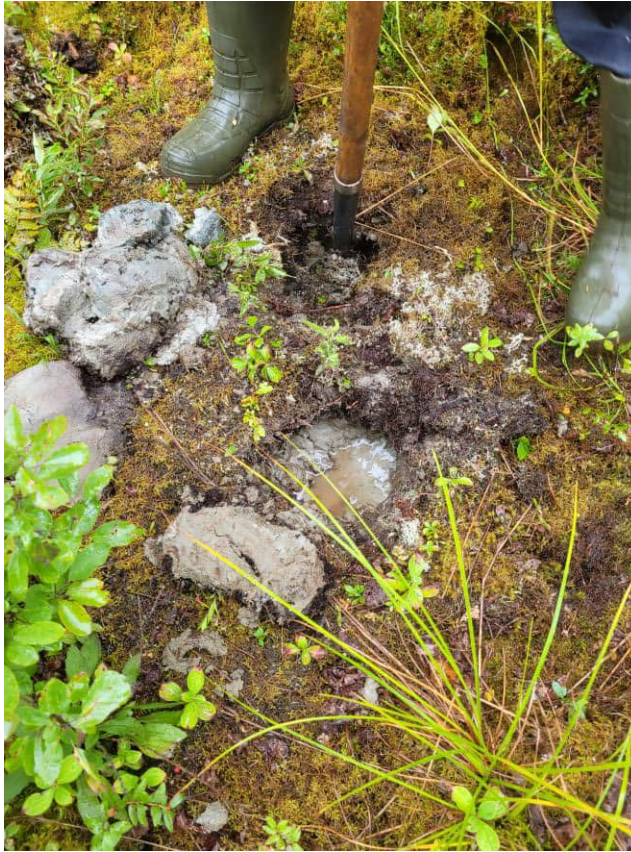
Photo No. 2-01	Date 9/7/2023
Subsite 02	
Description Tailing deposit at Subsite 02. Soil profile had a shallow depth.

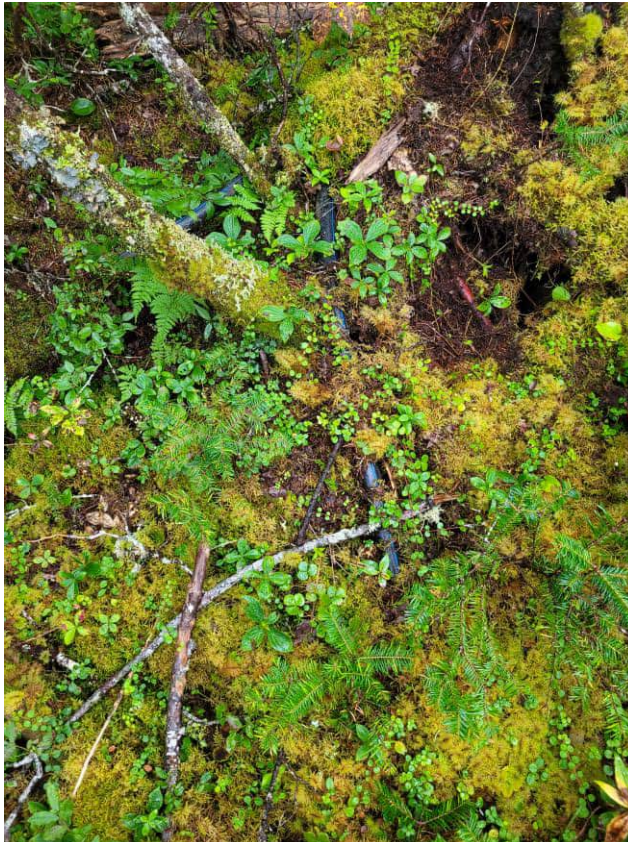
Photo No. 2-02	Date 9/7/2023
Subsite 02	
Description Tubes found near Subsite 02 at the camp location.

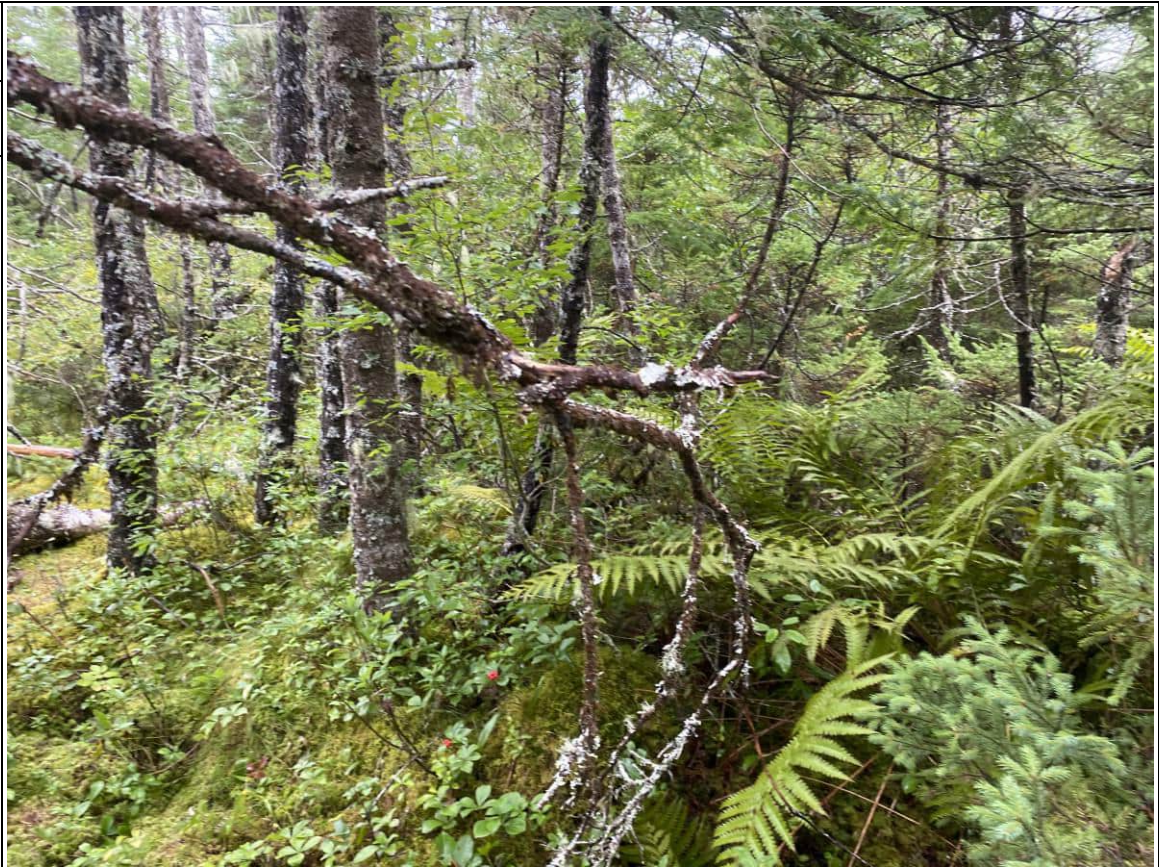
Photo No. 2-03	Date 7/18/2023
Subsite 02	
Description Subsite 02, at crusher location. No materials or sign of crusher could be visually identified.

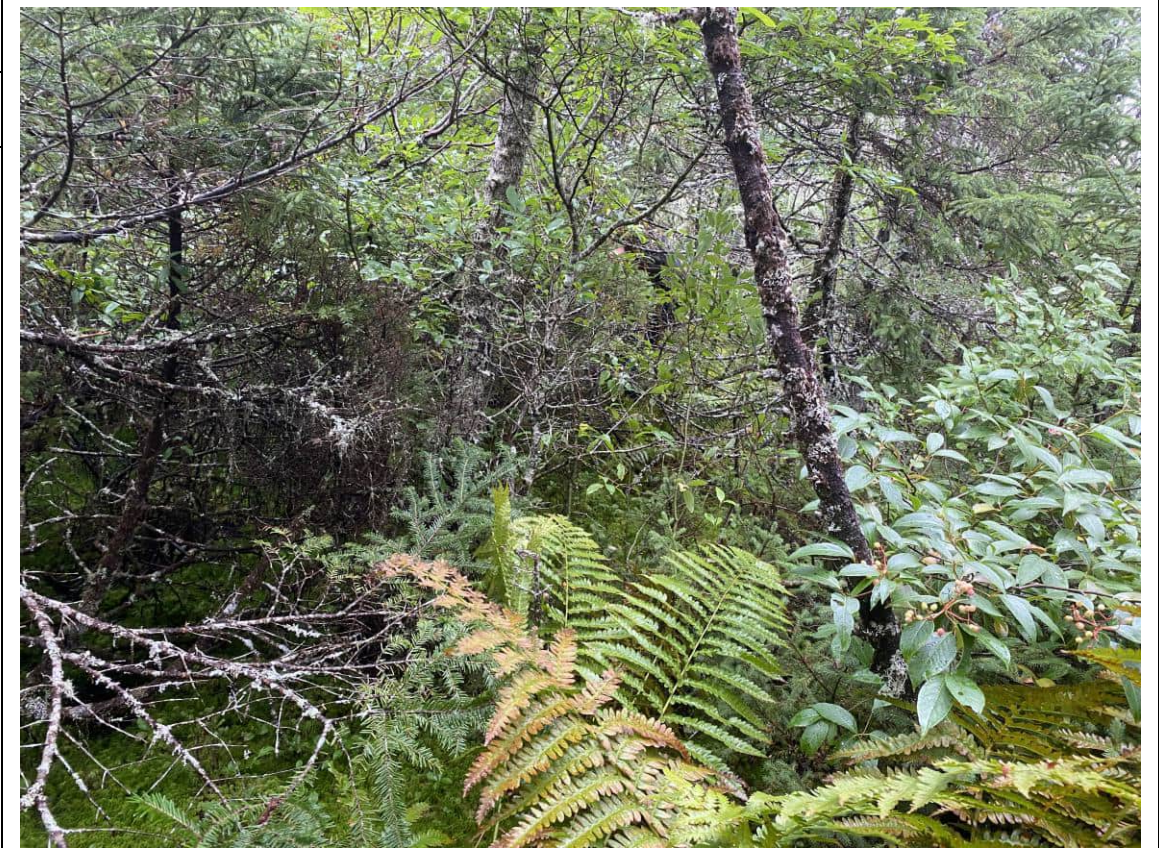
Photo No. 2-04	Date 7/18/2023
Subsite 02	
Description Subsite 02, at crusher location. No materials or sign of crusher could be visually identified.

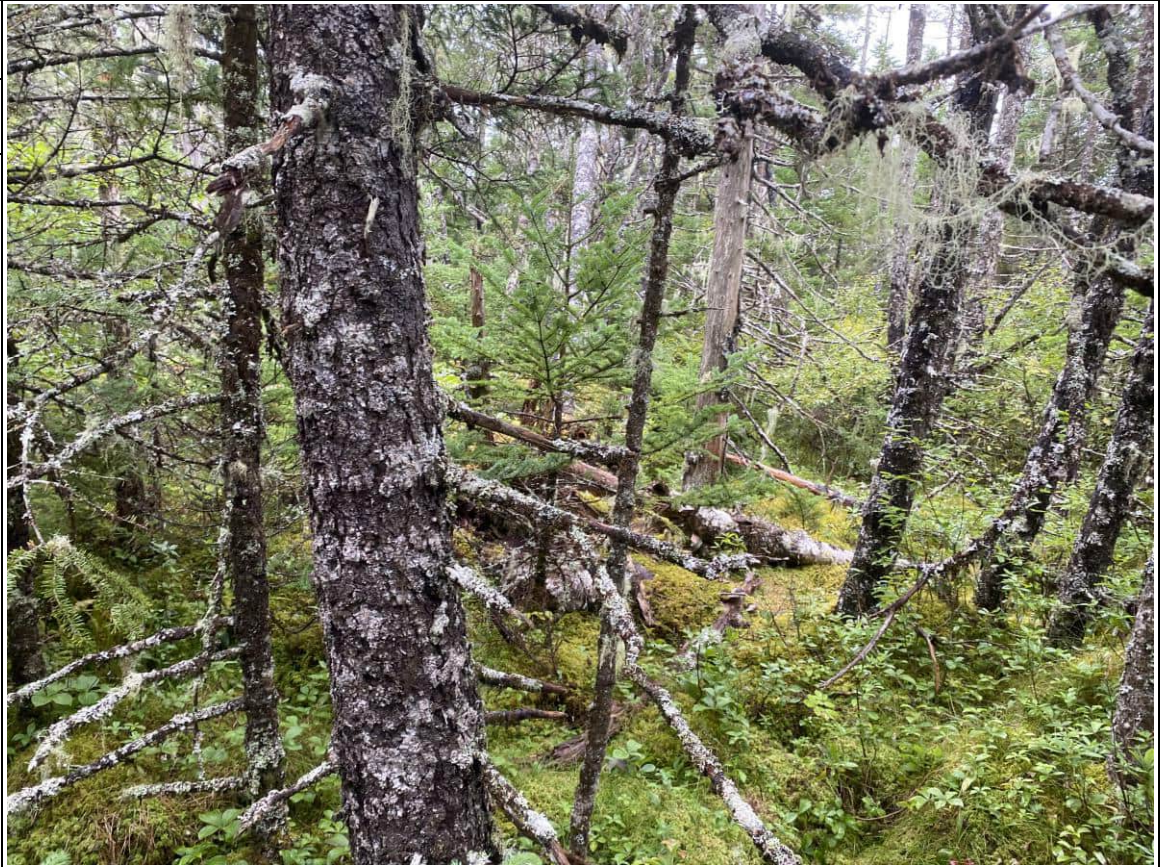
Photo No. 2-05	Date 9/7/2023
Subsite 02	
Description Subsite 02, at crusher location. No materials or sign of a crusher could be visually identified

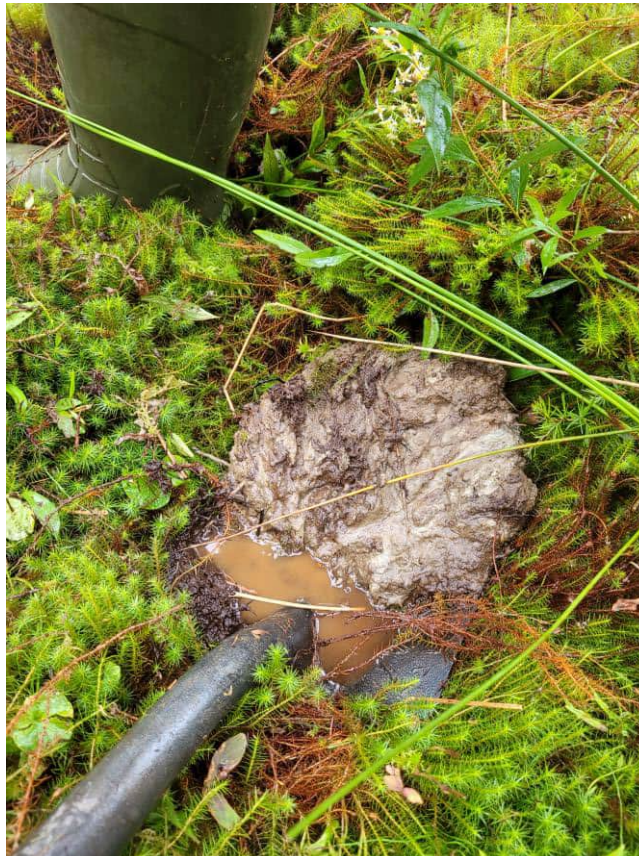
Photo No. 3-02	Date 9/7/2023
Subsite 03	
Description Tailings deposit Tailing sample at Subsite 03.

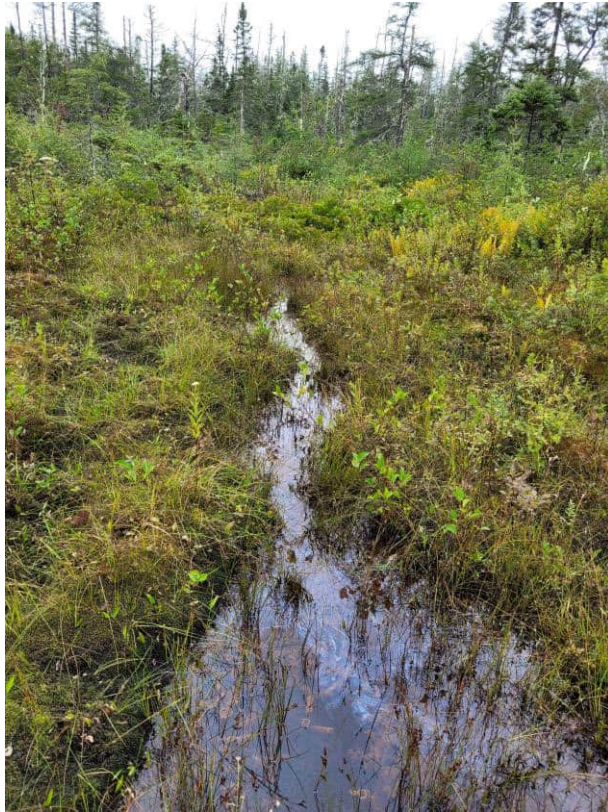
Photo No. 3-05	Date 9/7/2023
Subsite 03	
Description Sheen observed on standing water inside and downstream of wetland where tailings are deposited.

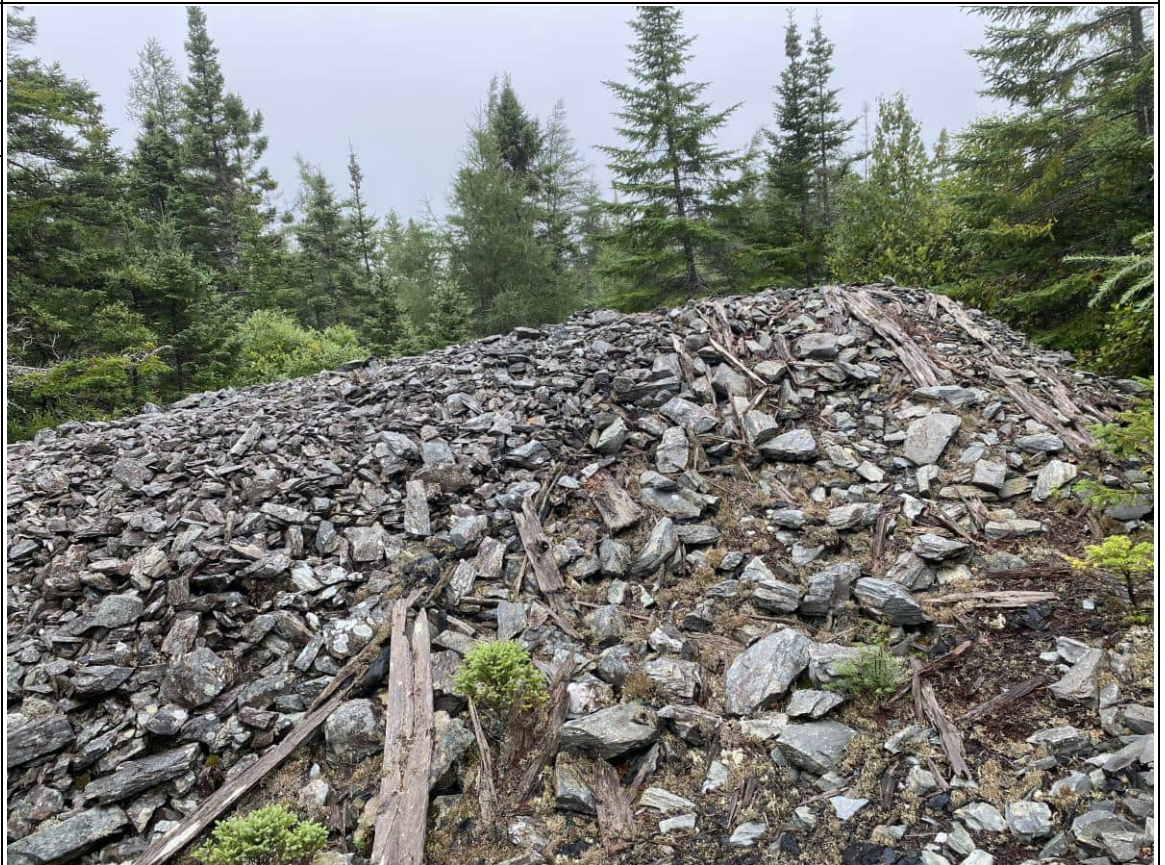
Photo No. 3-06	Date 9/7/2023
Subsite 03	
Description Waste rock pile found at Subsite 03

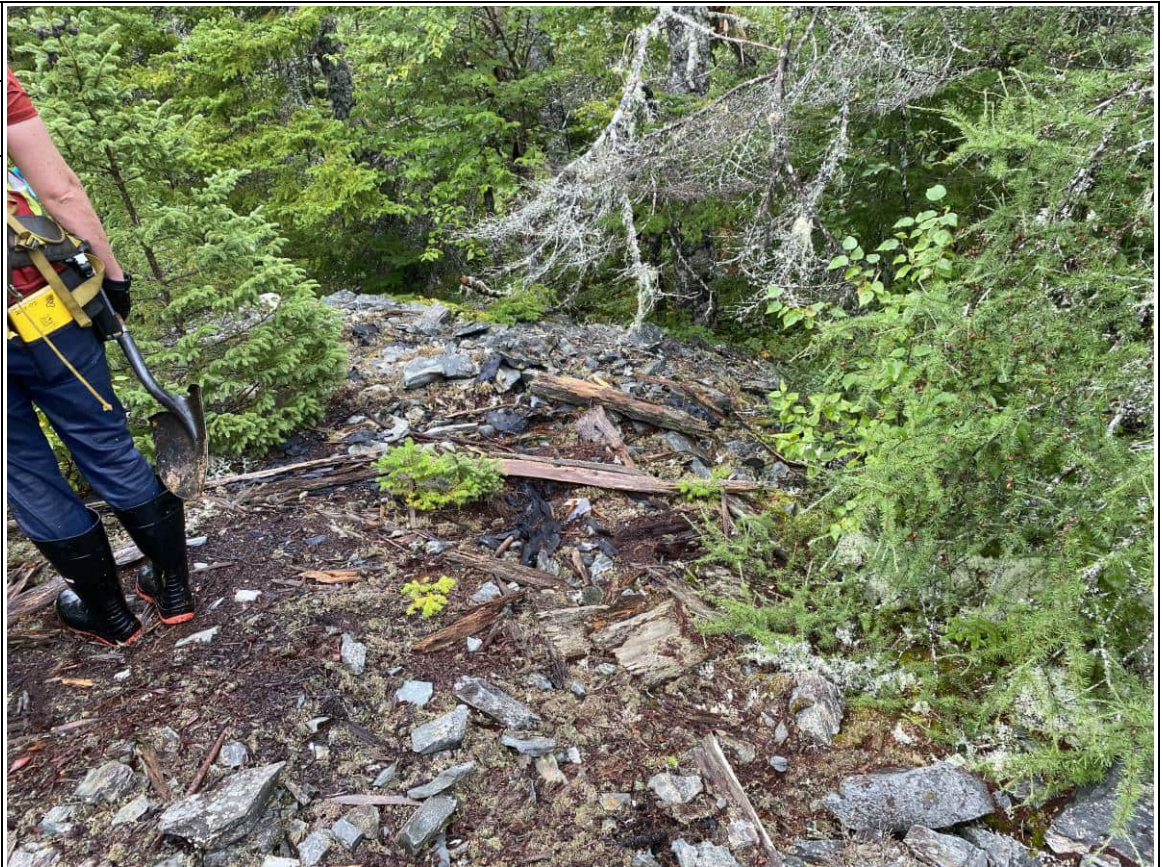
Photo No.	Date
3-07	9/7/2023
Subsite	
03	
Description	
Waste rock pile found at Subsite 03	
Some fabric material and lumber can be seen in the waste rock piles.
