Appendix B

Soil Compaction Test Results

Harrietsfield C&D Landfield Cap Replacement and Site Closure

Crusher Dust Compaction – Harrietsfield C&D Landfill Cap Replacement and Site Closure
1275 Old Sambro Road, Harrietsfield, NS
Our ref.: 2108130.000

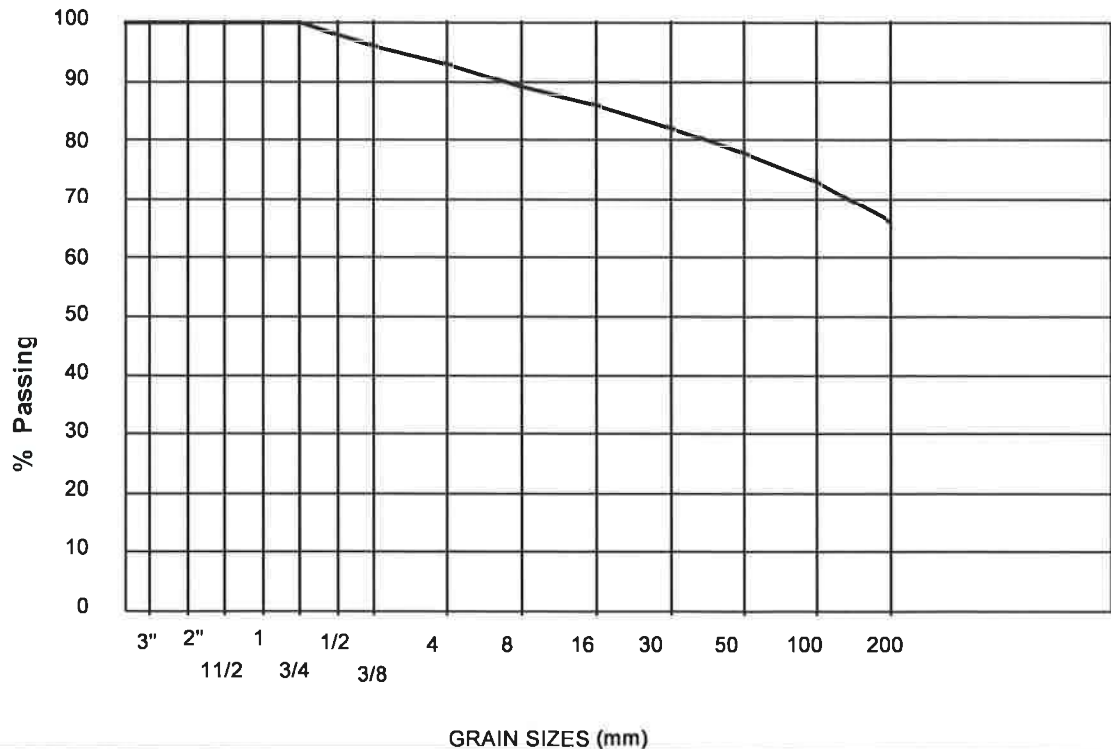
Sieve Size	Percent Passing	Spec. Band
6"	100	
4"	100	
3"	100	
2"	100	
1 1/2"	100	
1"	100	
3/4"	100	
1/2"	98	
3/8"	96	
4	93	
8	89	
16	86	
30	82	
50	78	
100	73	
200	66.0

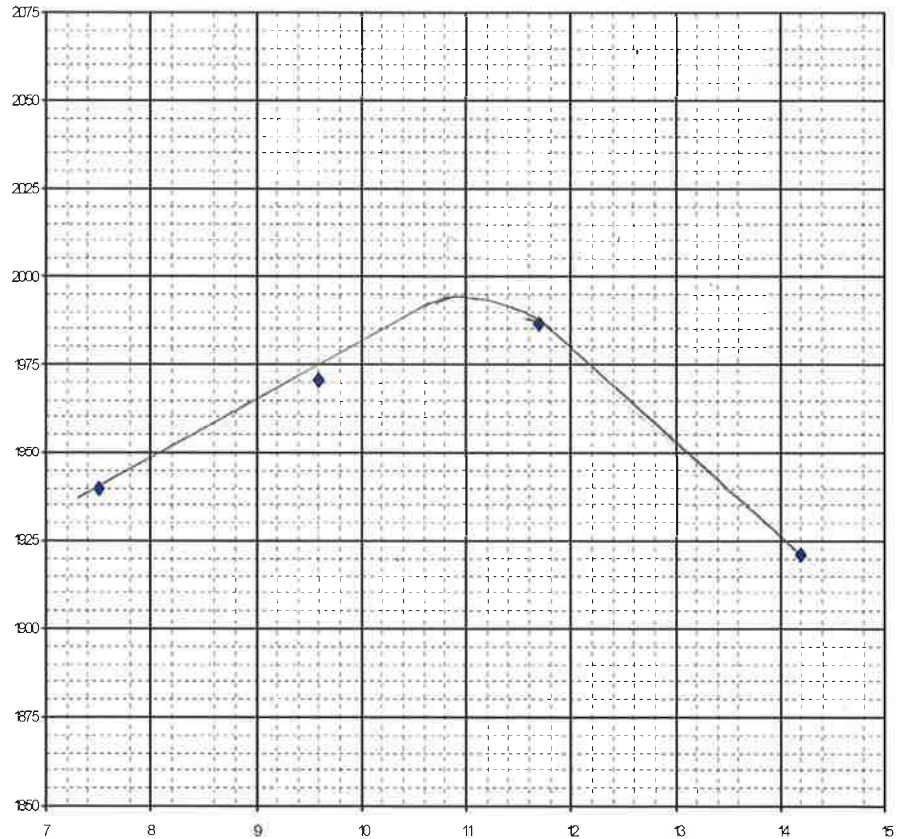
Wet Density (kg/m3)	2085	2160	2219	2194	0	0
Dry Density (kg/m3)	1940	1971	1987	1921	0	0
Moisture Content %	7.5	9.6	11.7	14.2	0	0

Optimum Moisture (%): 10.8

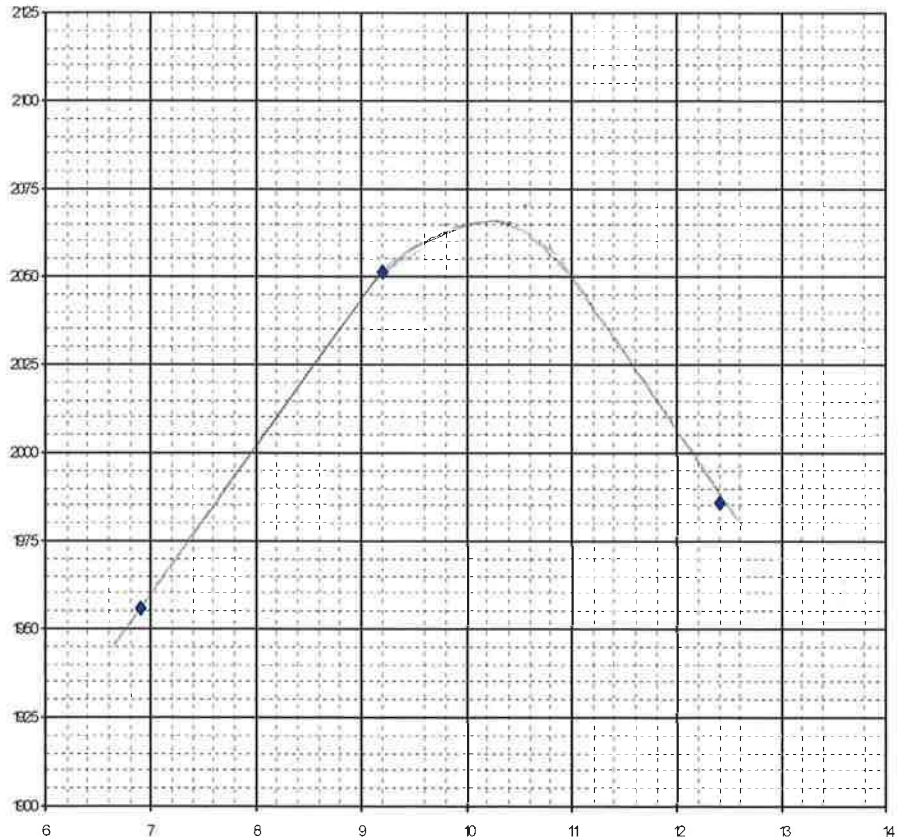
Wet Density (kg/m3)	2091	2240	2232		0	0
Dry Density (kg/m3)	1956	2051	1986		0	0
Moisture Content %	6.9	9.2	12.4		0	0

Optimum Moisture (%): 10.4

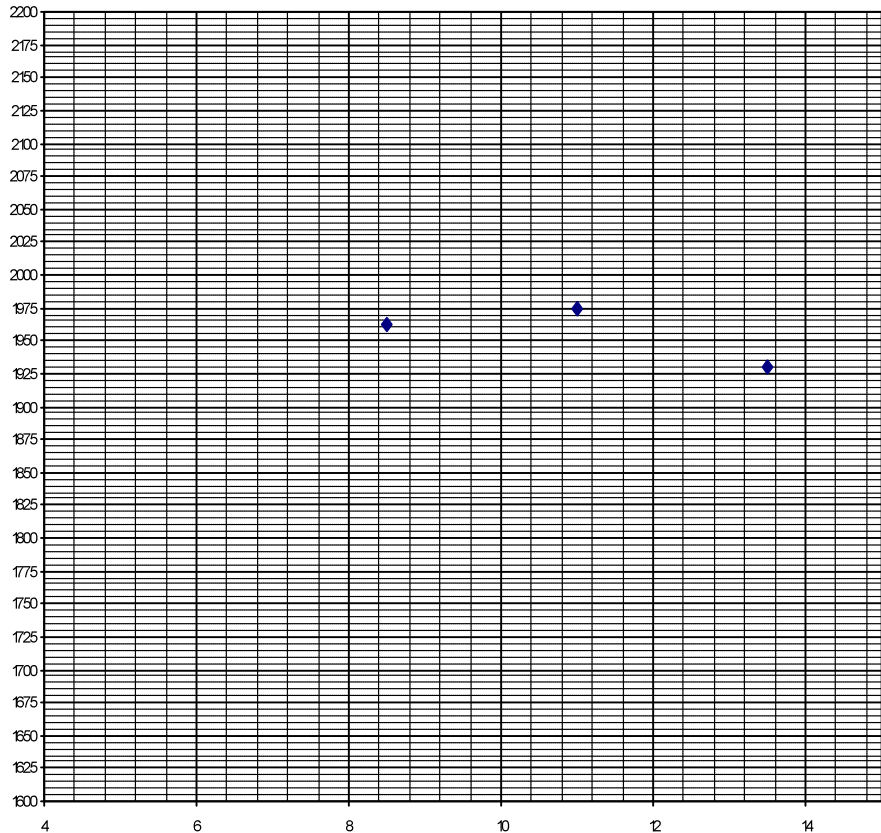
Borrow Pit-01

Wet Density (kg/m3)	2191	2190	2130	0	0
Dry Density (kg/m3)	1974	1930	1963	0	0
Moisture Content %	11	13.5	8.5	0	0

Optimum Moisture (%): 10.7

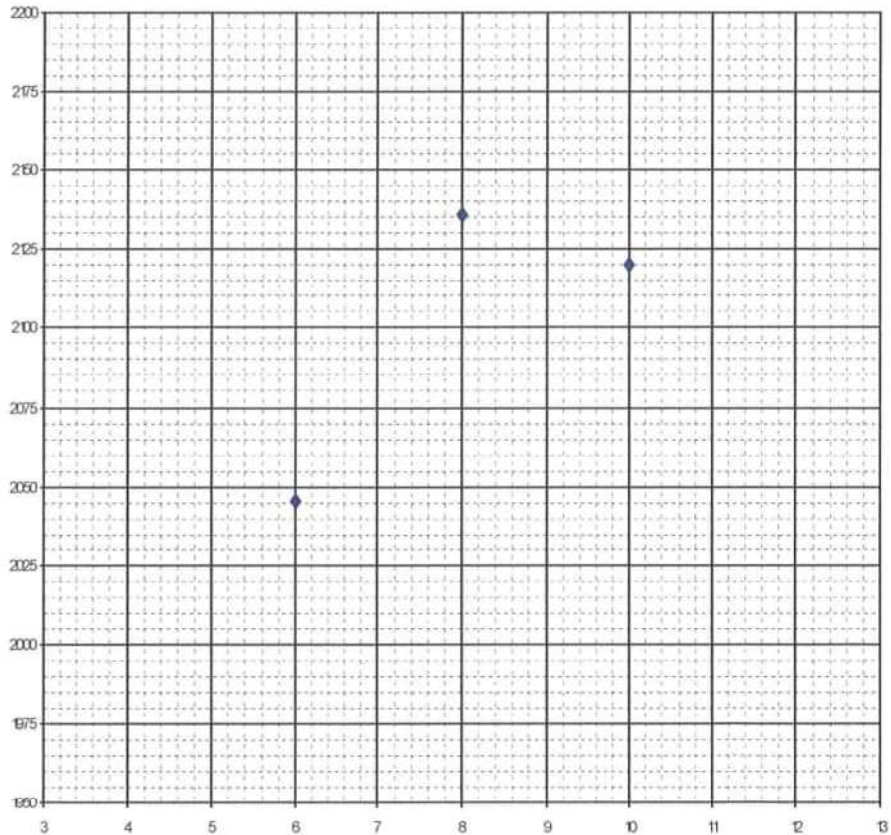
Crusher Dust

Wet Density (kg/m3)	2168	2307	2332		0	0
Dry Density (kg/m3)	2045	2136	2120		0	0
Moisture Content %	6	8	10		0	0

Optimum Moisture (%): 9.0

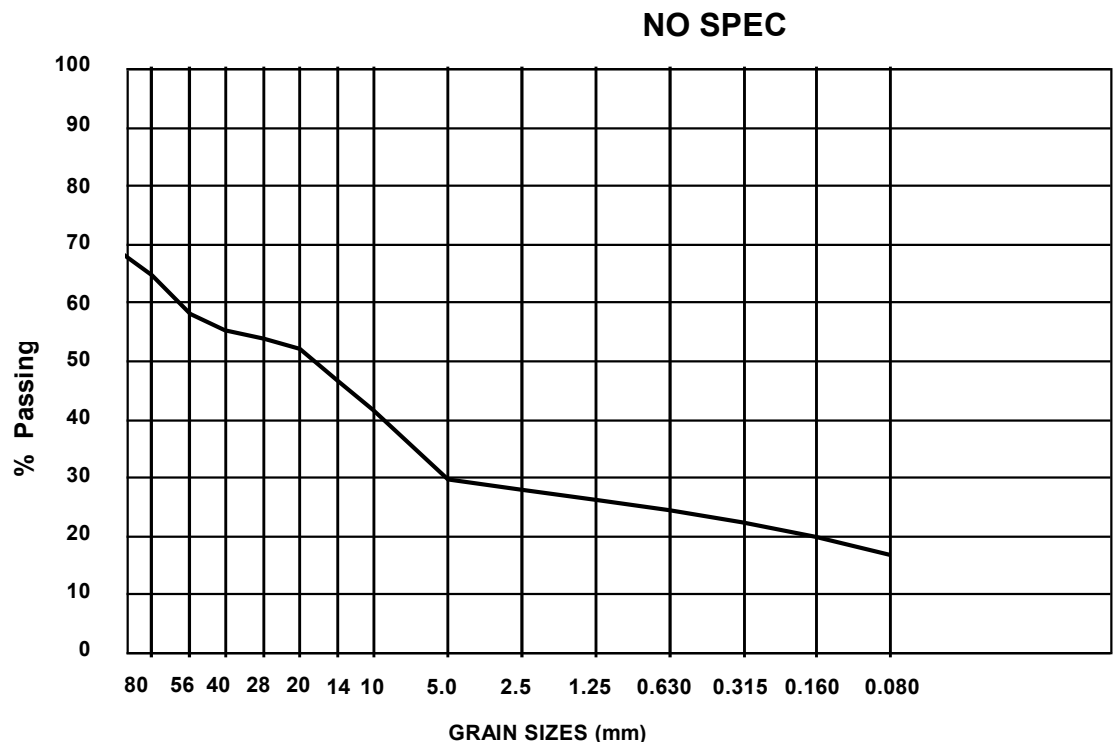
Sieve Size (mm)	Percent Passing	Spec. Band
150	100	
112	69	
80	65	
56	58	
40	55	
28	54	
20	52	
14	46	
10	42	
5.0	30	
2.5	28	
1.25	26	
0.630	25	
0.315	23	
0.160	20	
0.080	16.9

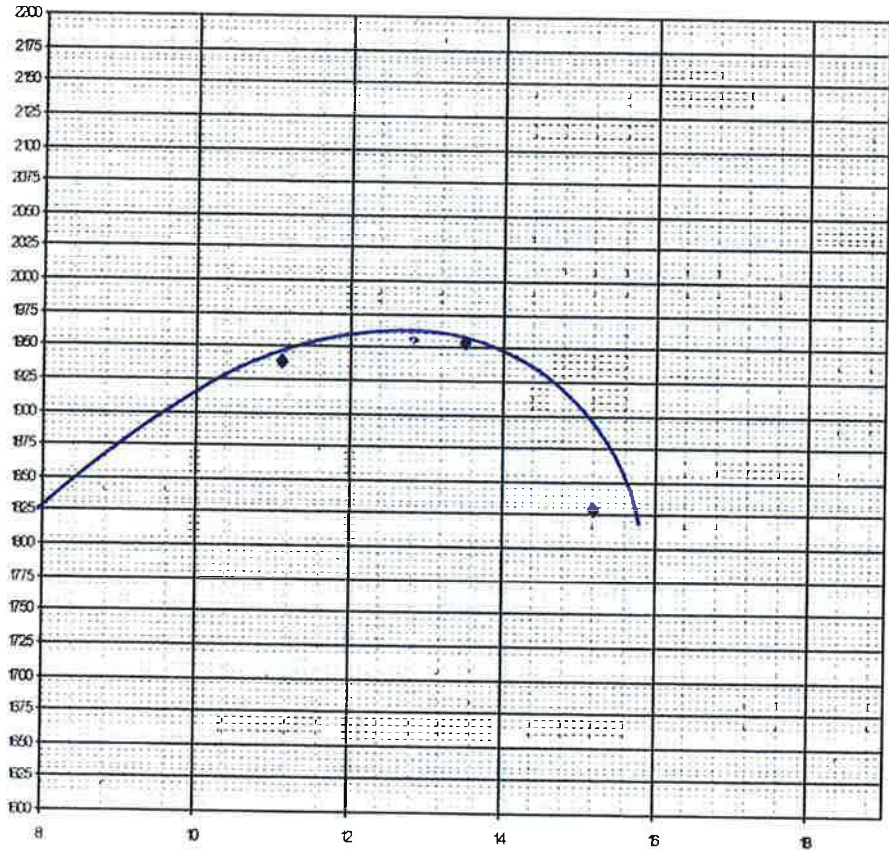
Borrow Pit 02

Wet Density (kg/m3)	2154	2218	2106		0	0
Dry Density (kg/m3)	1939	1954	1828		0	0
Moisture Content %	11.1	13.5	15.2		0	0

Optimum Moisture (%): 12.8

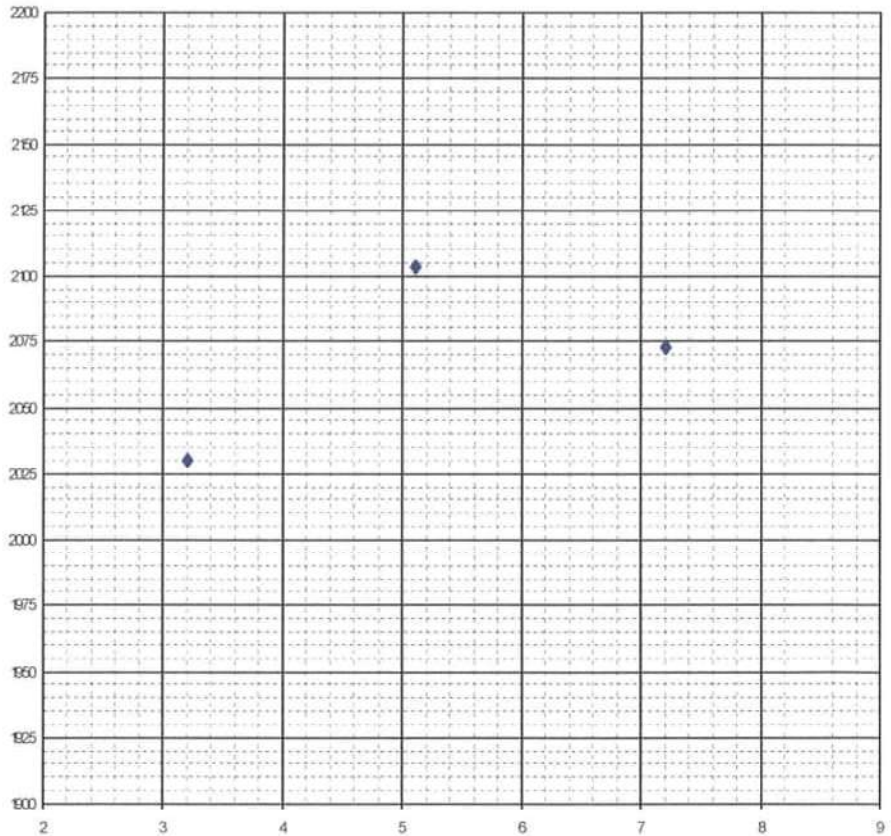
2" gravel

Wet Density (kg/m3)	2095	2211	2222		0	0
Dry Density (kg/m3)	2030	2104	2073		0	0
Moisture Content %	3.2	5.1	7.2		0	0

Optimum Moisture (%): 5.1

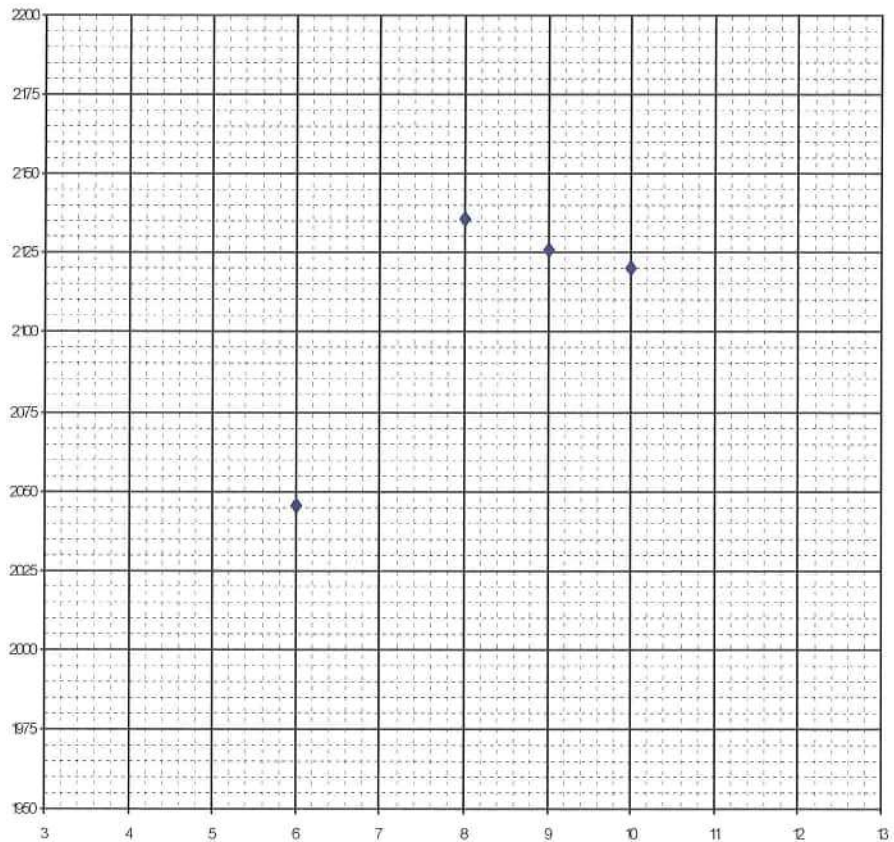
Crusher Dust

Wet Density (kg/m ³)	2168	2307	2317	2332	0	0
Dry Density (kg/m ³)	2045	2136	2126	2120	0	0
Moisture Content %	6	8	9	10	0	0

Optimum Moisture (%): 8.0

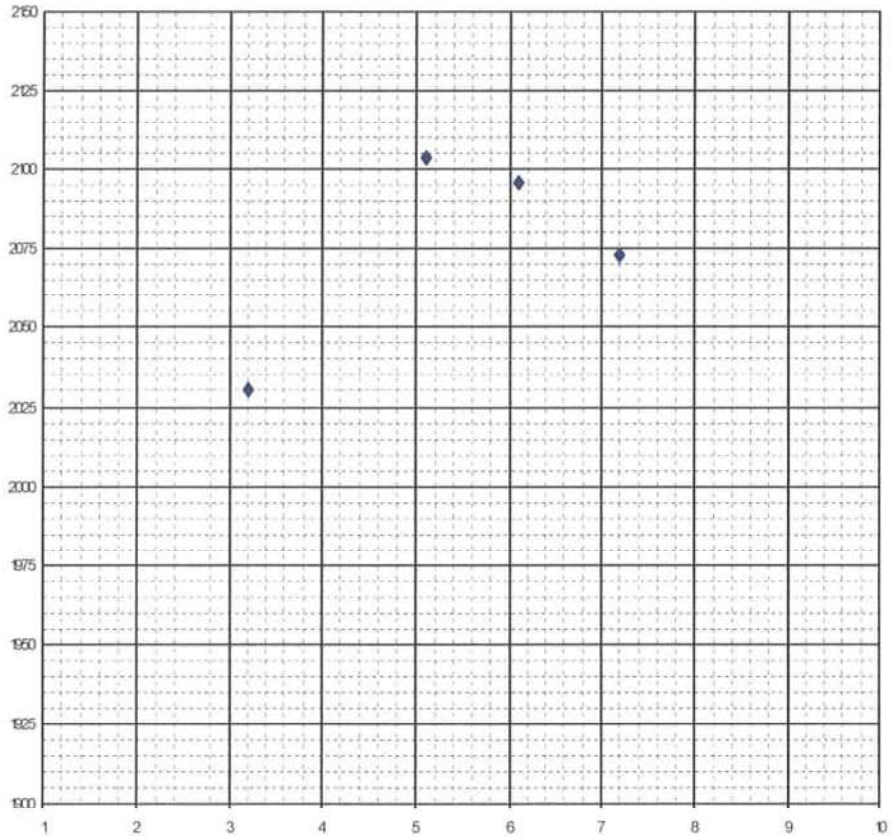
2" gravel

Wet Density (kg/m ³)	2095	2211	2224	2222	0	0
Dry Density (kg/m ³)	2030	2104	2096	2073	0	0
Moisture Content %	3.2	5.1	6.1	7.2	0	0

Optimum Moisture (%): 5.6

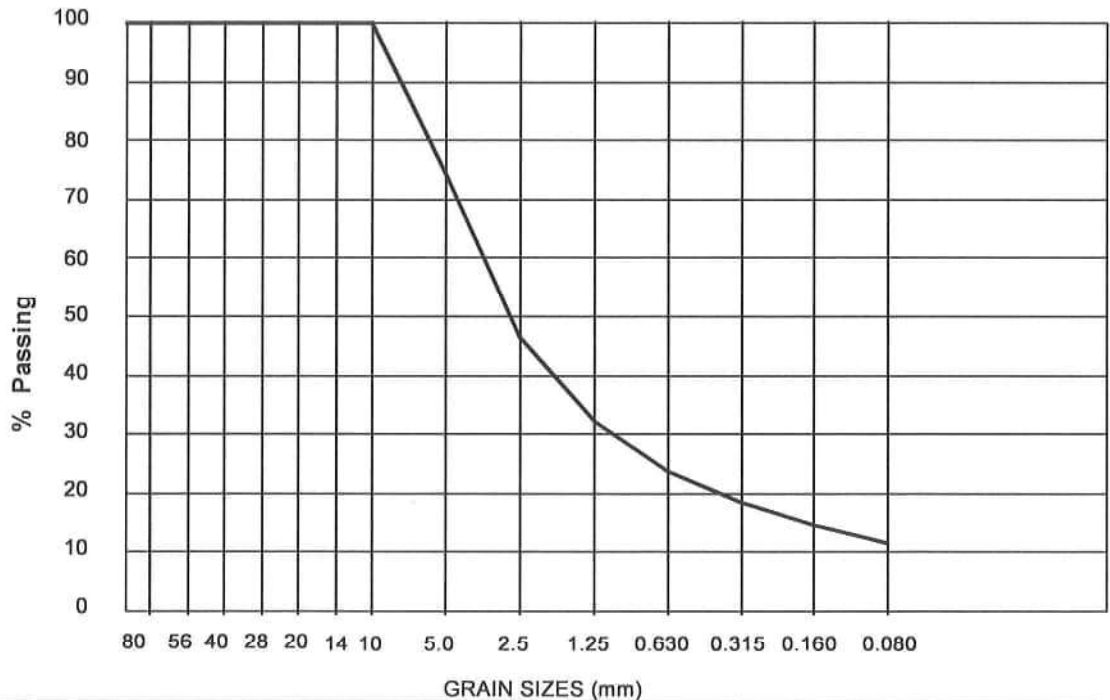
GRAIN SIZE CURVE

PHYSICAL PROPERTY TESTS					
Soil Type	Crusher Dust	Liquid Limit		Flat and Elongated Particles, %	
Gravel, %	26	Plastic Limit		Coarse Spec. Gravity	
Sand, %	62	Plasticity Index		Fractured Faces, %	
Silt and Clay, %	12	Coarse Absorption, %		Petrographic No.	
Moisture Cont., %	1.6	Fine Absorption, %		Max. Dry Density, (kg/m ³)	
Abrasion Loss, %		Micro Deval Loss, %		Optimum Moisture, %

Comments: Crusher Dust Depth = 4.5"

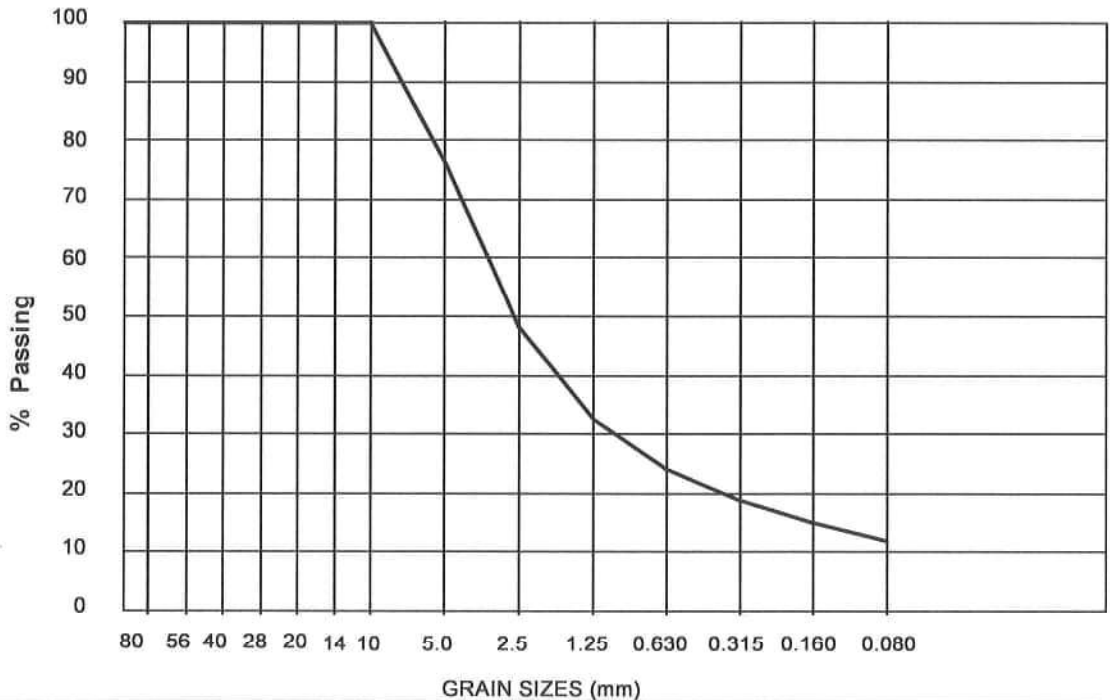
GRAIN SIZE CURVE

PHYSICAL PROPERTY TESTS					
Soil Type	Crusher Dust	Liquid Limit		Flat and Elongated Particles, %	
Gravel, %	24	Plastic Limit		Coarse Spec. Gravity	
Sand, %	64	Plasticity Index		Fractured Faces, %	
Silt and Clay, %	12	Coarse Absorption, %		Petrographic No.	
Moisture Cont., %	3.9	Fine Absorption, %		Max. Dry Density, (kg/m ³)	
Abrasion Loss, %		Micro Deval Loss, %		Optimum Moisture, %

Comments: Crusher Dust depth = 1"

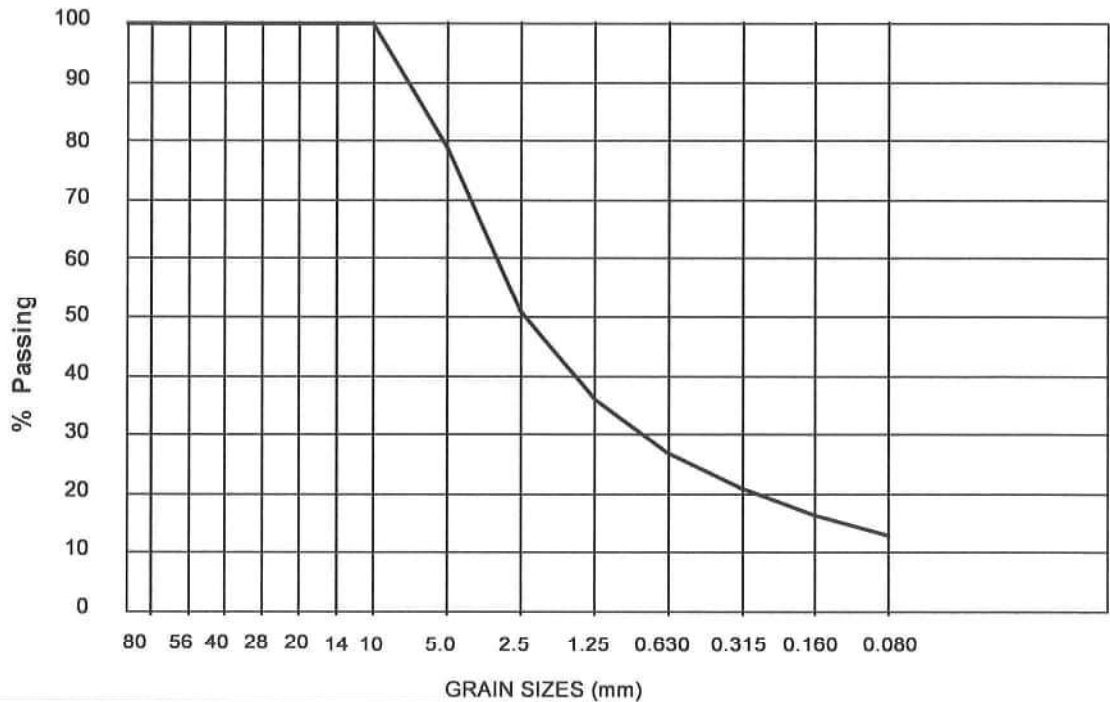
GRAIN SIZE CURVE

PHYSICAL PROPERTY TESTS					
Soil Type	Crusher Dust	Liquid Limit		Flat and Elongated Particles, %	
Gravel, %	21	Plastic Limit		Coarse Spec. Gravity	
Sand, %	66	Plasticity Index		Fractured Faces, %	
Silt and Clay, %	13	Coarse Absorption, %		Petrographic No.	
Moisture Cont., %	2.9	Fine Absorption, %		Max. Dry Density, (kg/m3)	
Abrasion Loss, %		Micro Deval Loss, %		Optimum Moisture, %

Comments: Crusher Dust depth = 2"

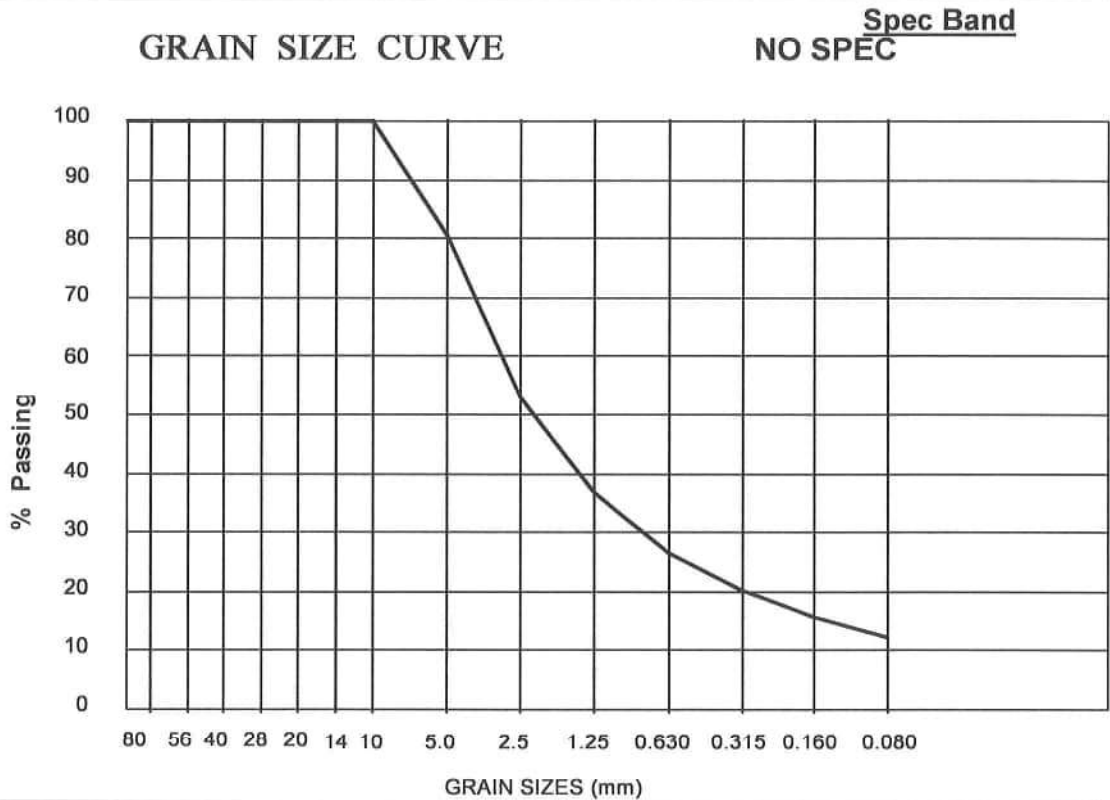
Sieve Size (mm)	Percent Passing	Spec. Band
112		
80		
56		
40		
28		
20		
14		
10	100	
5.0	80	
2.5	53	
1.25	37	
0.630	27	
0.315	20	
0.160	16	
0.080	12.3

Comments: Crusher Dust depth = 5"

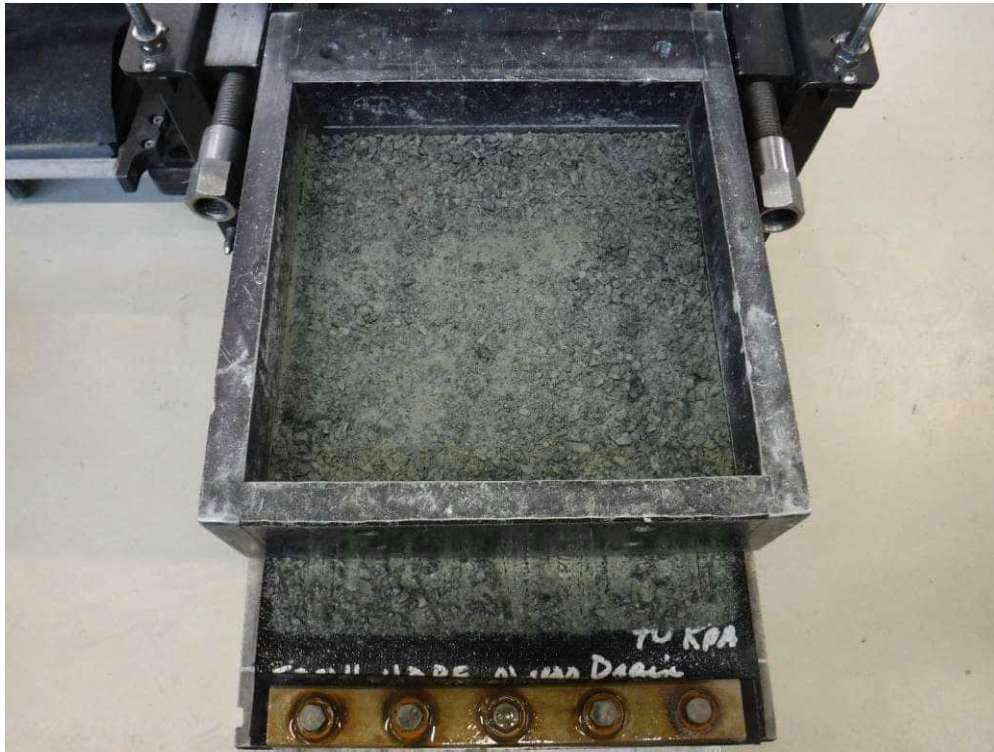
Shear Stress vs Normal Stress

TEST CONDITIONS: Shear surface 304 x 304 mm;
Data acquisition period (seconds): 1.2;
Flat surfaces grips fixed with 4 bolts + rasp surface in lower box and upper box ;
Normal load: Micro-Stepper Motor;
Rate of horizontal displacement(mm/min); 1;
Tested in machine direction ;
Submerged interface ;
Asperity Height: 5 measurements per specimen according to ASTM D7466 (HDPE Microdrain GMB(textured side));
Thickness: 5 measurements per specimen according to ASTM D5994 (HDPE Microdrain GMB);
Testing configuration - Upper box / Lower box: Soil / HDPE Microdrain GMB (textured side);
Date of test: June 7 & 8, 2021

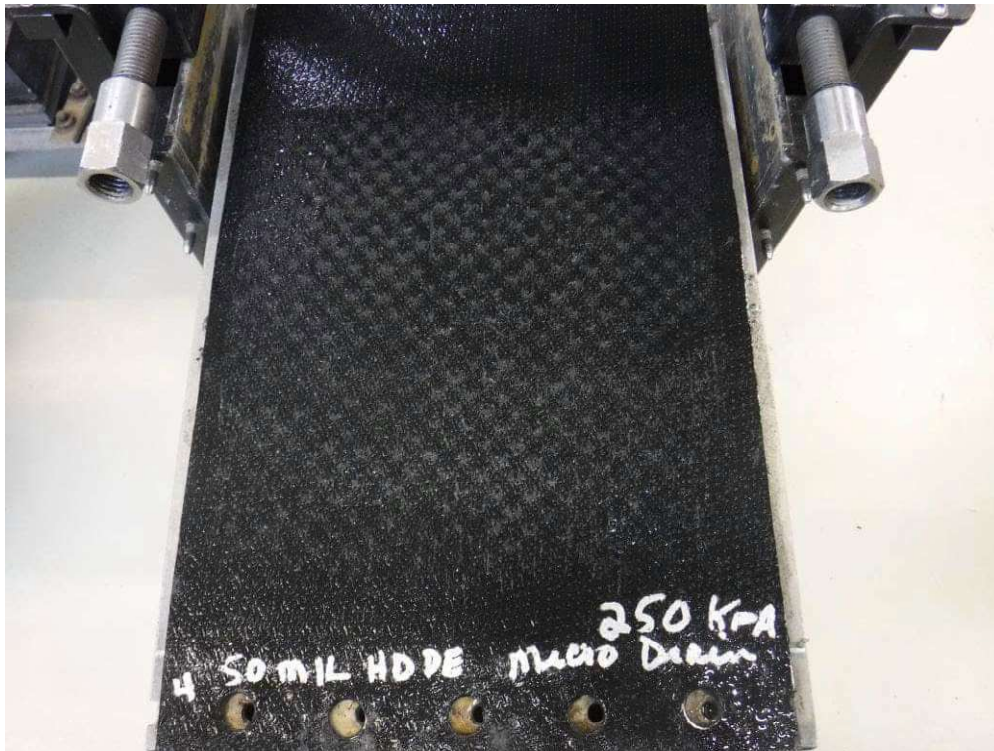
50 mil HDPE Microdrain Geomembrane after the test – Test at 70kPa

50 mil HDPE Microdrain Geomembrane after the test – Test at 250kPa
