FIELD QUALITY CONTROL REPORT

50mil HDPE MICRODRAIN INSTALLATION FOR:

HARRIETSFIELD C & D LANDFILL

Cap Replacement and Extension

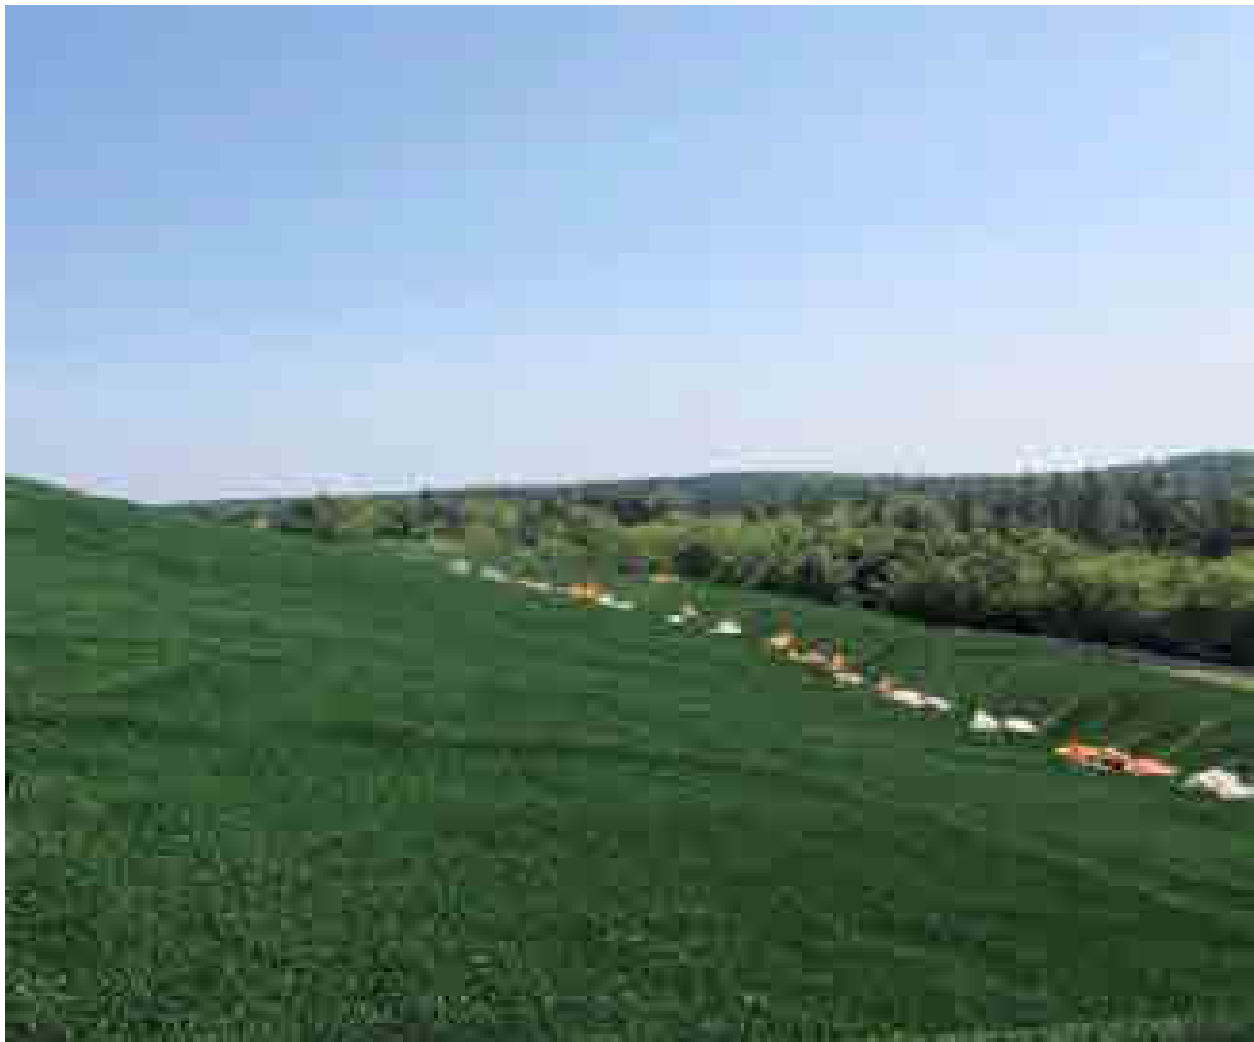
Example of turf installed on the South side of the cap. Grade breaks are ballasted.

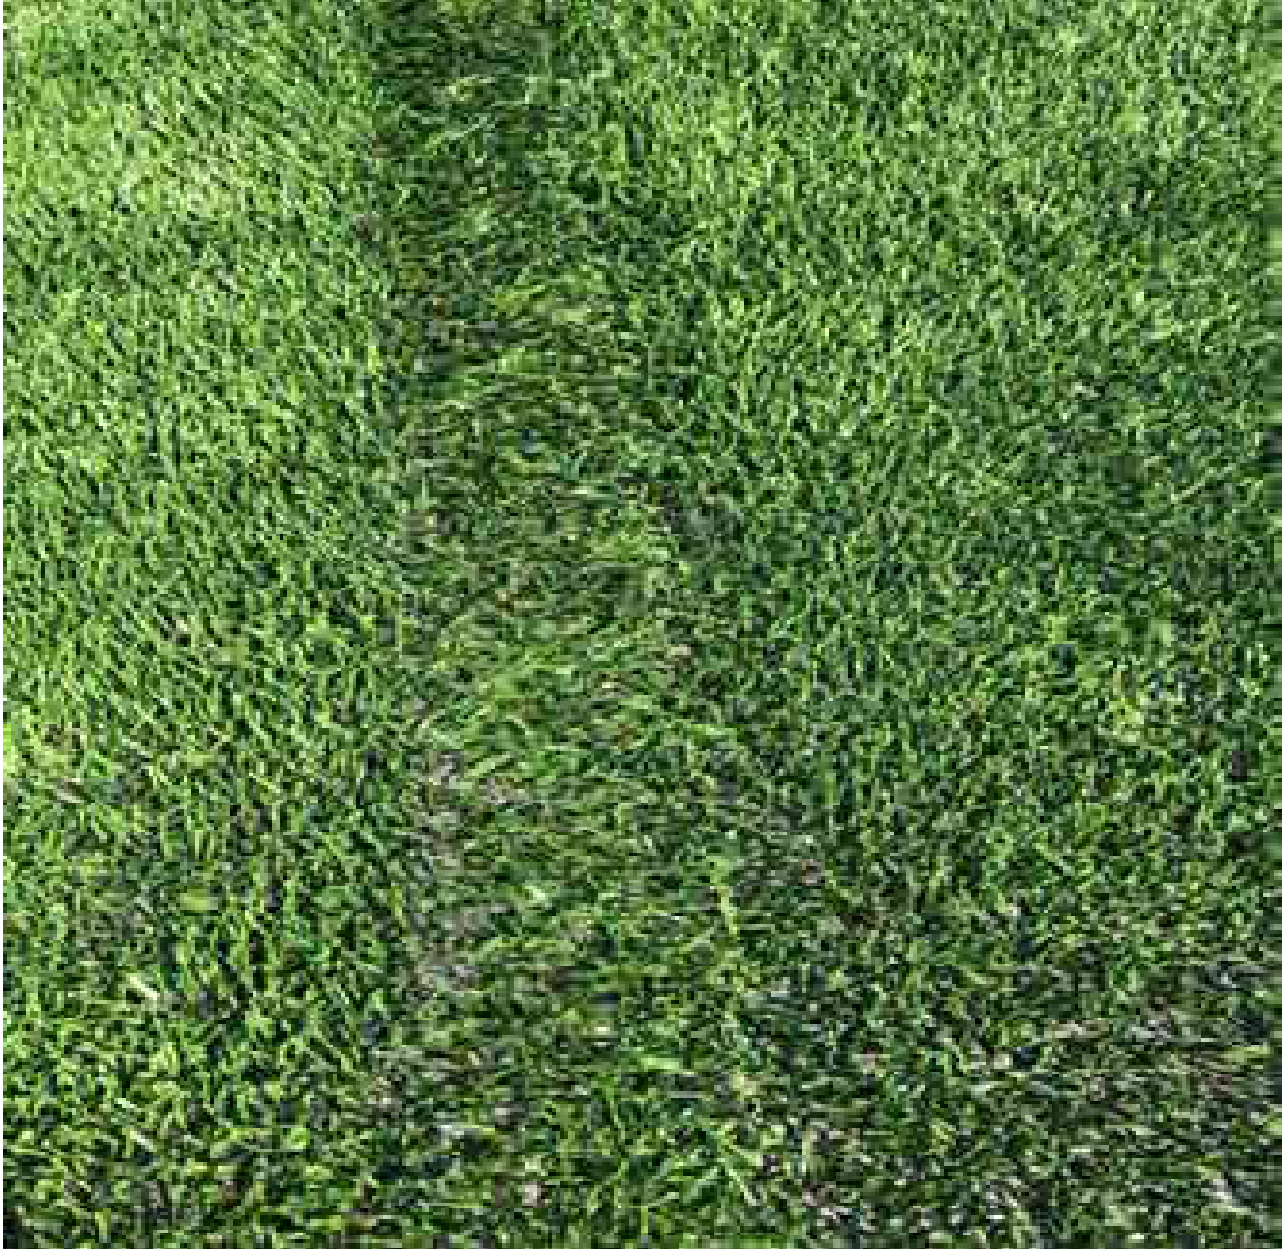
An example of a seam that meets WG specifications for wedge welding. All seams were welded from the top of the slope to the bottom. The selvage edge was trimmed correctly.

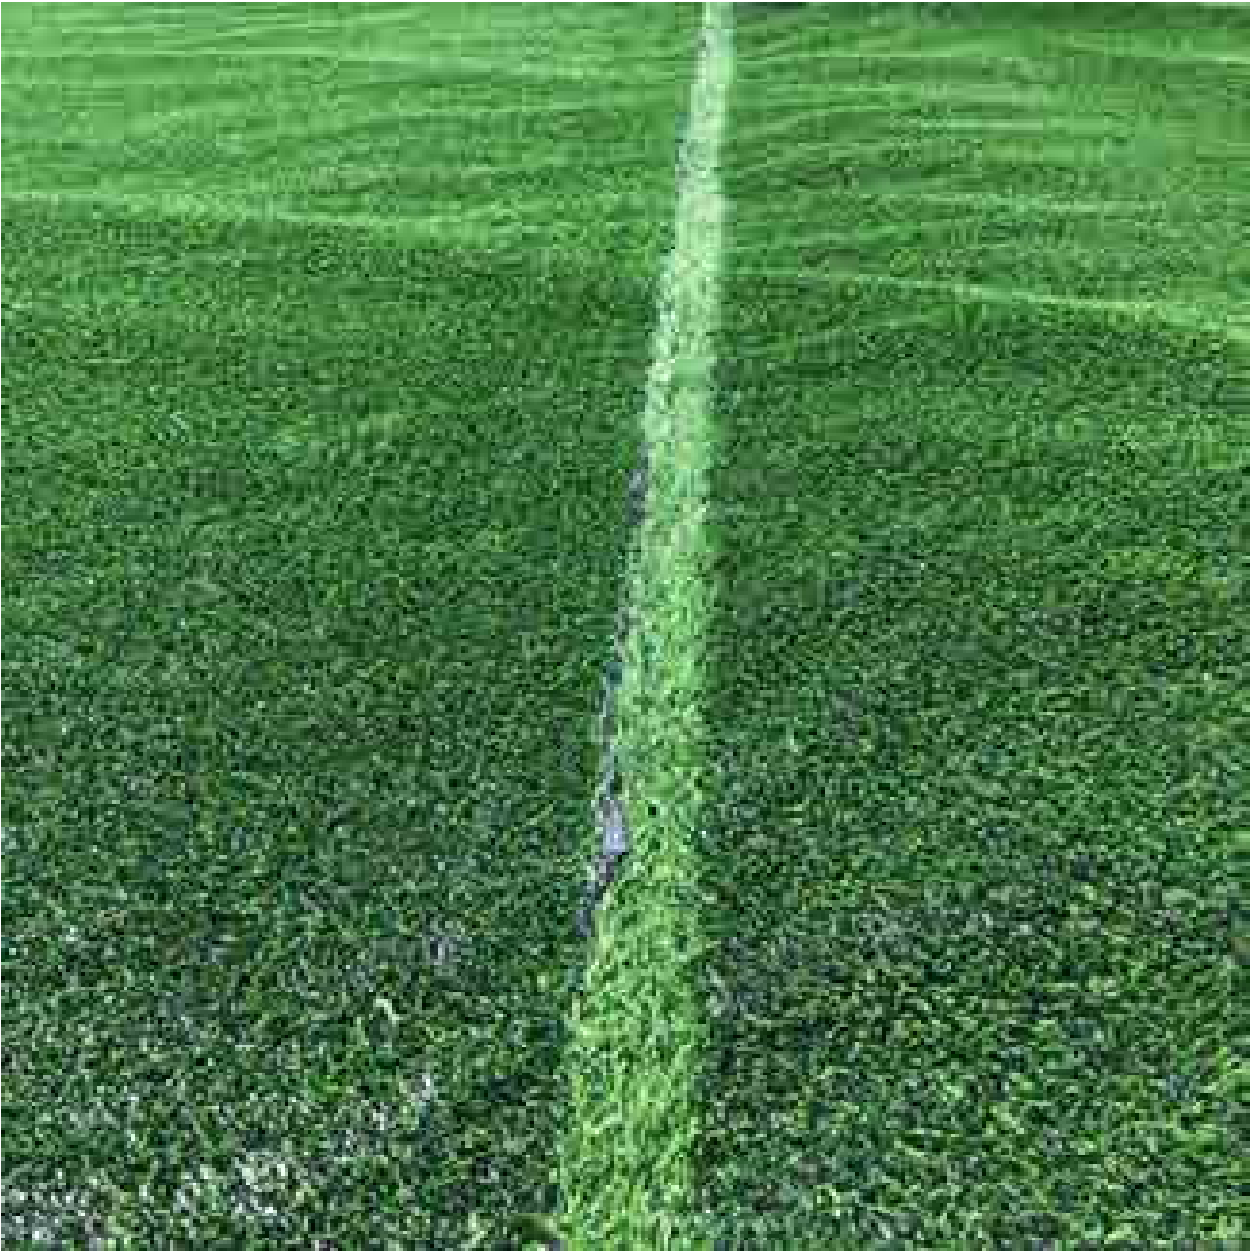
Example of a wedge welded seam with excess selvage not trimmed correctly. Selvage should not be seen after wedge welding. Corrective measures are required to meet WG specifications.

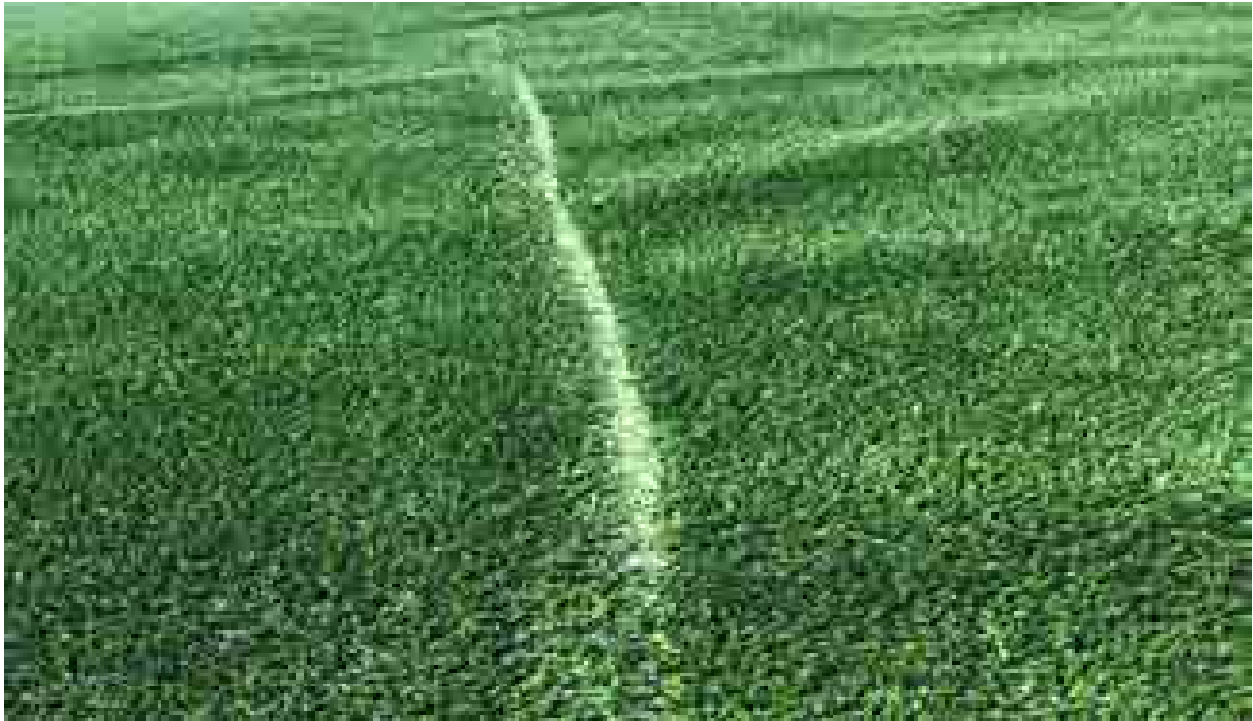
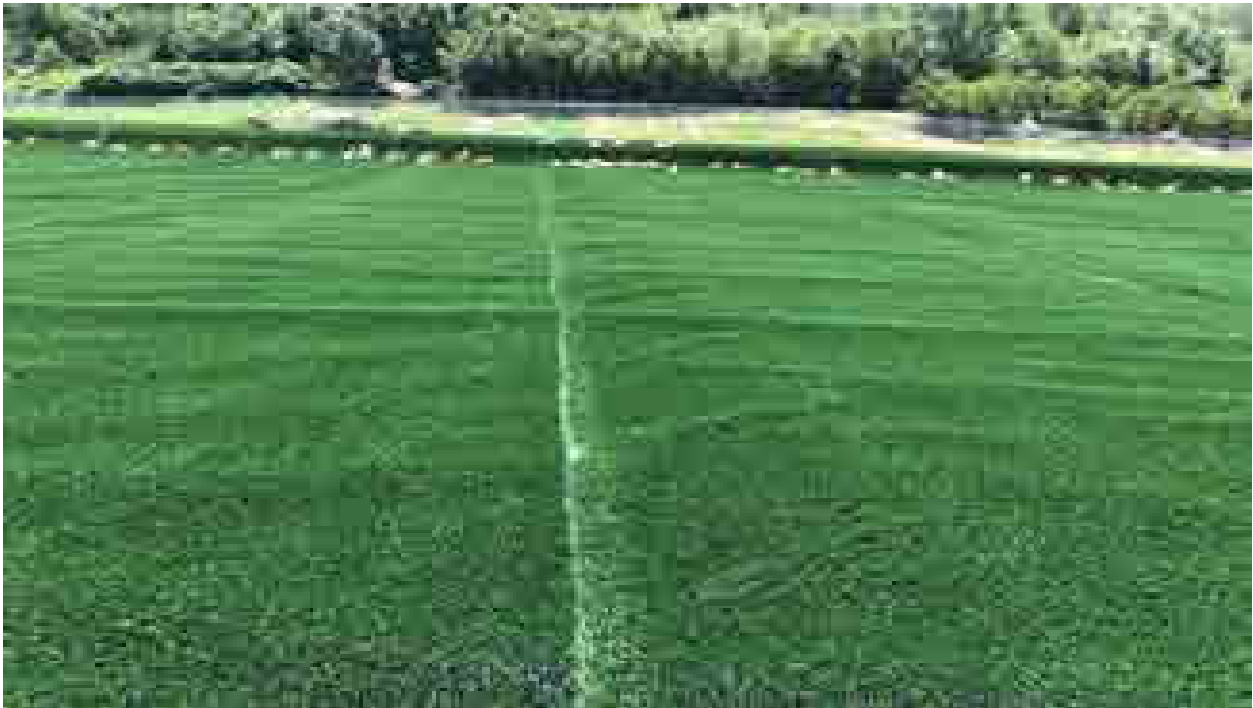
Examples of melted turf fibers outside the wedge welded seam area. Corrective measures such as a cap strip should be placed over these areas in small, isolated locations. The cap strip requires a fully made hand weld and should not exceed approx. 4-6 inches from the defected area, per WG Specifications. Larger areas with this defect should be a complete cut out of the seam and rewelded prior to placing a new panel.

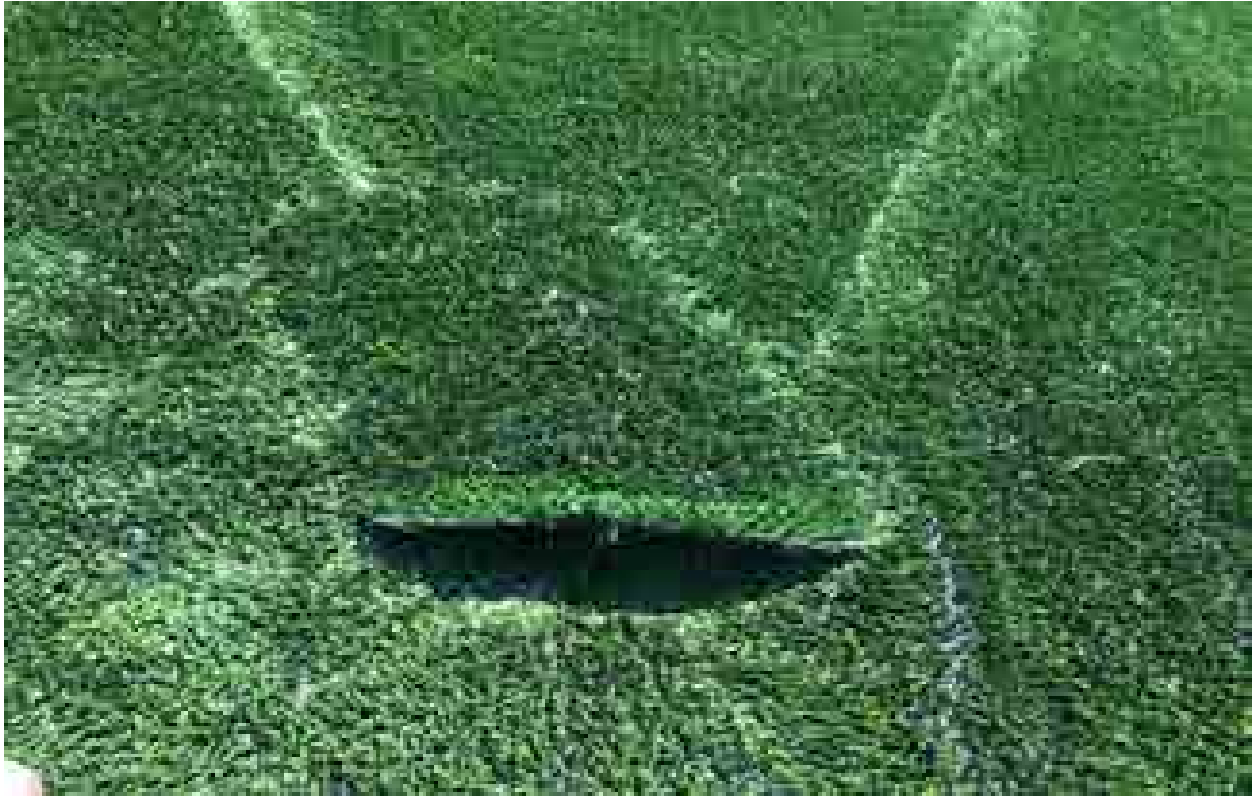
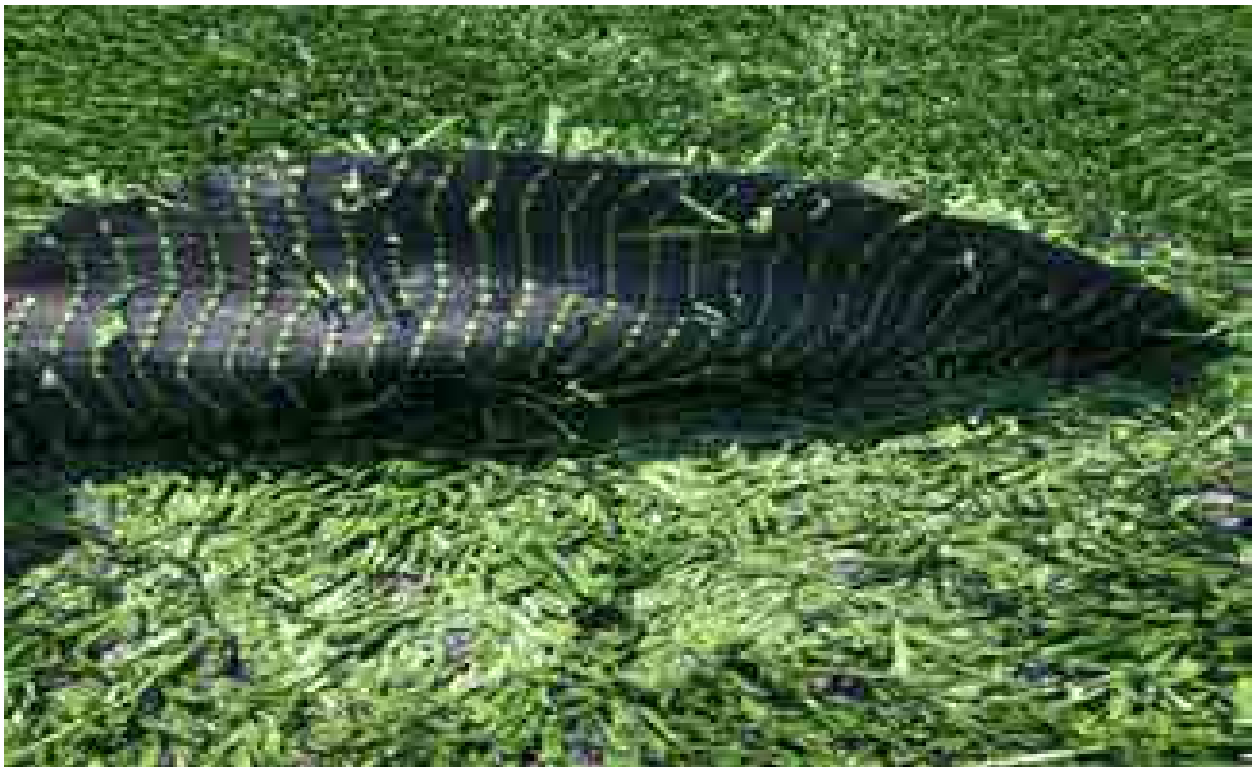
WG specification requires that the patches are 100% hand welded, not just the outer edge. Corrective measures are required to meet the WG specifications.

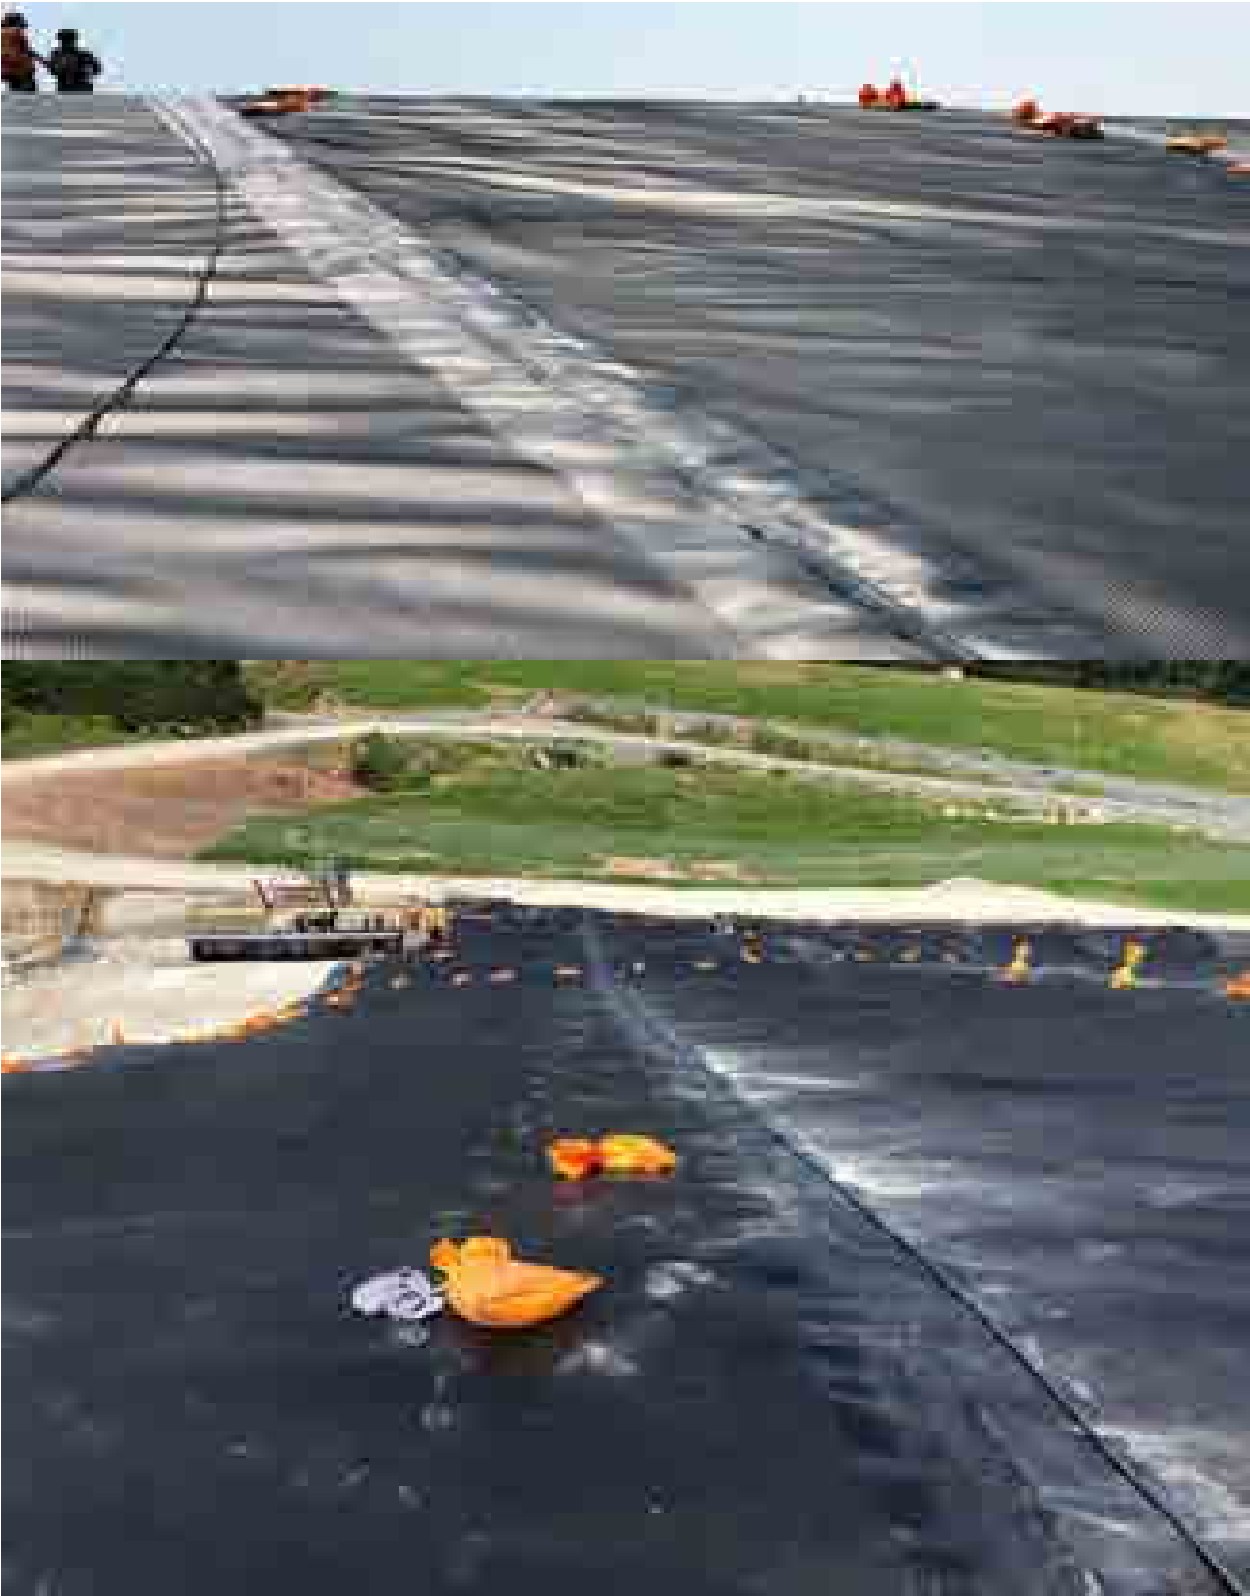
APL performed proper wrinkle management of the SGN membrane during installation and snapped the wedge welded seams as required by WG specifications. Example of SGN membrane during the heat of the day.

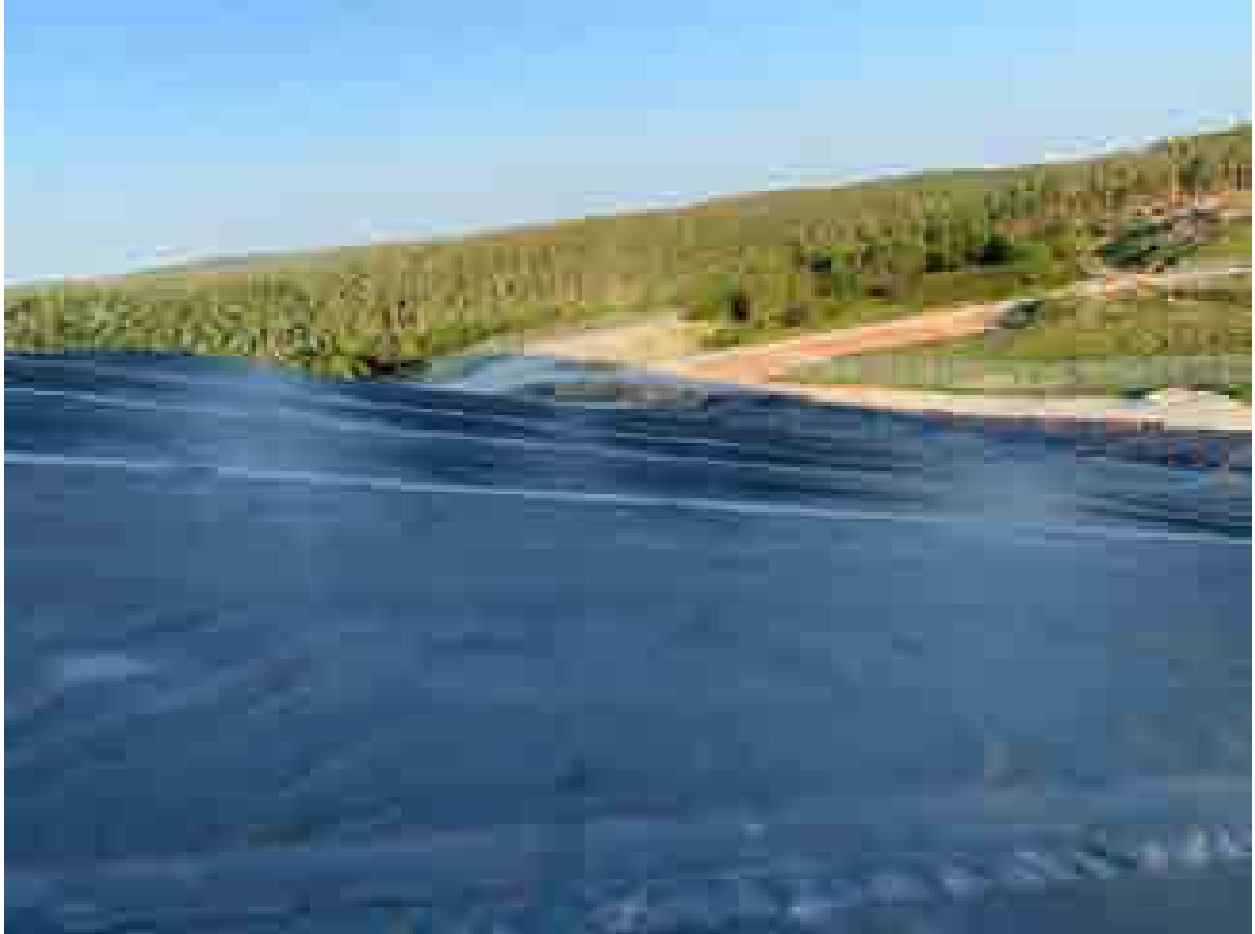
SGN membrane in a contracted state the following Monday morning. Based on the previous day photos and following day photos, it appears the SGN membrane is laying down relatively smooth. AECOM issued WG the Monday morning photo.

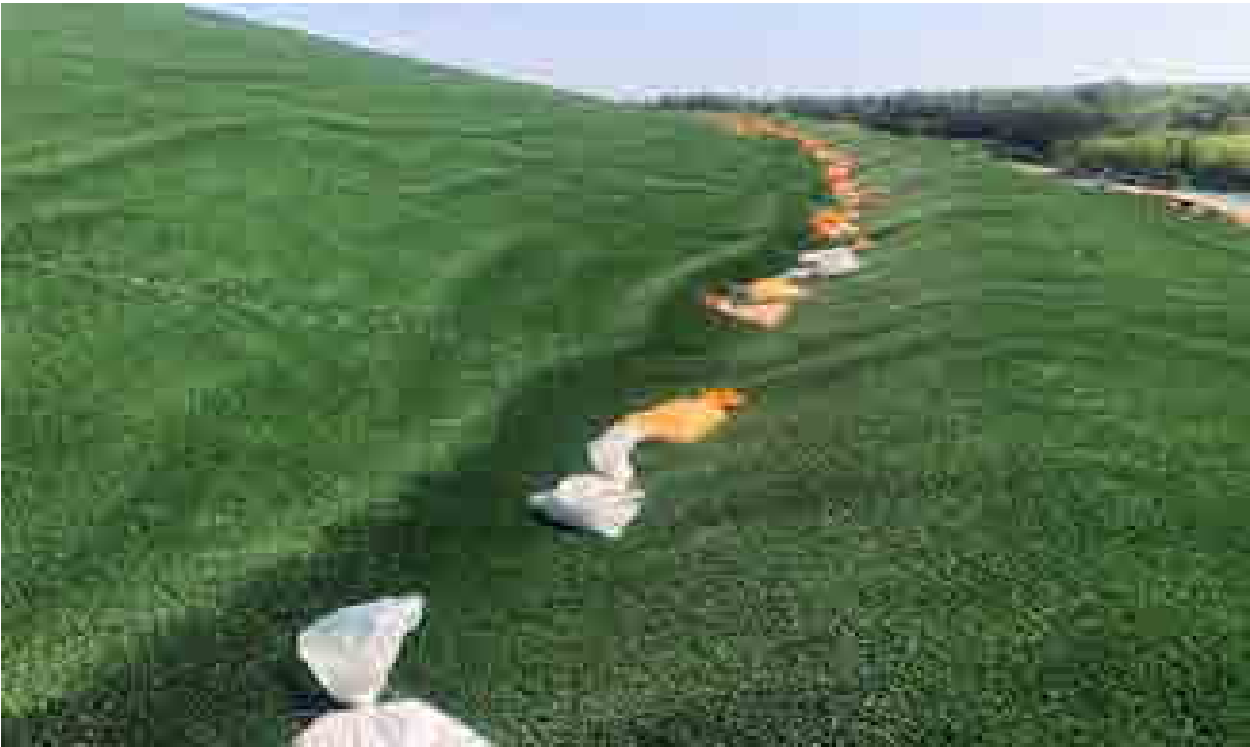
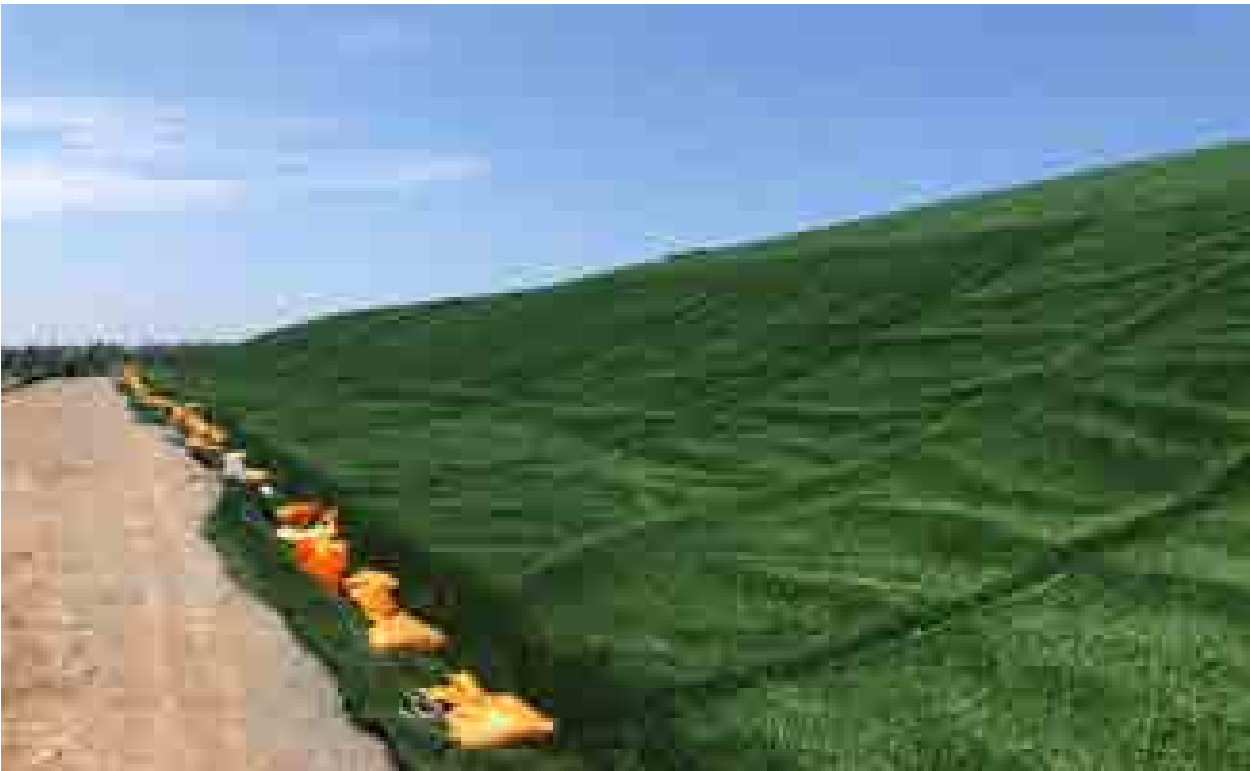
Examples of liner and turf areas that may require corrective measures if they fold over in the morning during cooler temperature. Stone will be placed in the solution trench.

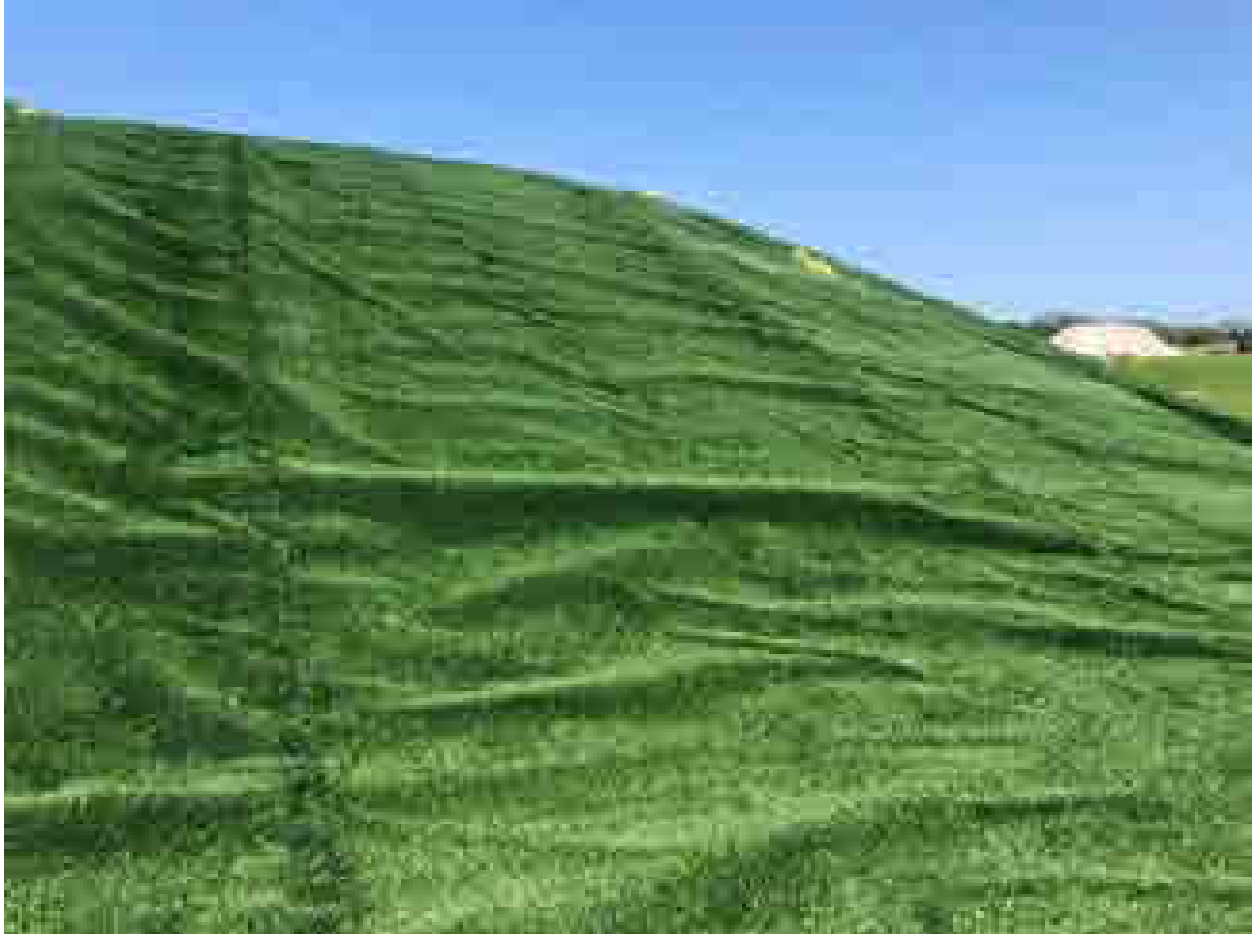
An area of loose turf that requires corrective measures to meet WG specifications. There is a wrinkle in the liner that may require corrective measures if exceeding the wrinkle specification. APL and AECOM were made aware of these from WG and will evaluate the SGN membrane in this area during the morning when it's in a cooler state.

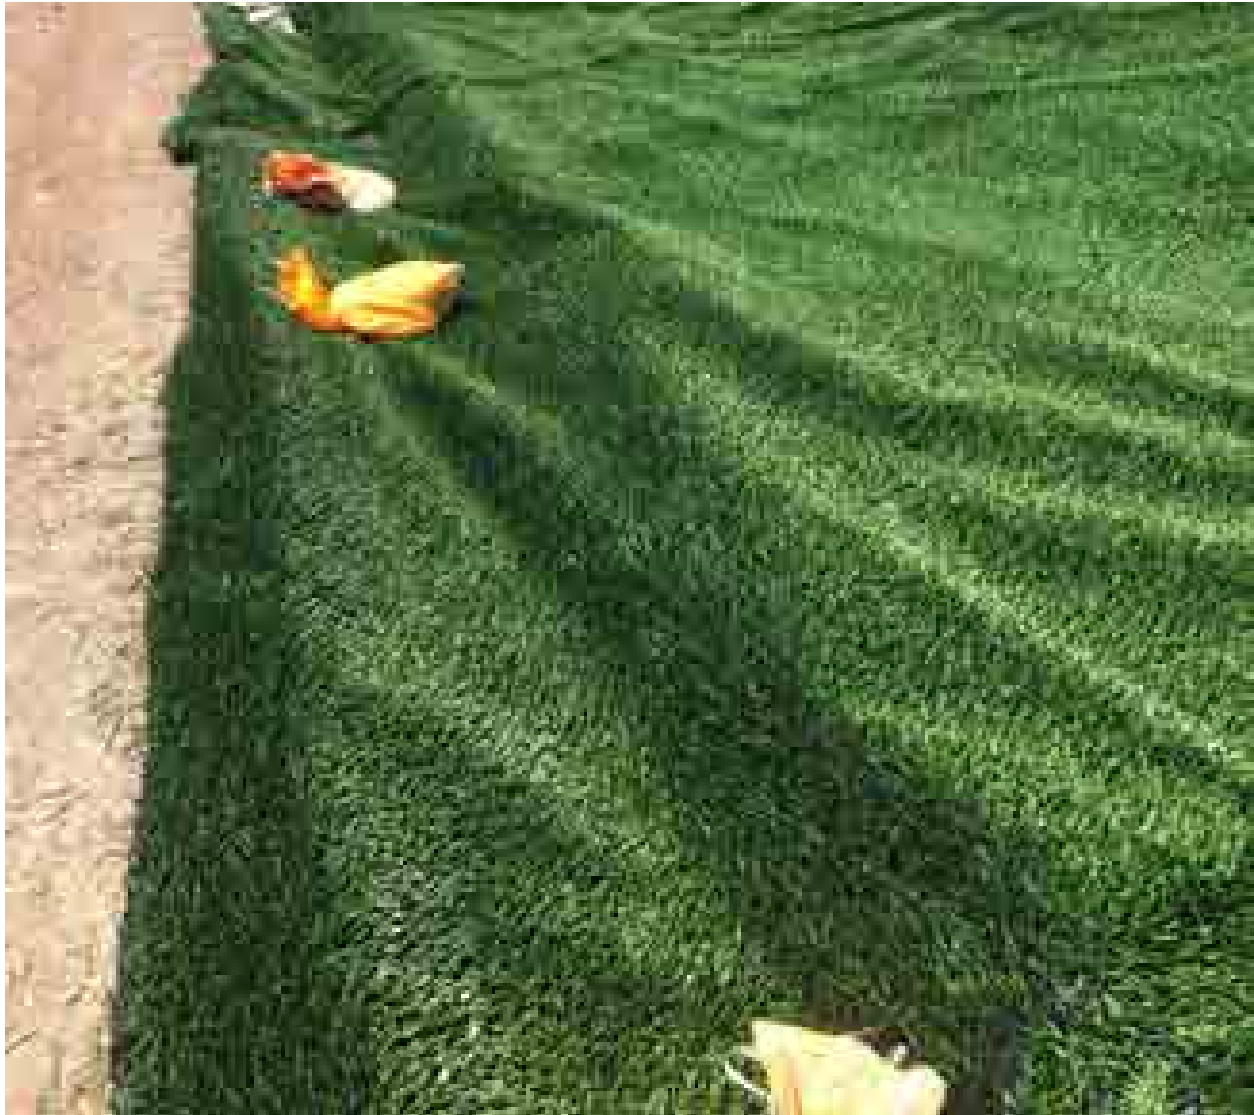
The liner in the anchor trench is partially backfilled around the perimeter of the cap. The turf is installed but doesn't have any backfill on it. In some areas the SGN membrane is not in contact with the crest of the anchor trench and pushed up with a wrinkle and a void. AECOM is aware of the issue. WG provided suggestions to AECOM on how to manage this when backfilling.

APL will self-perform the sand infill and HydroBinder componenta. Greg and I discussed trafficking, equipment ground pressure and backfilling the anchor trench prior to installing the sand infill and HydroBinder. APL will place additional sand where required by WG specifications.

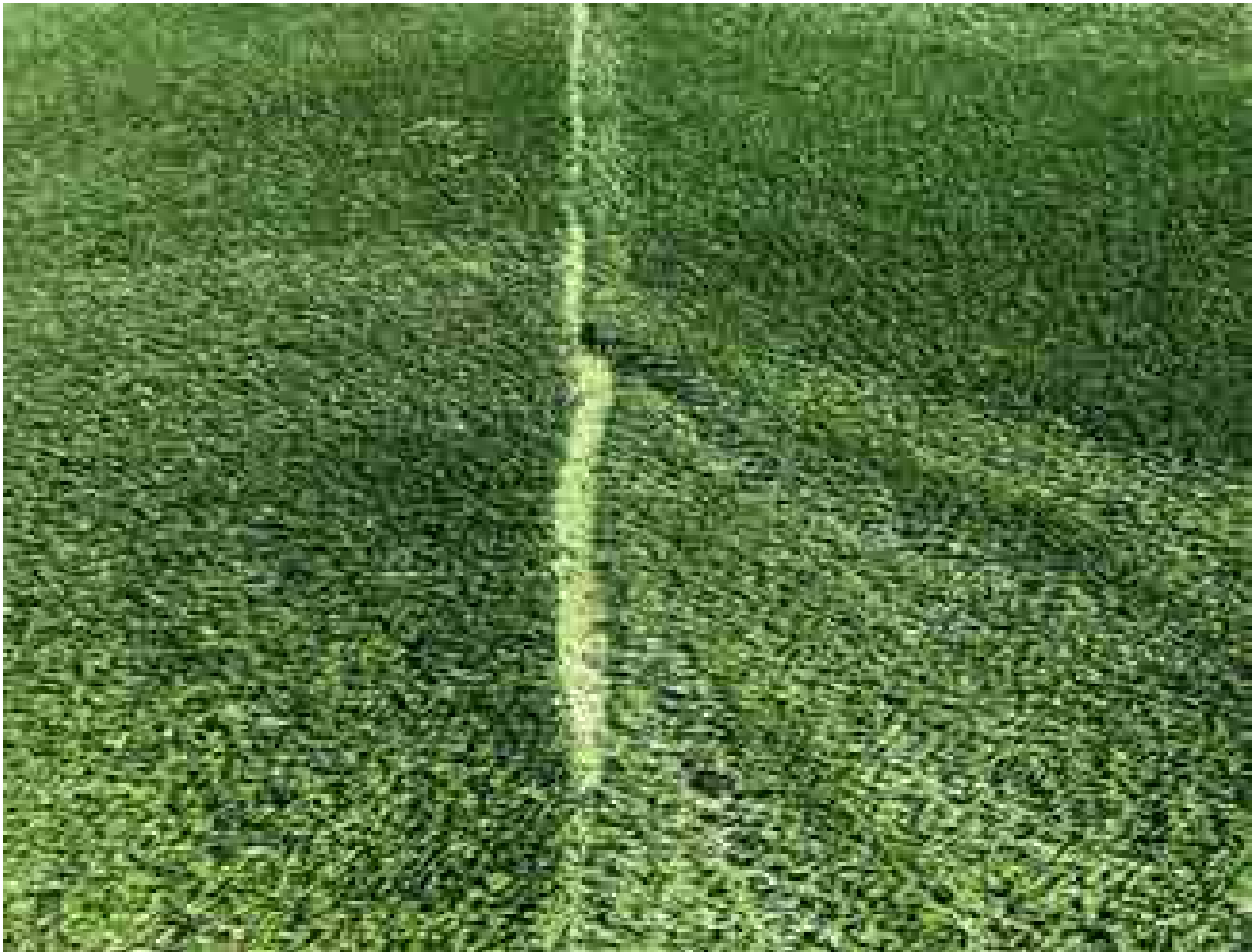
Turf seams

- Turf wedge welded seams that have been overheated and exhibit melted tuft blades requires a small turf patch in order for the sand infill to perform. As discussed, over time voids such as this have the potential to expose the geotextile.

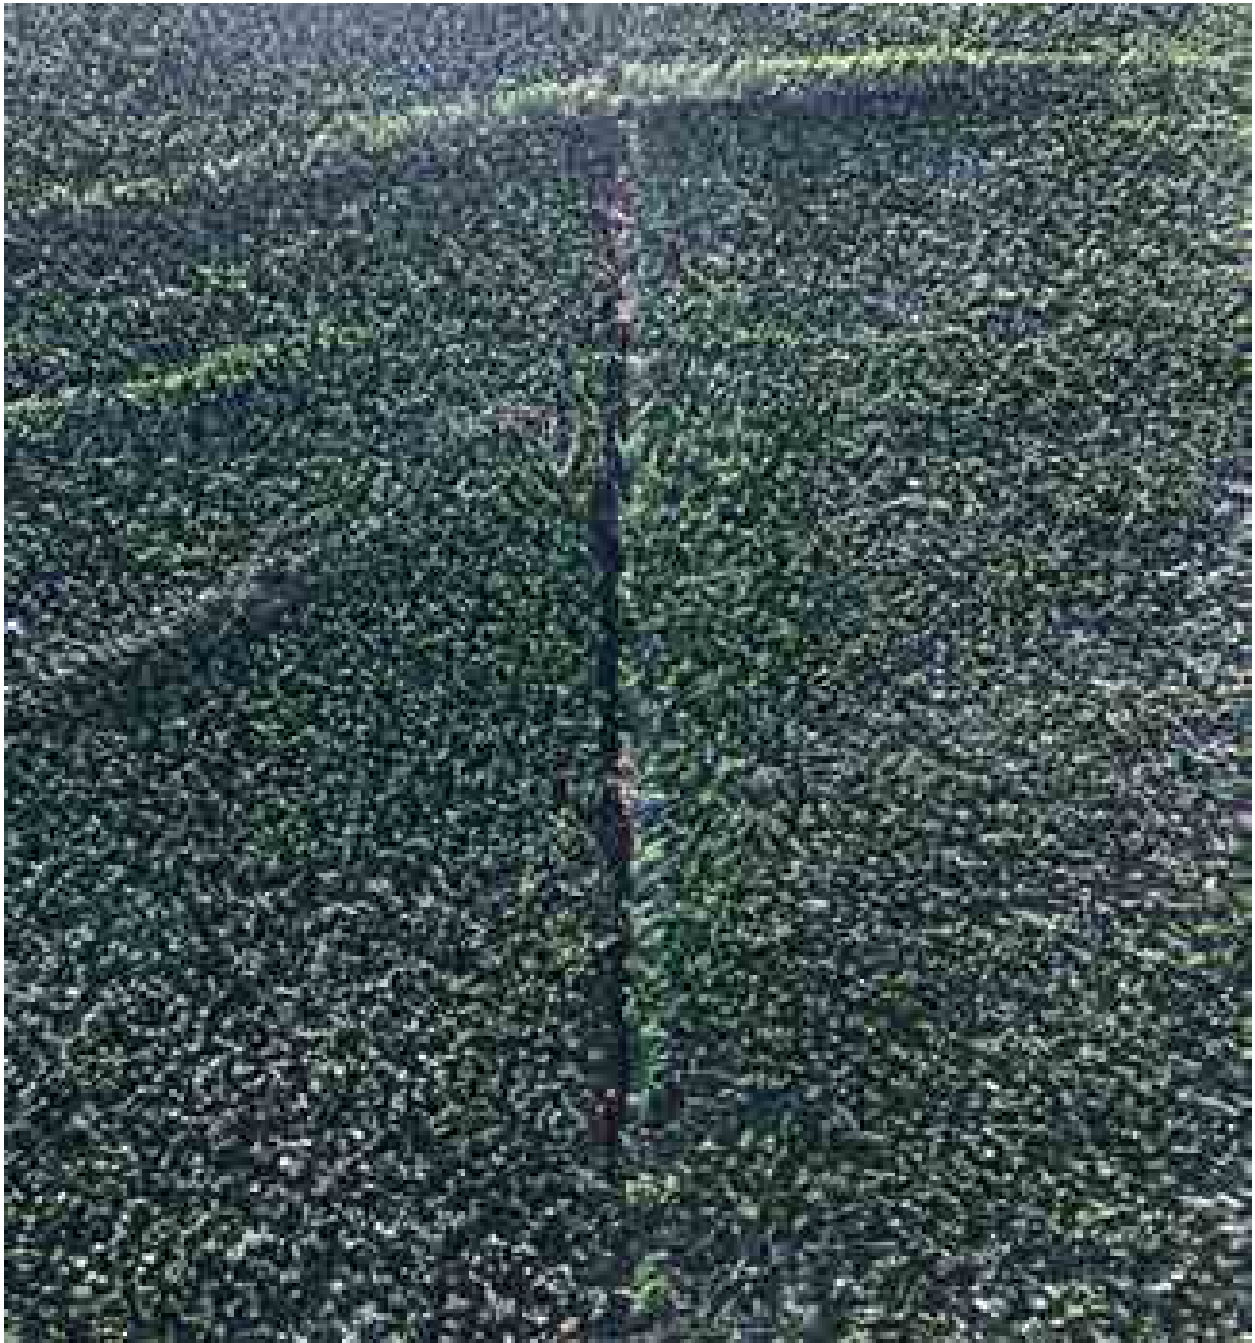
- Turf wedge welded seams that have excess selvage extending outside the top wedge welded seams are due to improper trimming. The

excess selvage creates a void overtime when the sand infill is not present. The void is created by the excess selvage trapping the tuft blades and will eventually lead to geotextile exposure. These areas require that the excess selvage be trimmed or patched and covered with sand infill.

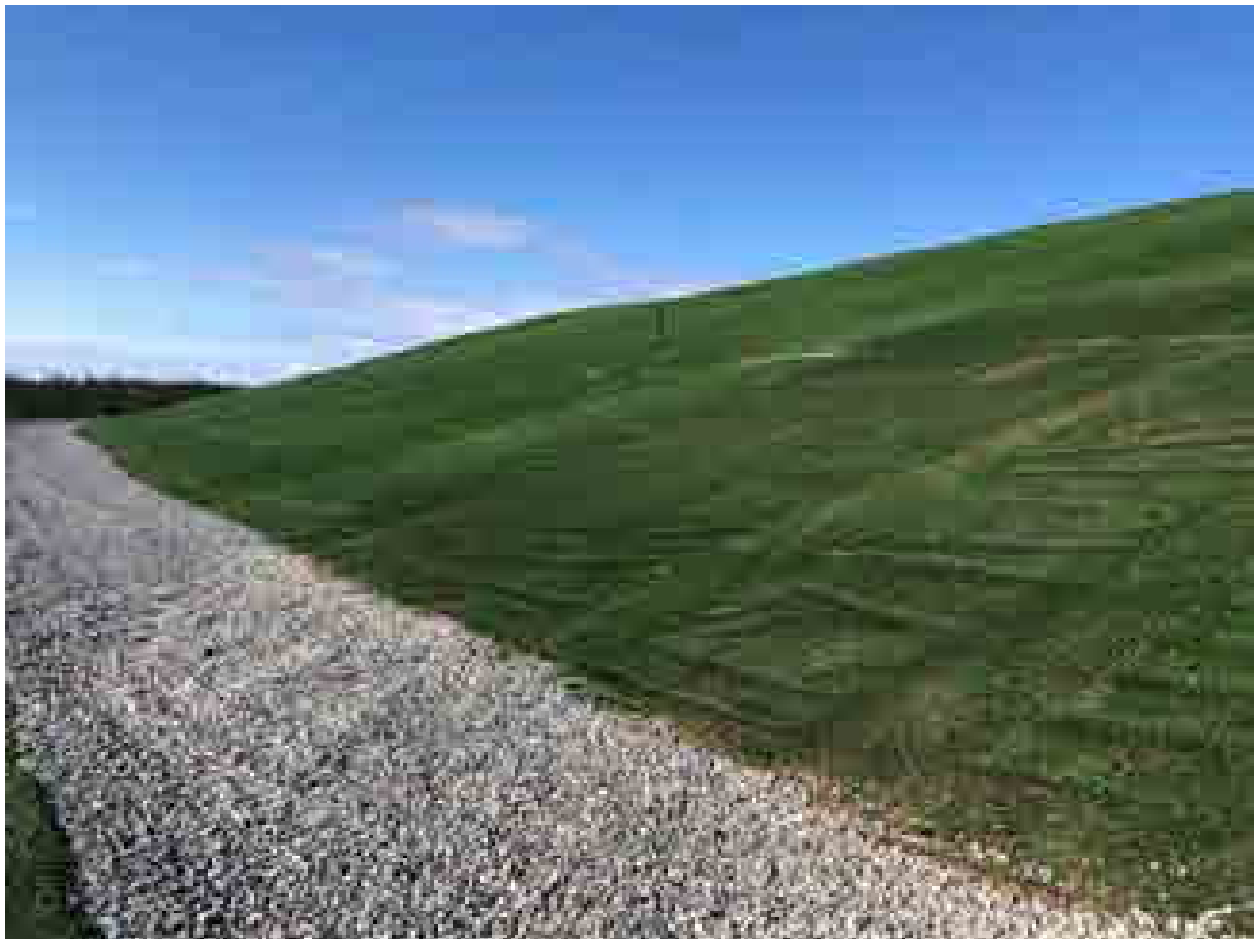
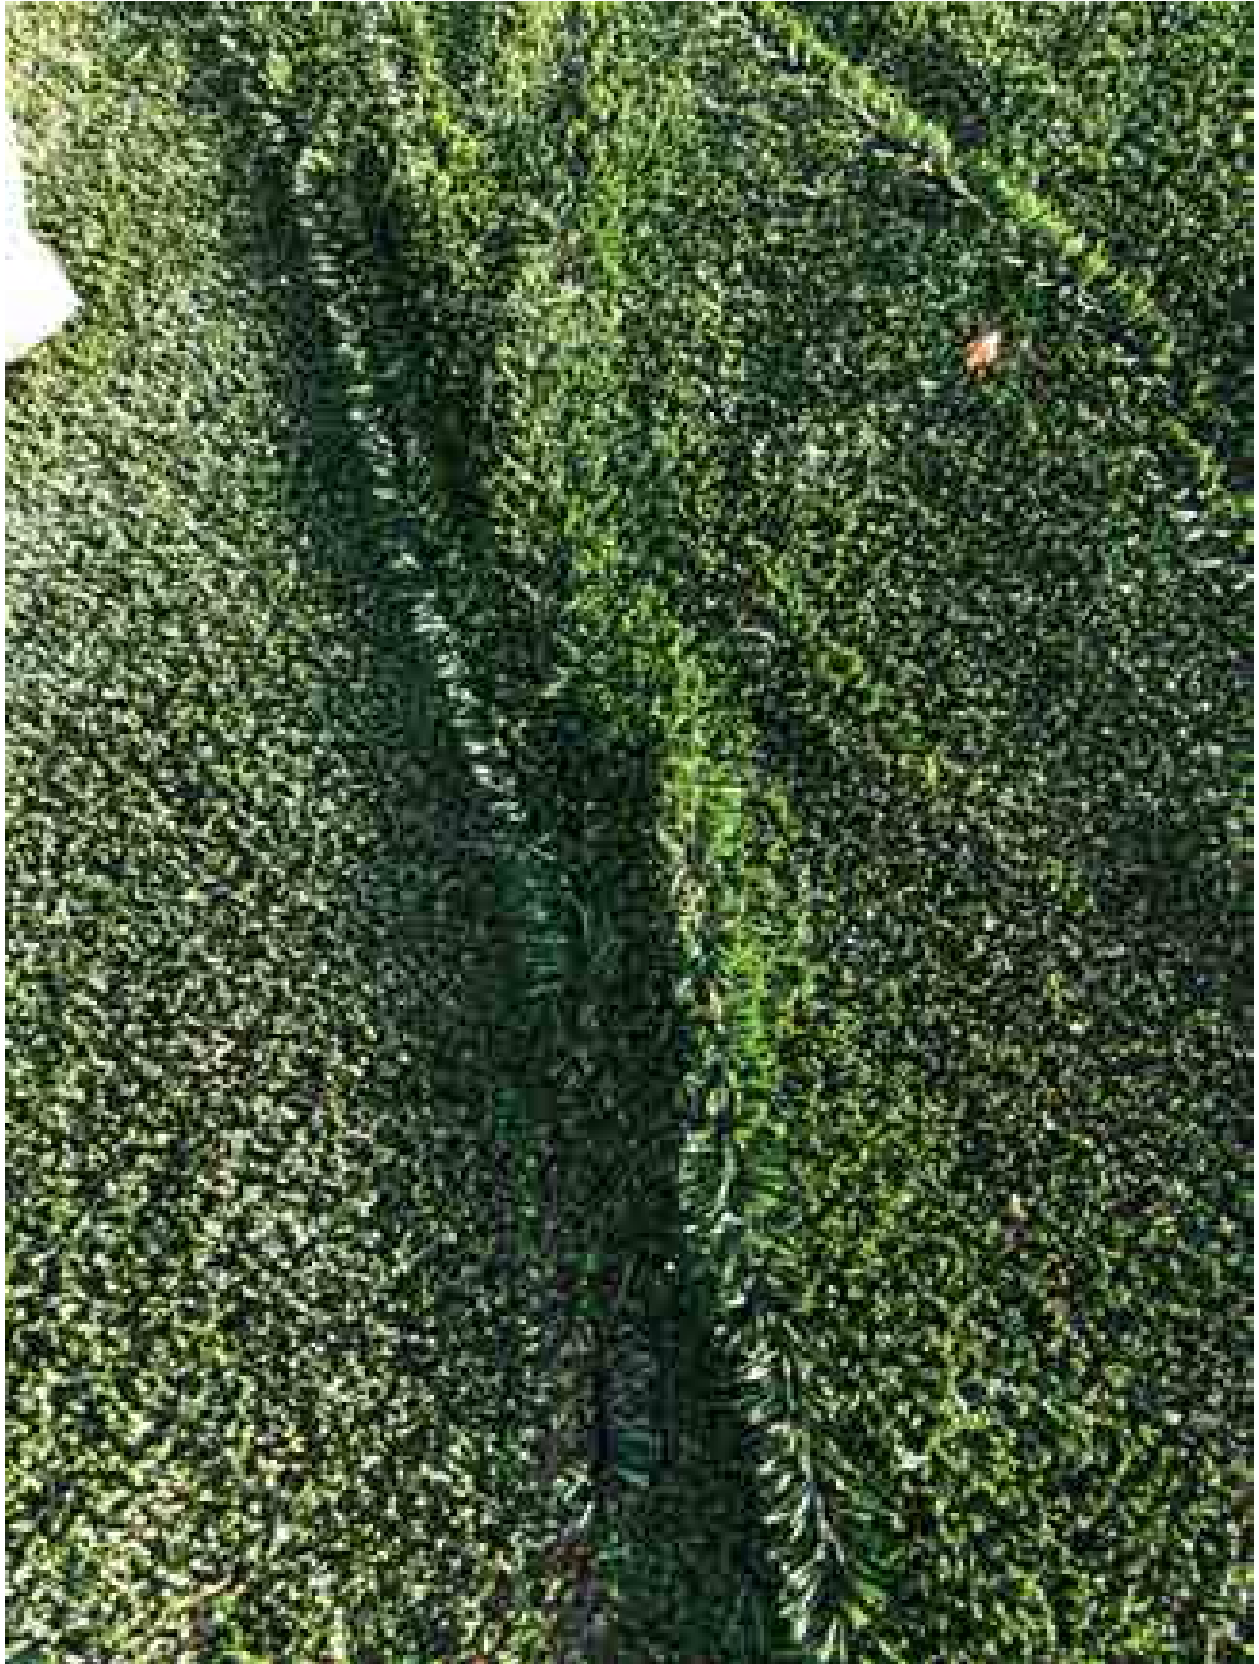
Turf/membrane Ripples

- Areas with ripples where sand has migrated off the peak areas with exposed geotextiles after the installation requires corrective measures. Ripples may be consolidated and repaired to minimize the number of repairs. Additional sand should be added to the top of any small ripples, however the sand infill will not stay over time. When maintenance is performed not to exceed 5-years from the end of construction, these types of areas will require an armoring application (WG to provide additional information at a later time) to protect the geotextile backing long term.
