FIELD QUALITY CONTROL REPORT

50mil HDPE MICRODRAIN INSTALLATION FOR:

HARRIETSFIELD C & D LANDFILL

Cap Replacement and Extension

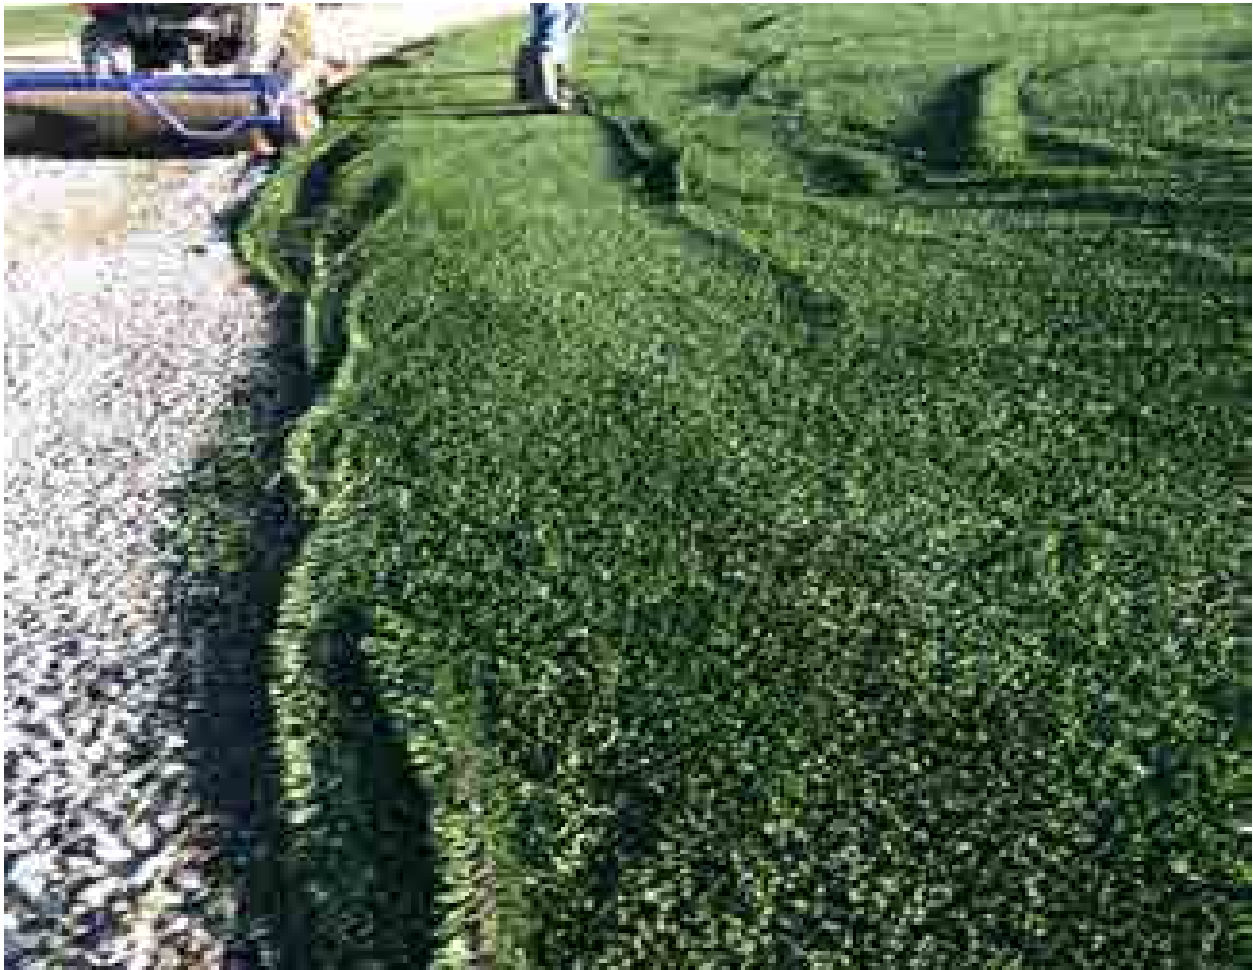
- Wrinkles in the turf and/or the liner exist along the anchor trench and the along the road area require corrective measures. Wrinkles are required by WG specifications to be corrected prior to signing off on a project, this can be achieved by excavating a small portion of the road or anchor trench and pushing the turf and/or membrane down into the excavated area prior to backfilling. Another option is placing additional road material to cover the wrinkles along the road section or anchor trench. Wrinkles in other areas of the closure require repair and sand infill to be placed and brushed once the repair is complete.

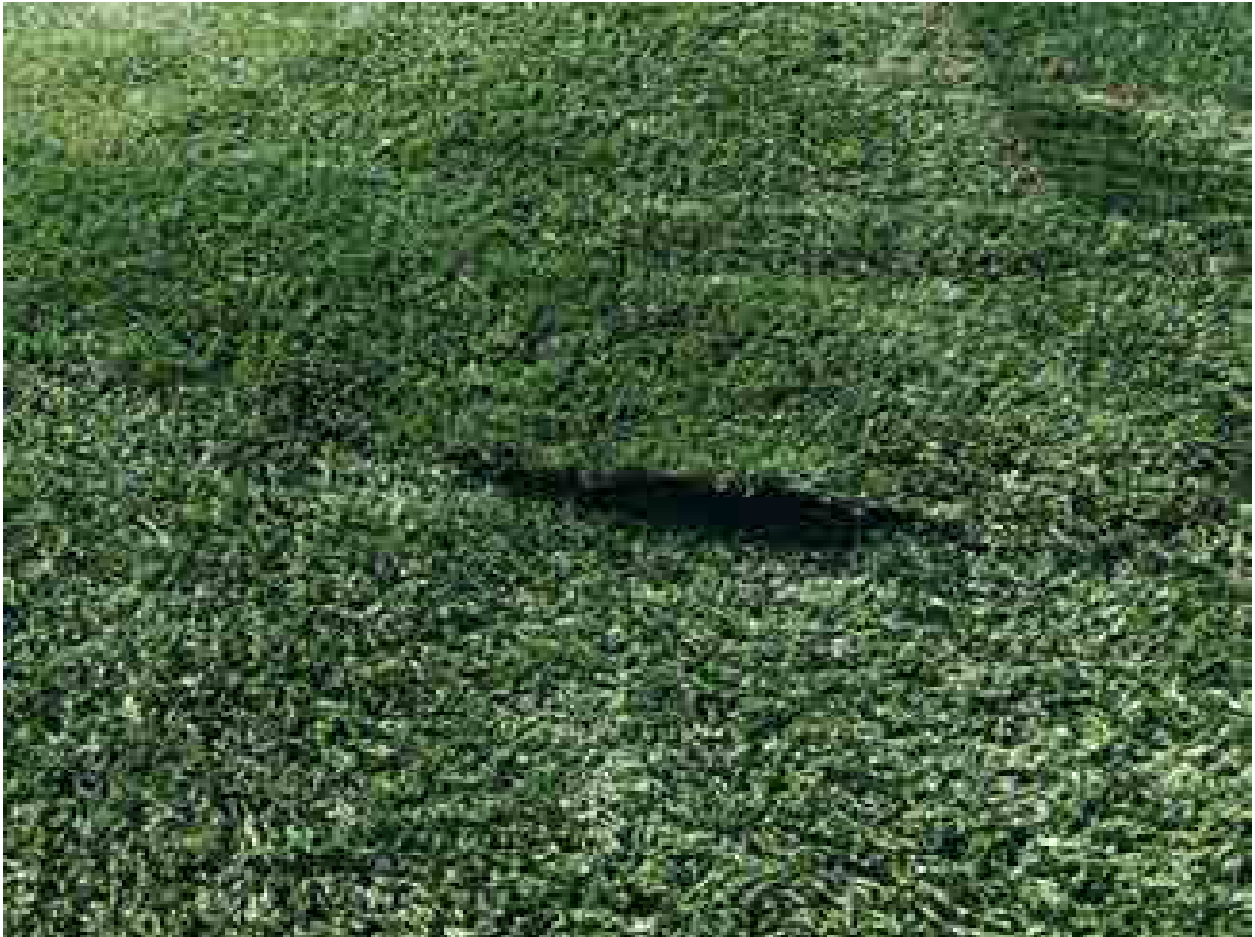
Turf Repairs

- All existing turf repairs should be re-examined. Several repairs were found to not be properly repaired as required by WG specifications and require corrective measures.

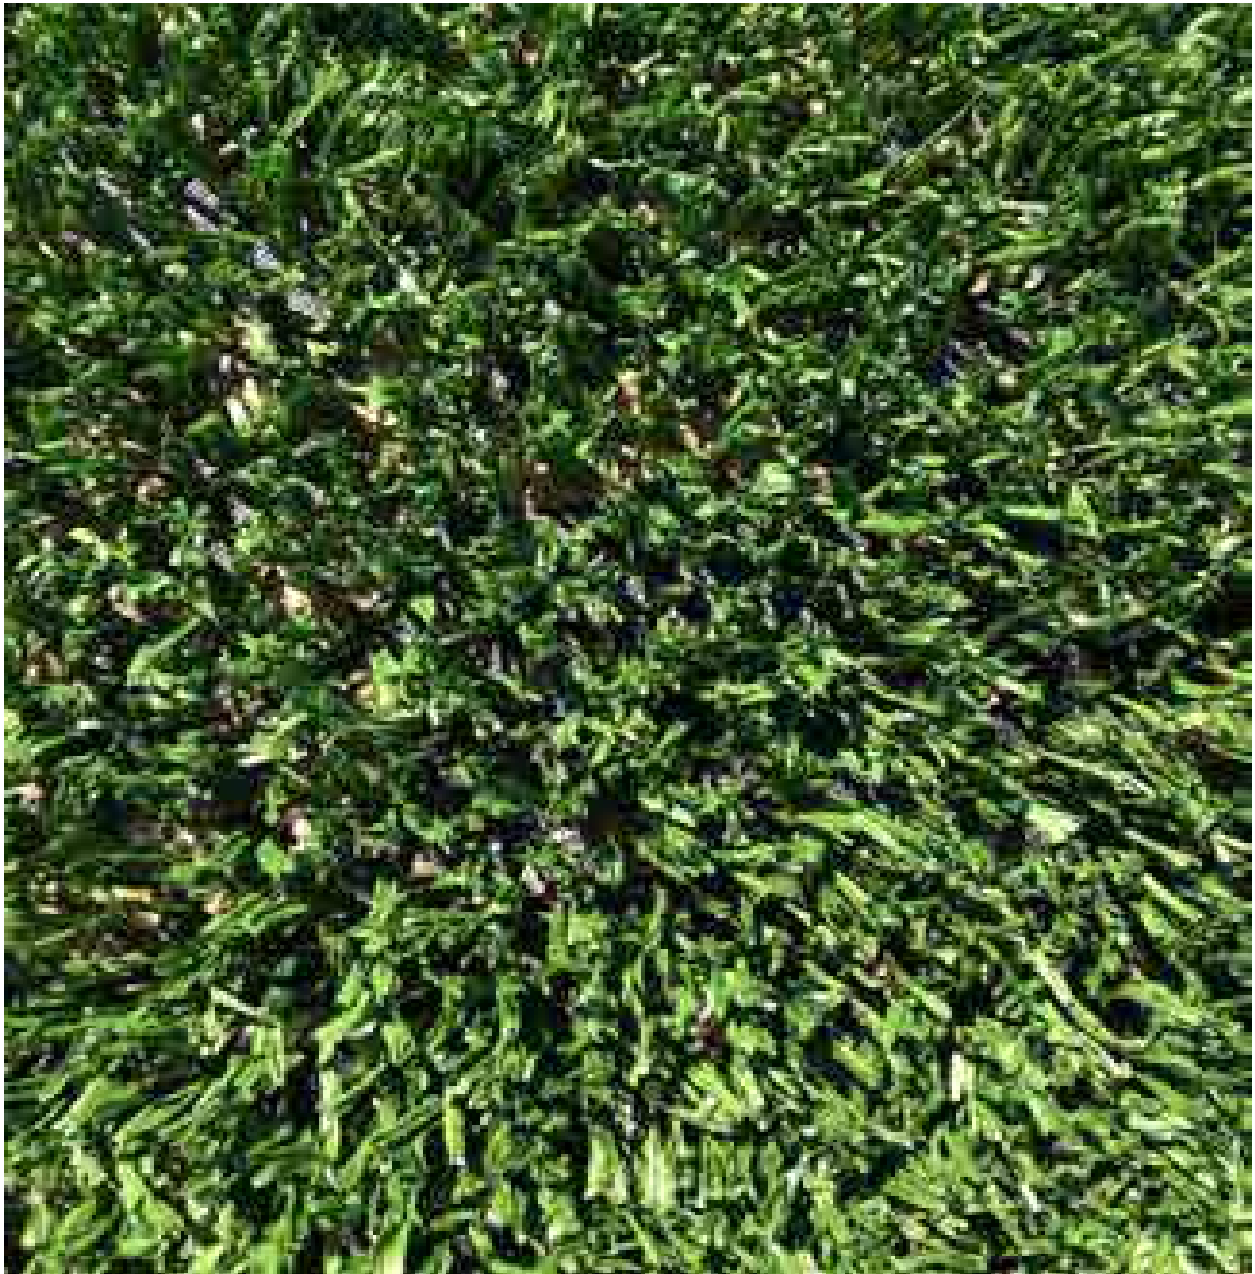
- There are some large areas on the slopes with exposed geotextile backing that were located during the walkthrough. Several other areas with minimal voids were discovered as well. Sand infill will need to be installed and brushed in these areas to meet the WG specifications. The entire system should be inspected to assure that the sand infill depth meets WG specifications.

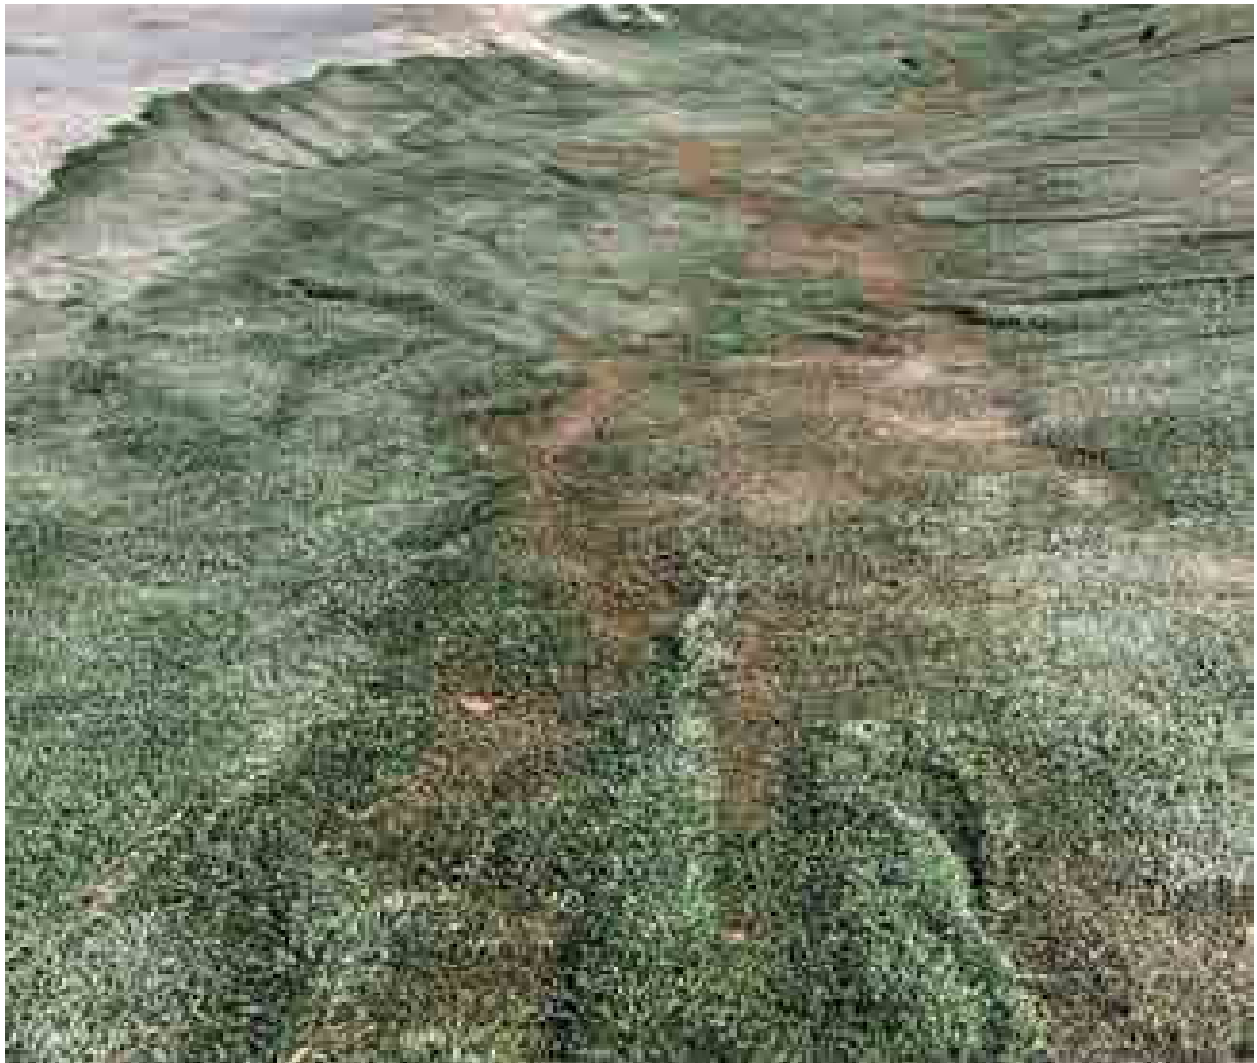
HydroBinder Infill

- There are many areas where the HydroBinder infill was not installed to the correct thickness or hydrated properly. Turf tuft blades are trapped. The thickness of the HydroBinder is not consistent. There are many areas where the HydroBinder is too thick and areas where the geotextiles are exposed.

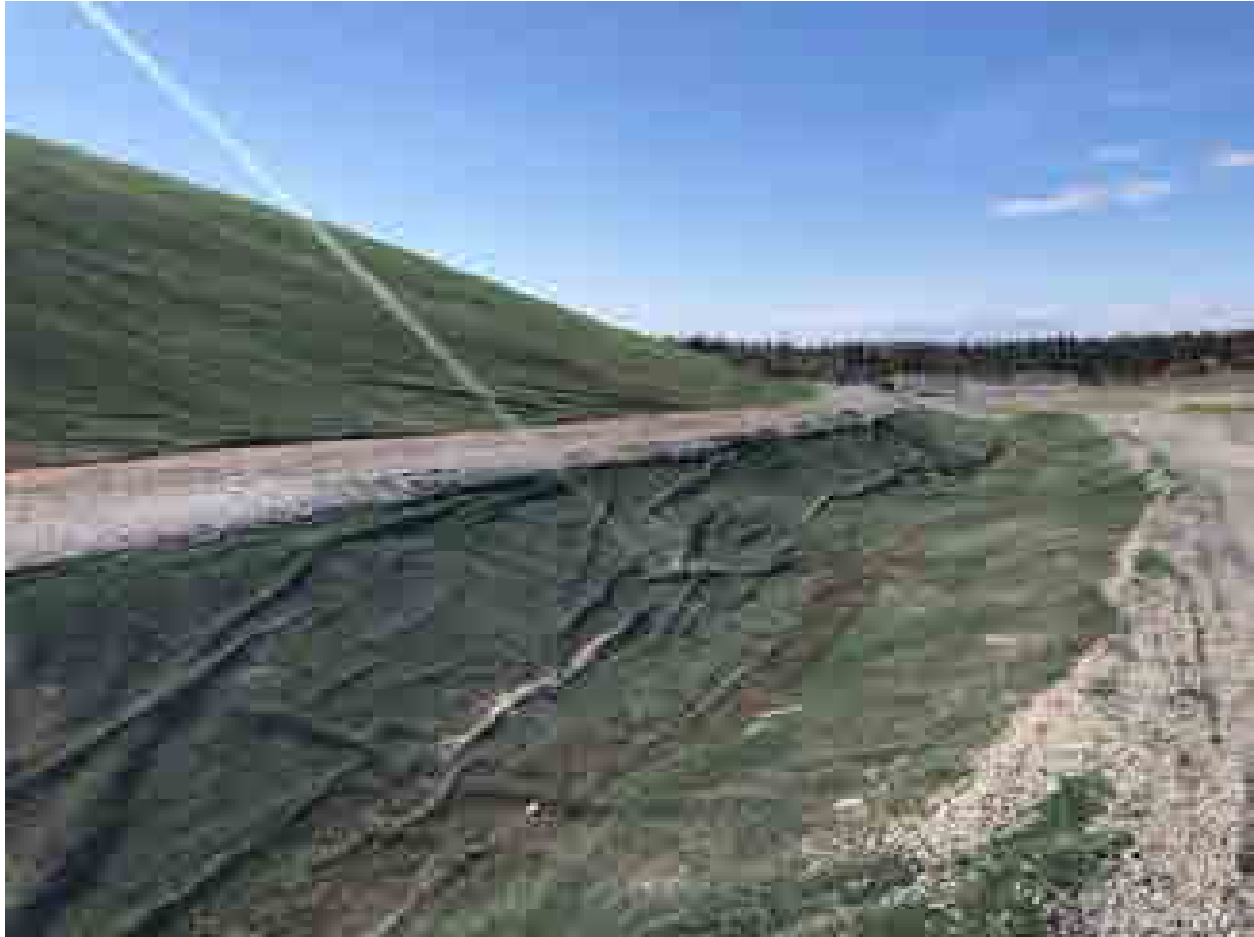
- Wrinkles in the turf should have been corrected prior to the installation of the HydroBinder. Unfortunately, several wrinkles are now

trapped. APL was in the process of installing HydroBinder in the collection trench the day of the walk through. WG HydroBinder installation specifications have been provided and discussed during this project. These areas require corrective measures.
