Wetland Assessment Report – Area 2 Addendum
Montague Gold Mines, Nova Scotia
Final Report

Project #: TV183013

November 2021

Prepared for:
Intrinsic Corporation on Behalf of Nova Scotia Lands

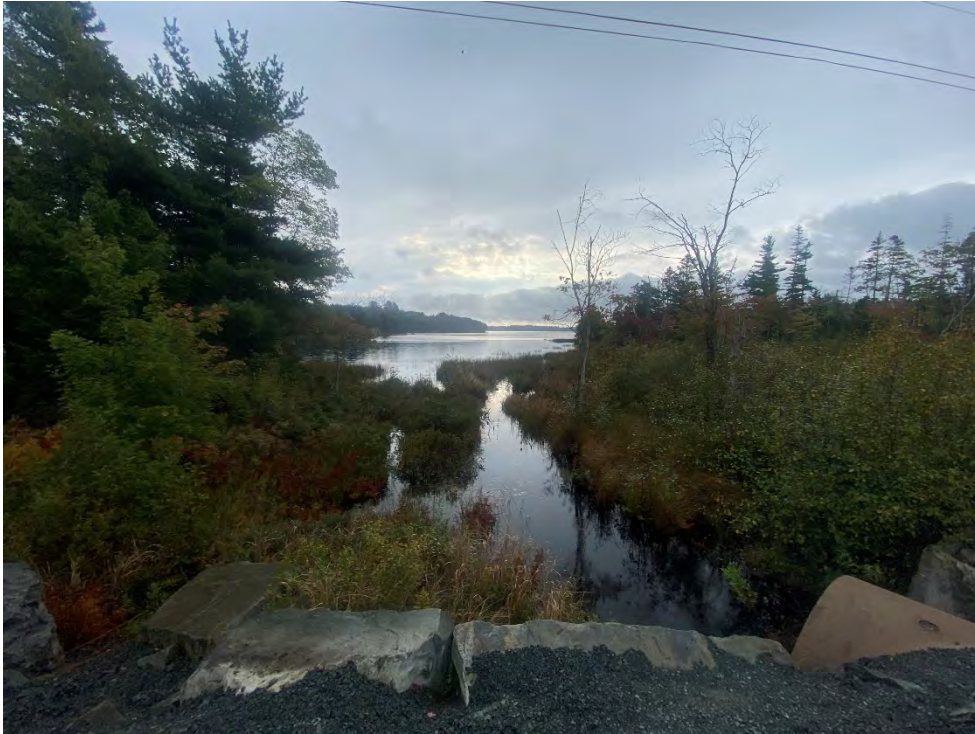
Photo 1. Area 2 – Looking southeast toward Loon Lake from the inlet of the Area 2 wetland at Lochmoor Lane.

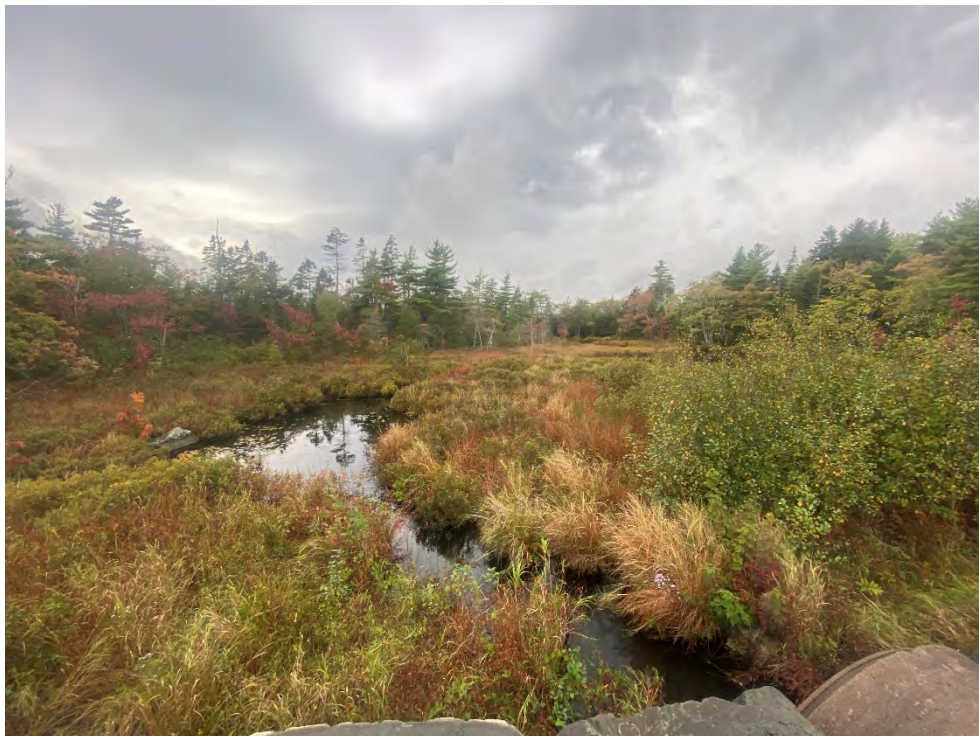
Photo 2. Area 2 – Looking northwest from the location above, toward the Area 2 wetland along Mitchell Brook. This part of the wetland is upstream of apparent historic mining impacts.

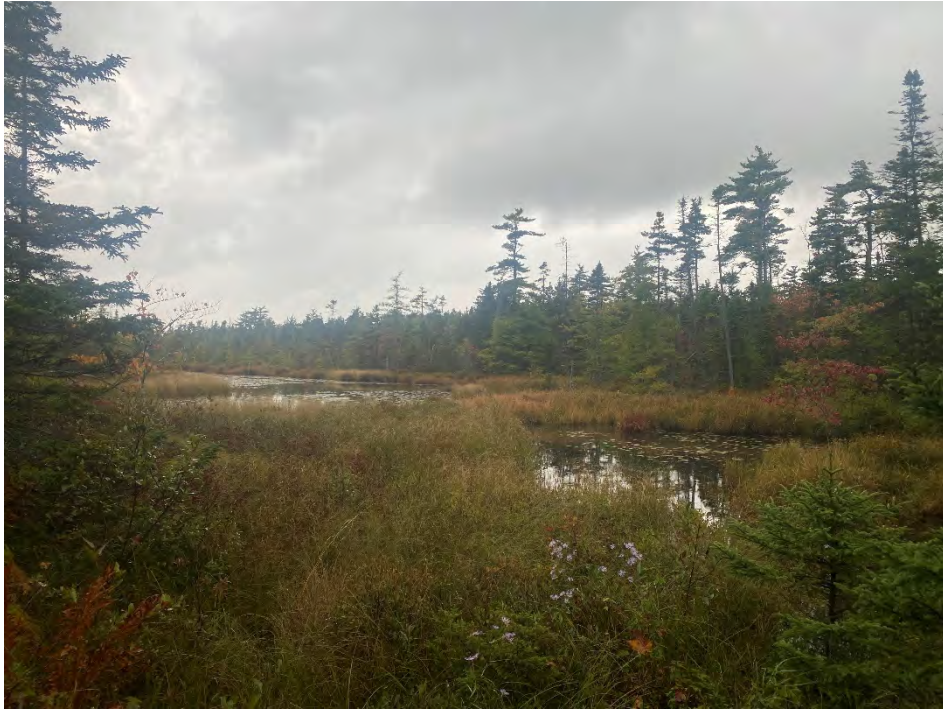
Photo 3. Area 2 – The eastern half of the wetland is a broad shrubby meadow with a wide slow flowing channel in the middle.

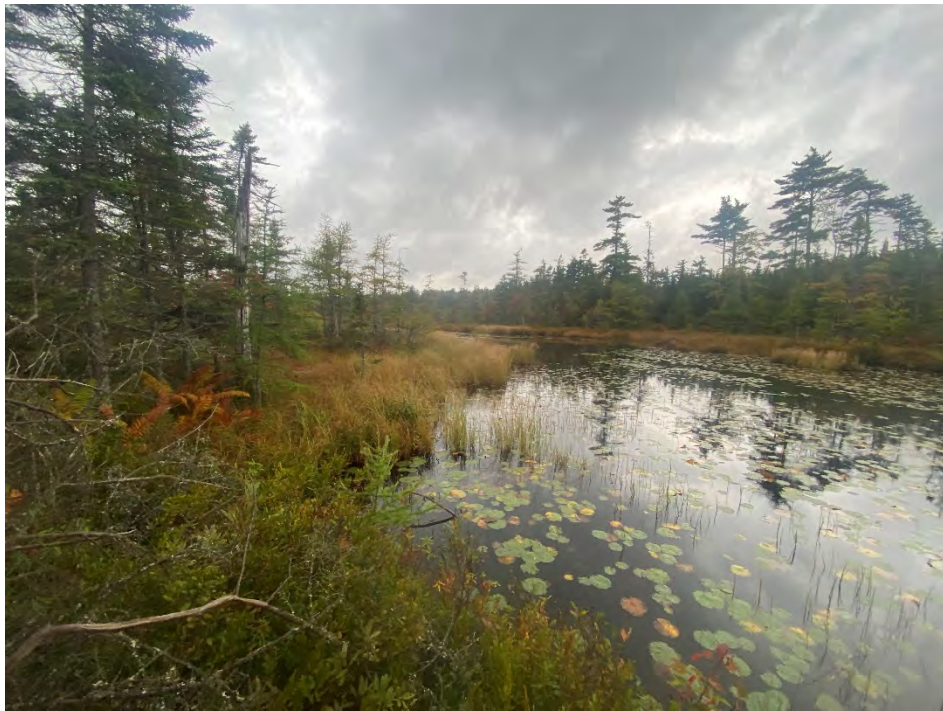
Photo 4. Area 2 – The water is relatively deep (1-2 m) with abundant aquatic vegetation.

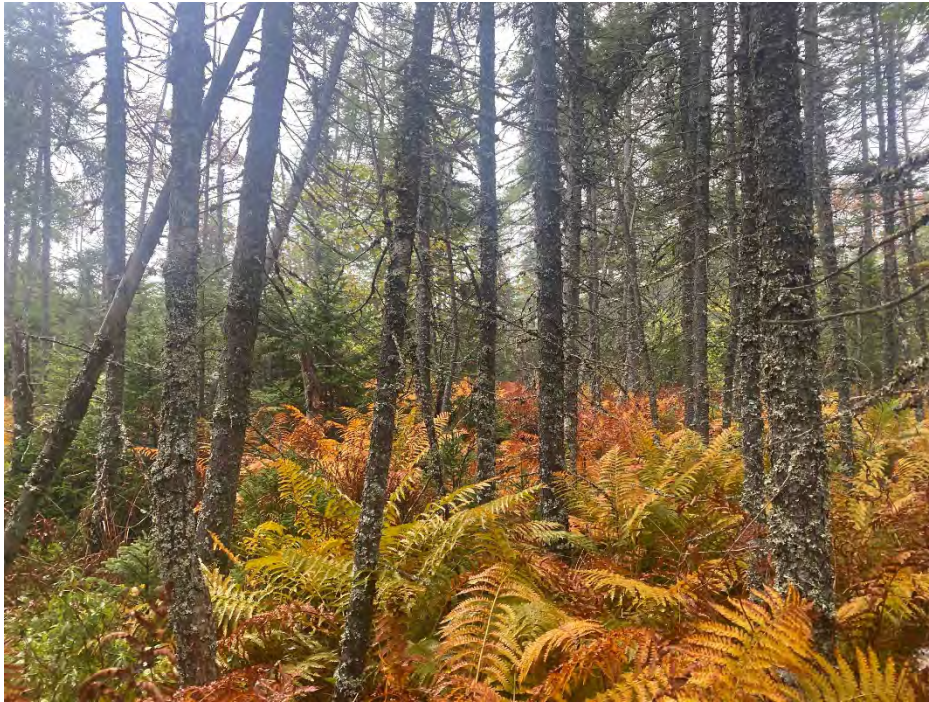
Photo 5. Area 2 – Along the south edge of the wetland there are areas of forest swamp dominated by black spruce and cinnamon fern.

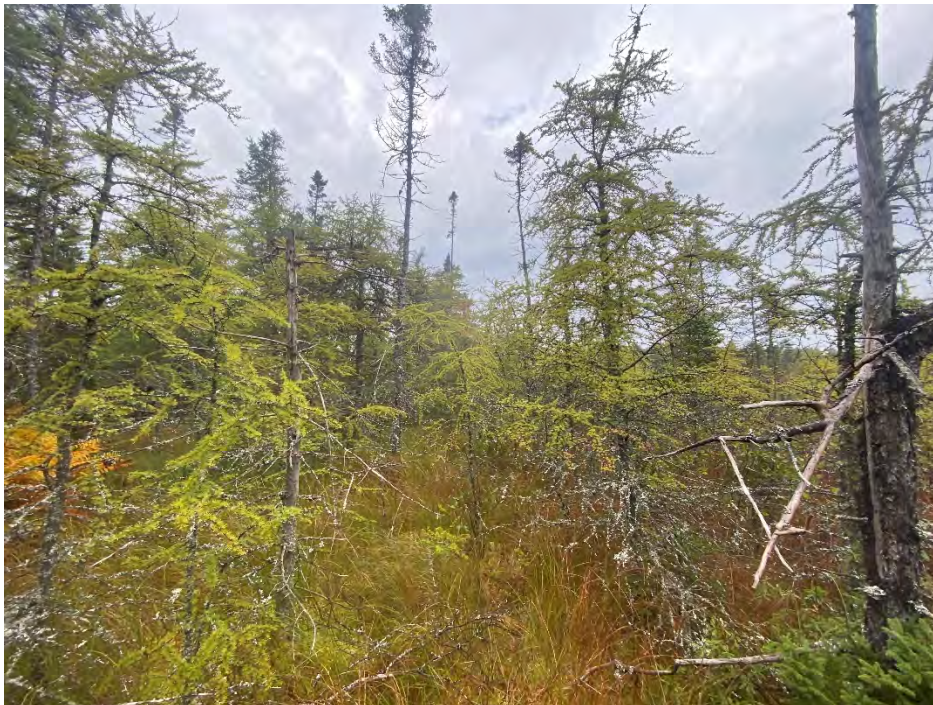
Photo 6. Area 2 – The forest swamp gradually transitions into more open emergent wetland further north toward the middle of the wetland. Tamarack becomes co-dominant with black spruce in the open areas.

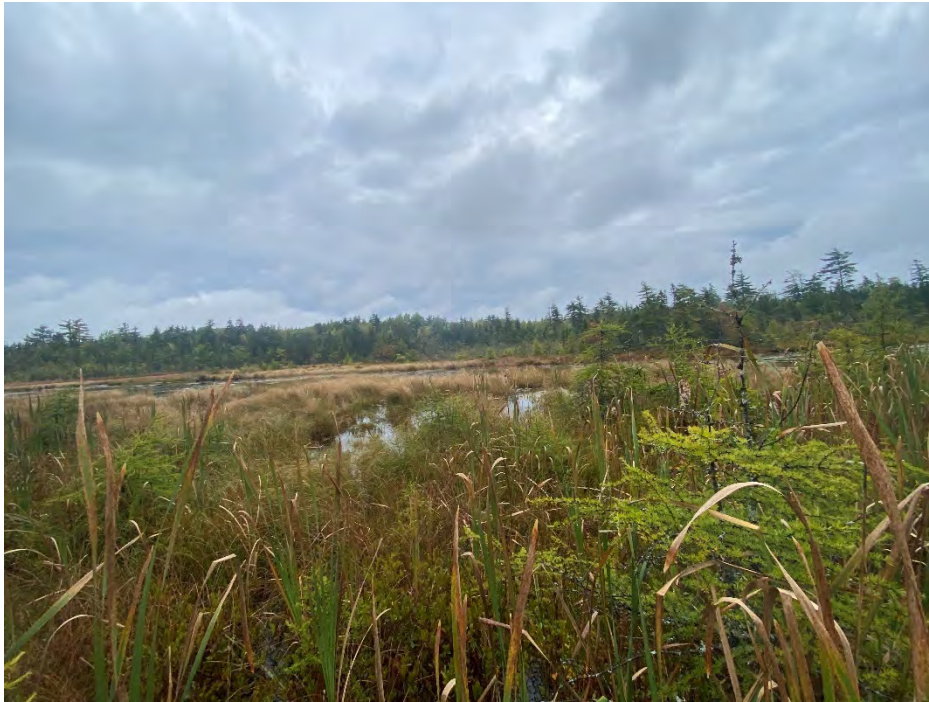
Photo 7. Area 2 – Looking north from the south shore of Mitchell Brook across the large open centre of the Area 2 wetland.

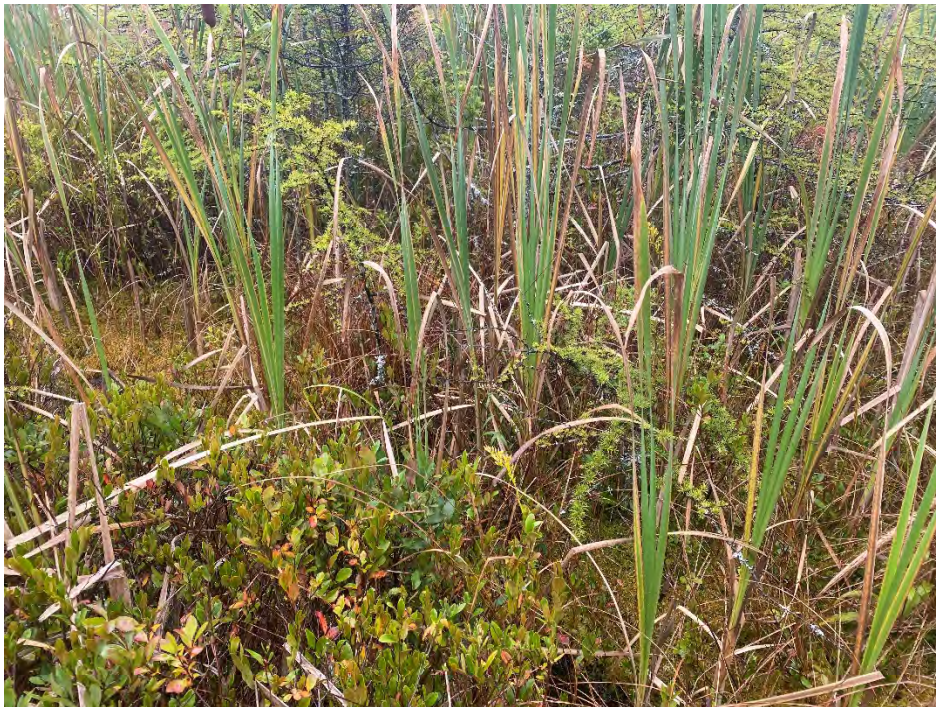
Photo 8. Area 2 – At this location, dominant vegetation includes a thick mat of sphagnum moss (fully saturated) with a dense cover of typical “bog” shrubs such as leather-leaf, Labrador-tea, and bayberry, with scattered patches of speckled alder and cattails.

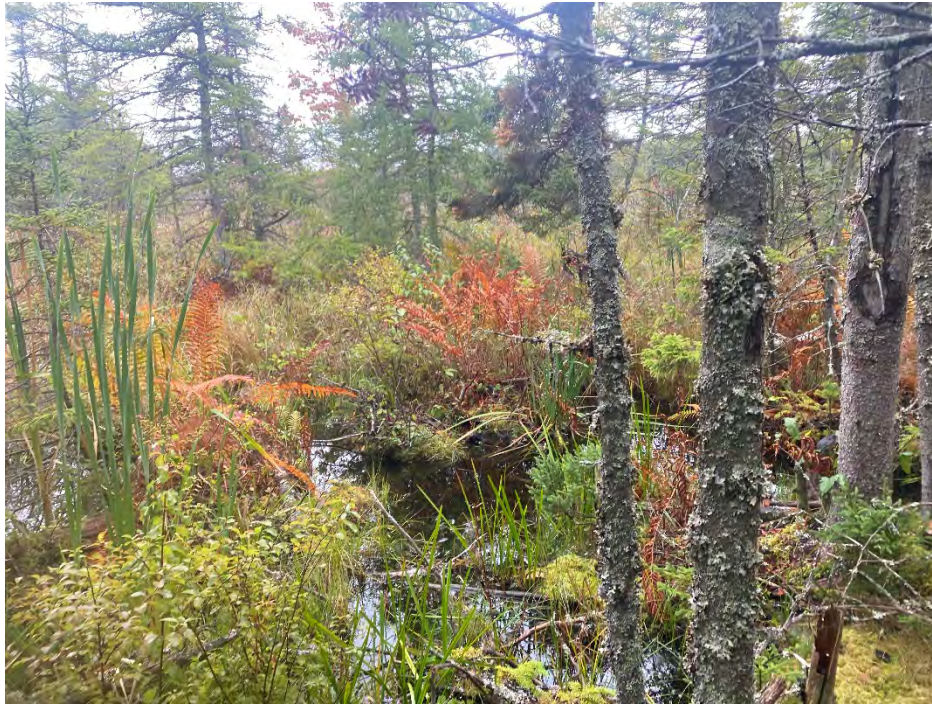
Photo 9. Area 2 – The south-central part of the wetland drains south from the main Mitchell Brook through a broad swampy area with multiple small, braided channels.

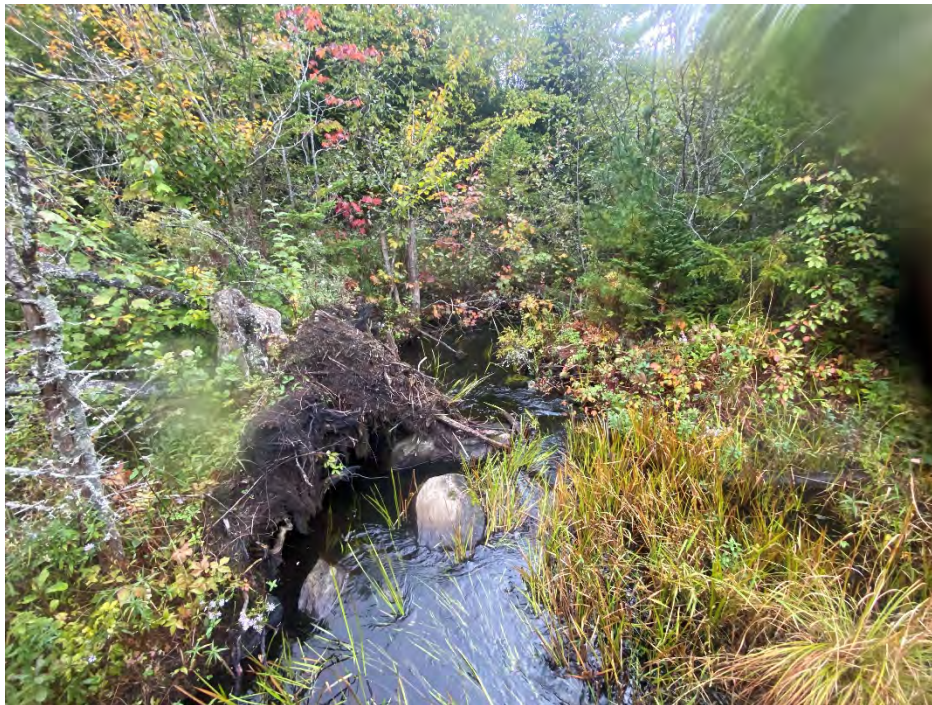
Photo 10. Area 2 – There is no “main channel” but rather flow is evenly distributed in small rocky channels and only concentrates again near the southern edge of the wetland. This drainage path may have resulted from historic mining water manipulation.

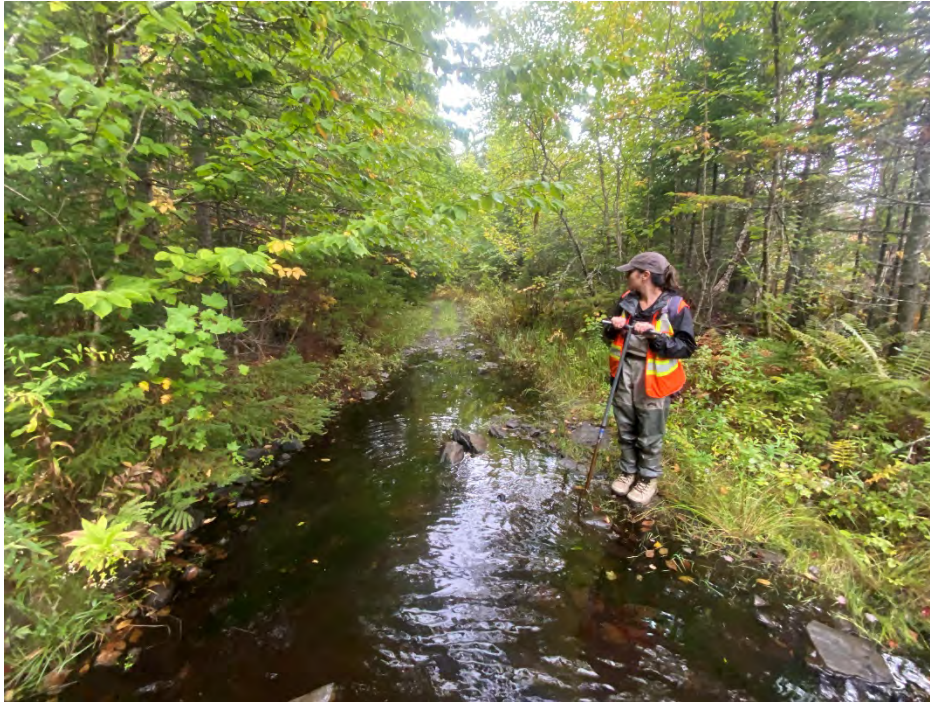
Photo 11. Area 2 – In the southwest part of the wetland, a permanently flowing man-made channel was discovered that drains out of Area 2. It could possibly be an old road.

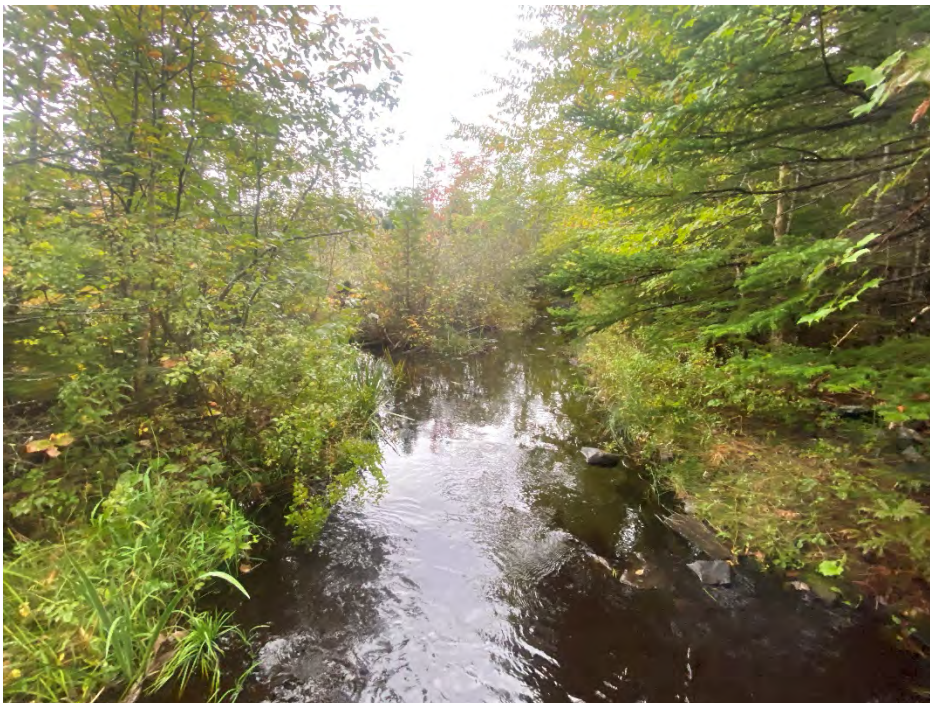
Photo 12. Area 2 – Looking northwest along the man-made channel flowing out of Area 2 toward Area 1B. This channel is a significant second drainage path from Area 2 that may rival the main mapped Mitchell Brook drainage in flow volumes.

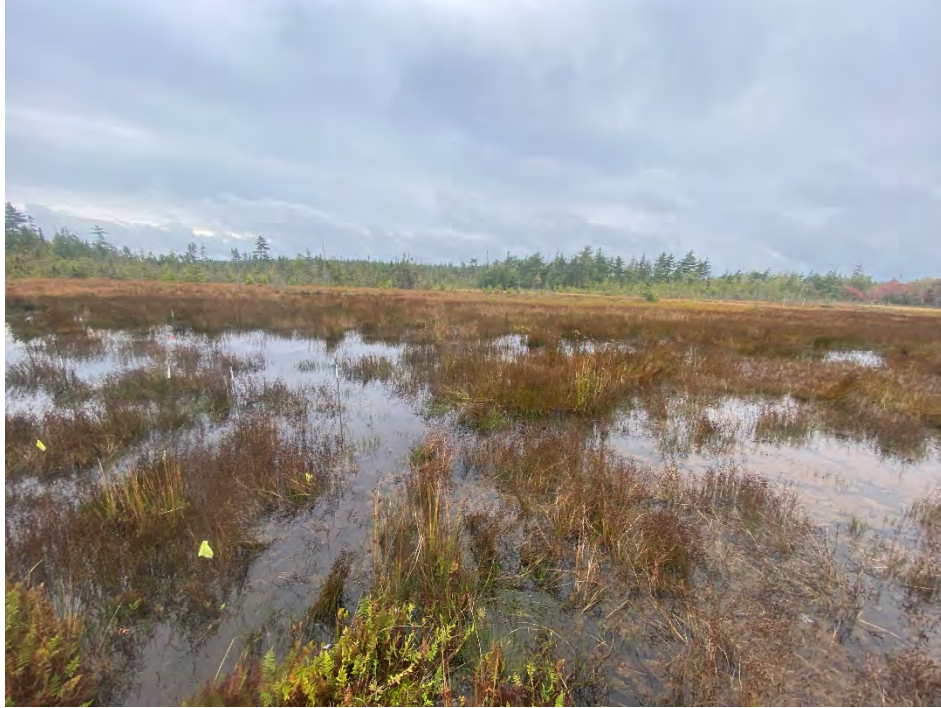
Photo 13. Area 2 – A historically disturbed area is present where fine tailings were deposited into the north-central part of the wetland from a stamp mill. Similar to other tailings impacted wetlands, the vegetation is low-growing and relatively low diversity.

The central wetland area north of Mitchell's Brook is essentially growing on fine tailings (dense coarse grey sand with relatively low organic content). Technically it is wetland based on hydrophytic vegetation, hydrology, and what is considered a "problem soil" as defined in the delineation guidelines. However, it is a highly disturbed form of wetland and not considered "normal". The soil condition may be suboptimal but despite this, vegetation present is apparently composed of native species consistent with local wetland habitats. Where the wetland soil is composed largely of mine tailings, the vegetation is low growing (30-60 cm) and herbaceous species are more abundant. In more naturally developed wetland areas, the vegetation is much taller (60 cm – 2.5 m) and woody species are co-dominant with taller herbaceous species. Near to the watercourse and south of the watercourse, the wetland appears to be more natural in its development (i.e., fewer disturbances and "normal" organic soil and more typical vegetation growth pattern). The low-growing nature may indicate poor soil conditions, which could be improved over time by natural soil development processes. However, the current condition has reduced the relative functional value for habitat due to lower species diversity, and uniform low vegetation structure. The proximity to the adjacent watercourse and other more natural wetland areas within Area 2 impart benefits to the impacted area thus minimizing the overall negative effects. In other words, the wetland is impacted here but the negative effects are somewhat mitigated by the nearby presence of higher functioning wetland elements and the impacted wetland itself may be providing significant value to downstream habitats.

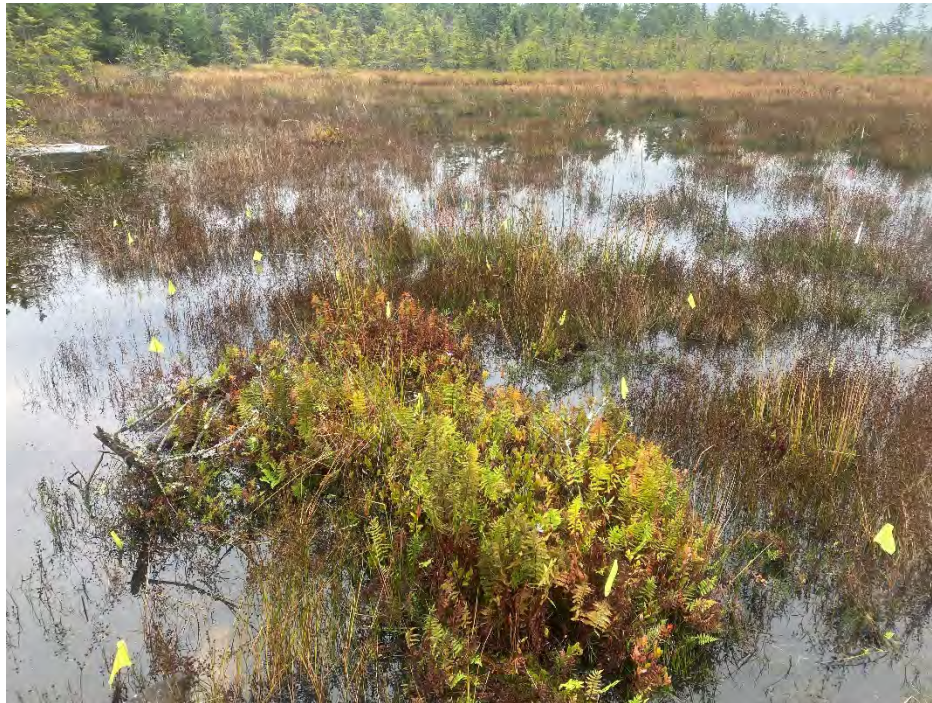
Photo 14. Area 2 – The impacted wetland in Area 2 is wetter than in Area 1A and the vegetation is indicative of longer periods of inundation (more horsetails and sedges), but on humps (bottom centre) the vegetation is very comparable to the Area 1A plant community. The yellow flags are associated with an academic study program that is ongoing.

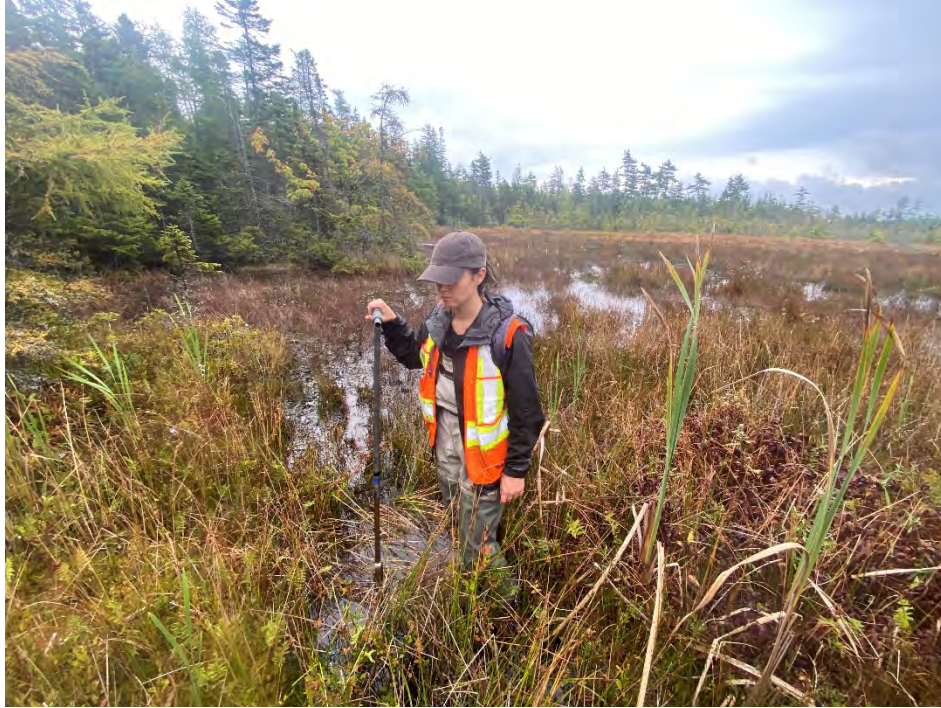
Photo 15. Area 2 – Looking southeast in the historically disturbed part of the wetland. Vegetation near the edge transitions sharply from low growing (30-60 cm) at far right up to more robust sizes (> 1 m) at bottom left, coincident with changing substrate from dense sand to soft organics.

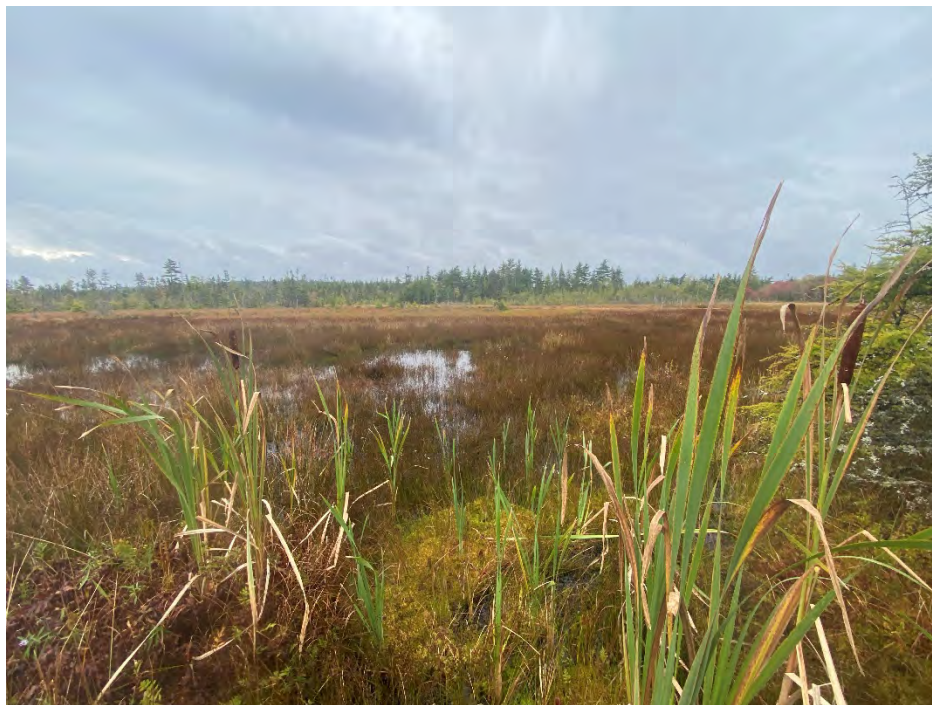
Photo 16. Area 2 – Looking northwest from the location above; the wide deep-marsh/meadow occupies the majority of the wetland centre.

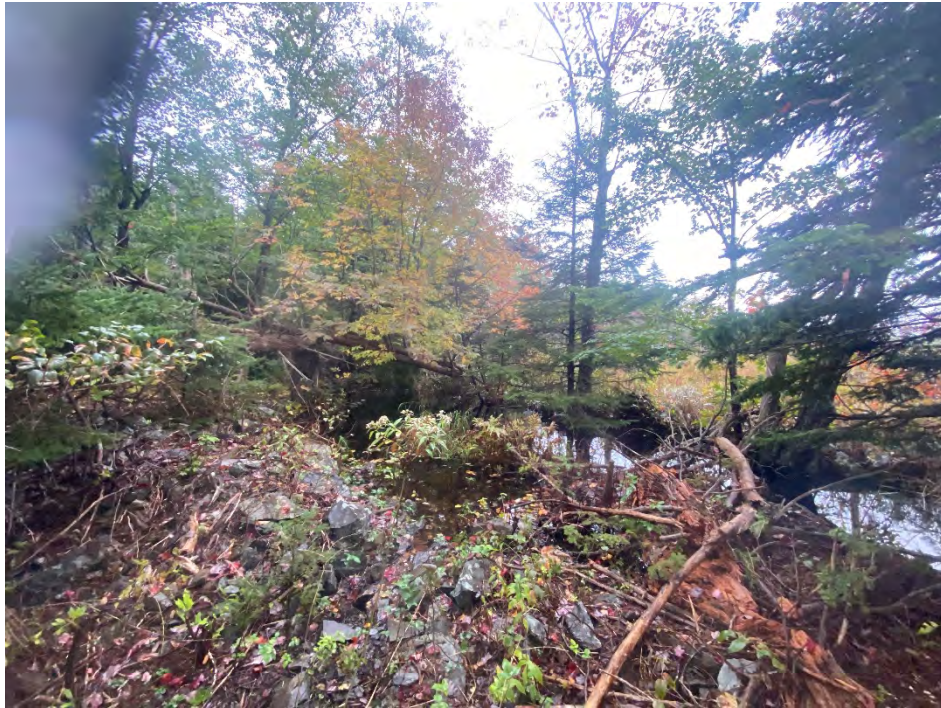
Photo 17. Area 2 – A large deposit of coarse waste rock (bottom centre-left) was observed at the edge of the wetland, southwest of the main Mitchell Brook outlet.

In addition to the relatively large fine tailings deposit in the wetland, there are some coarse waste rock deposits and former mine works (foundations and pits) around the eastern and norther edge of the wetland.

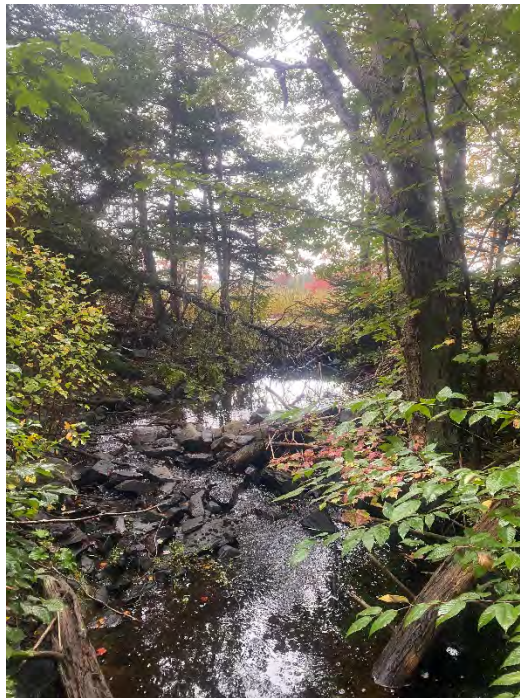
Photo 18. Area 2 – The Mitchell Brook outlet was partially impounded by a significant beaver dam (far centre) and flowed through a jumbled pile of rock rubble.

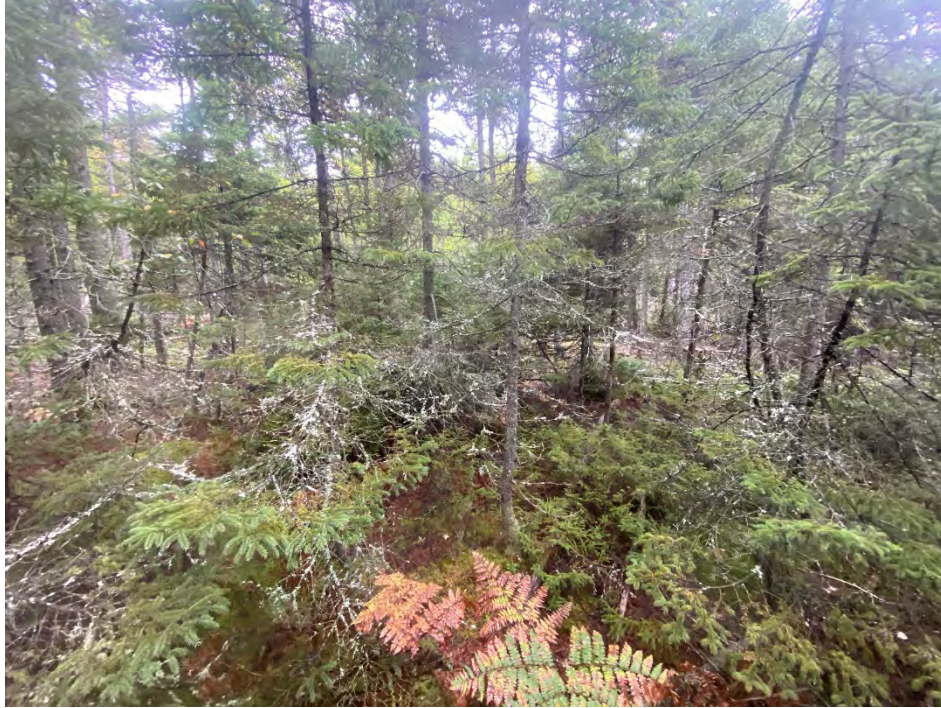
Photo 19. Area 2 – Typical mixed forest upland habitat around the wetland.

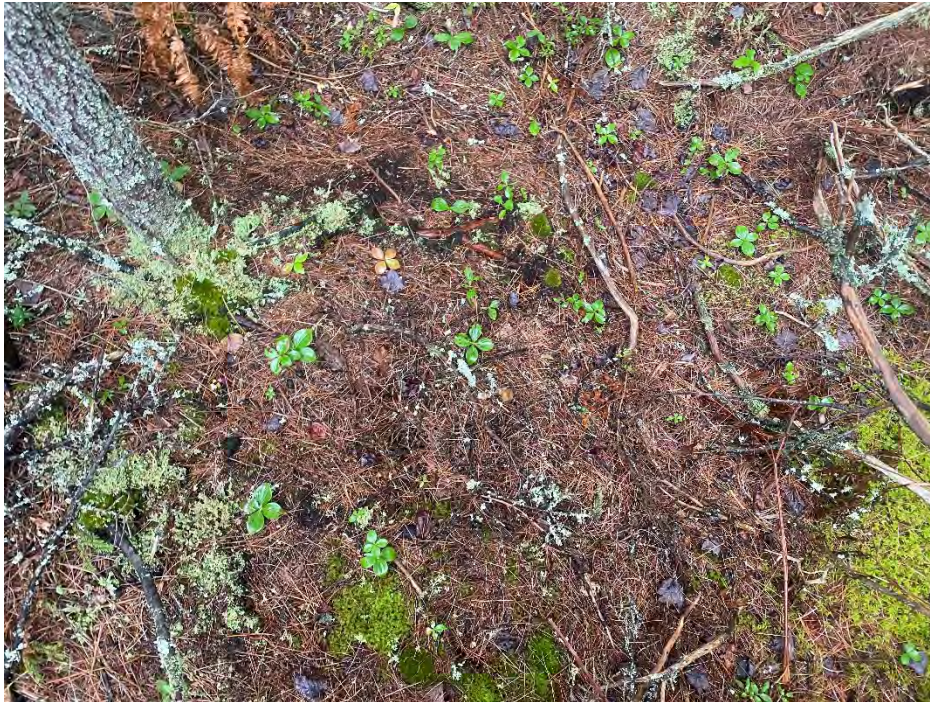
Photo 20. Area 2 – The ground cover is variable, sometimes sparse, with a thick layer of accumulated conifer needles.
