Appendix B. Photo Log

Client Name:
Nova Scotia Lands Inc.

Report Name
Mooseland Mine Site

Project No.
60680169

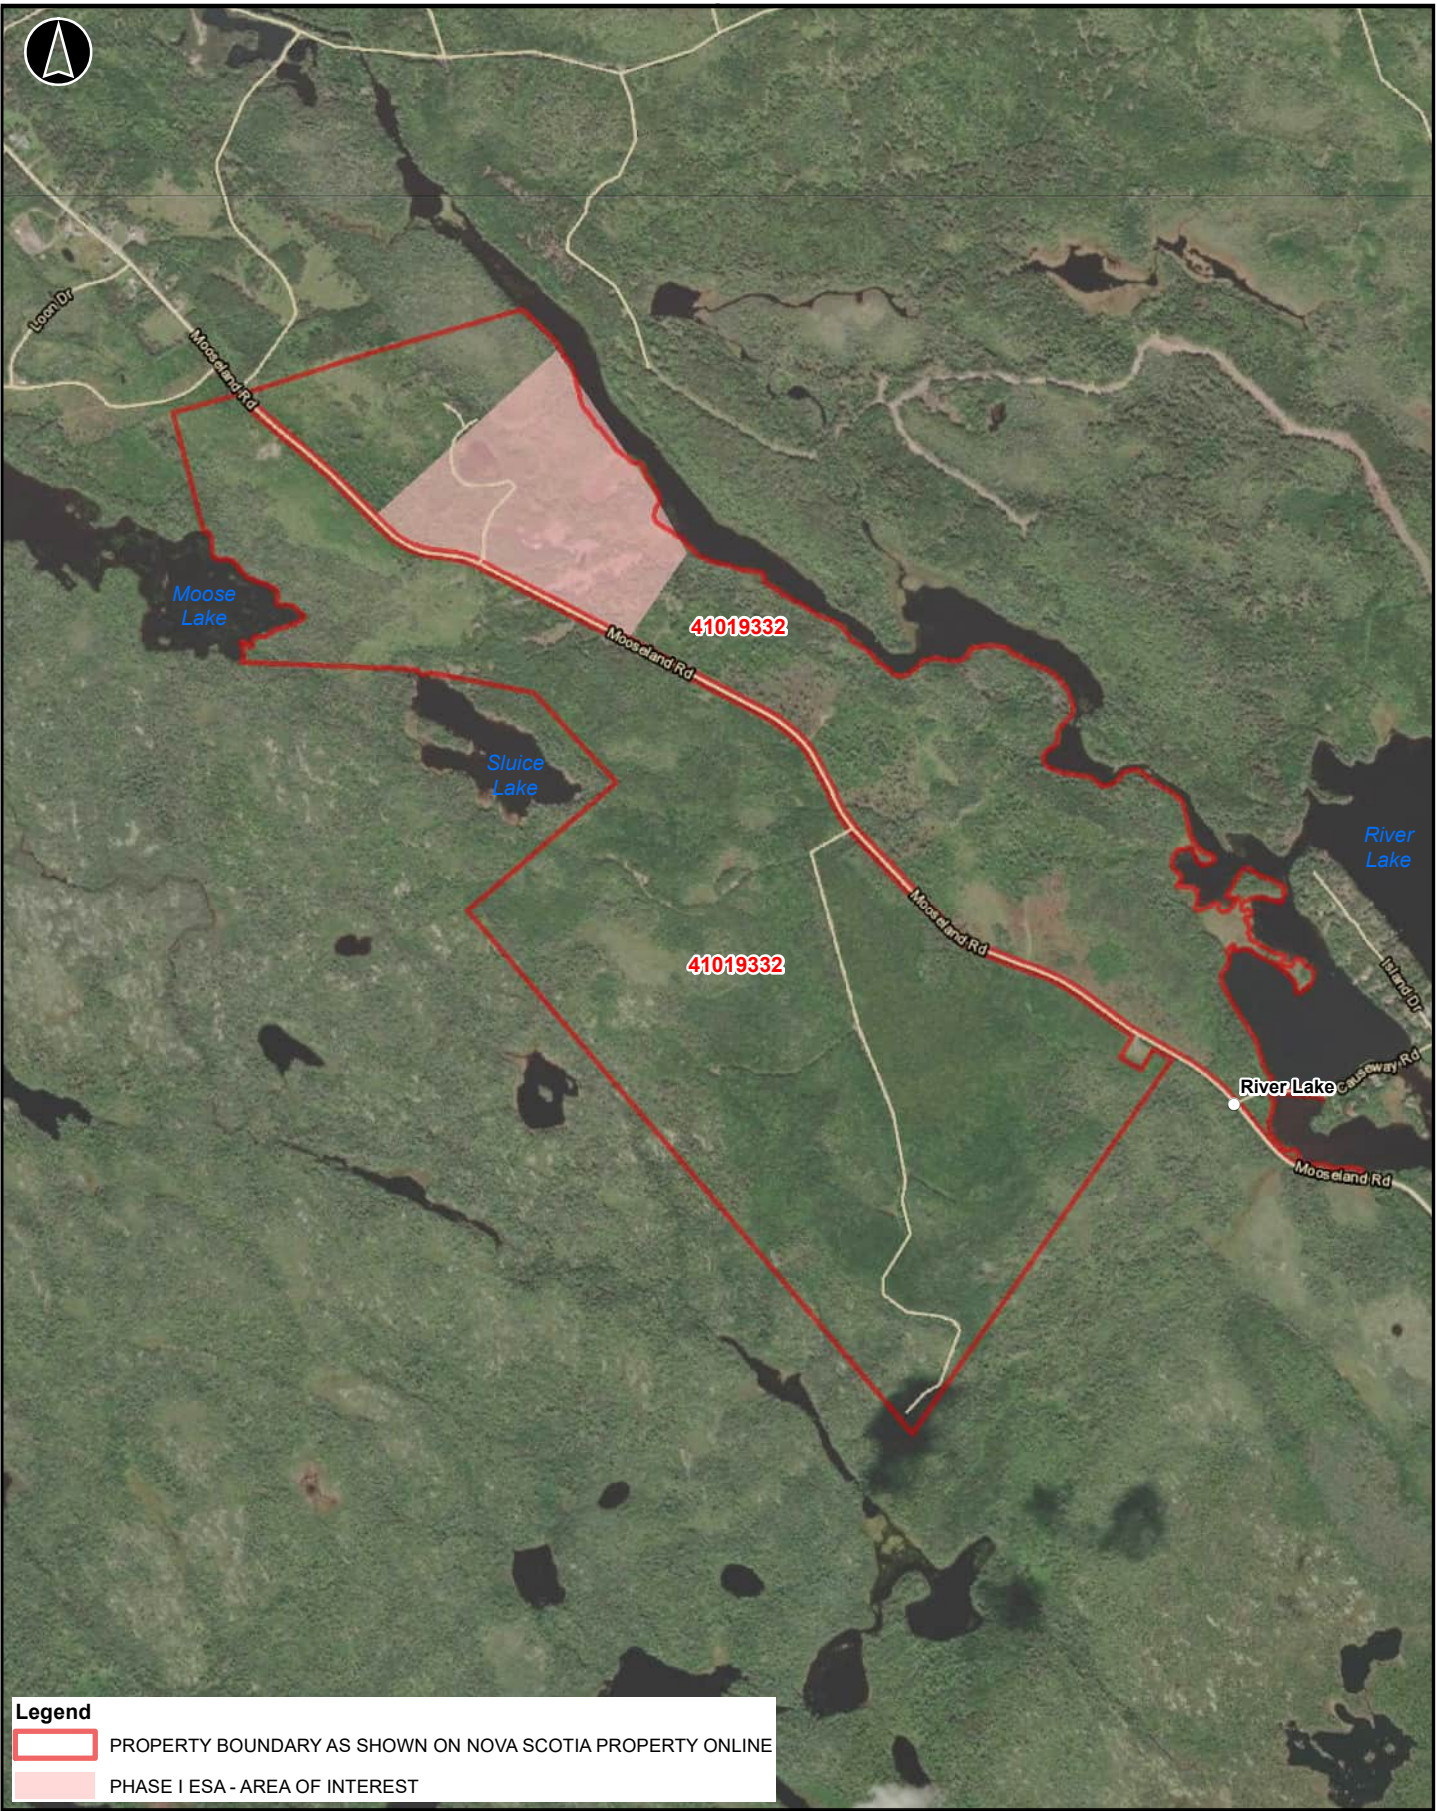
SITE PLAN - PROPERTY BOUNDARY

Legend	
	PROPERTY BOUNDARY AS SHOWN ON NOVA SCOTIA PROPERTY ONLINE
	PHASE I ESA - AREA OF INTEREST

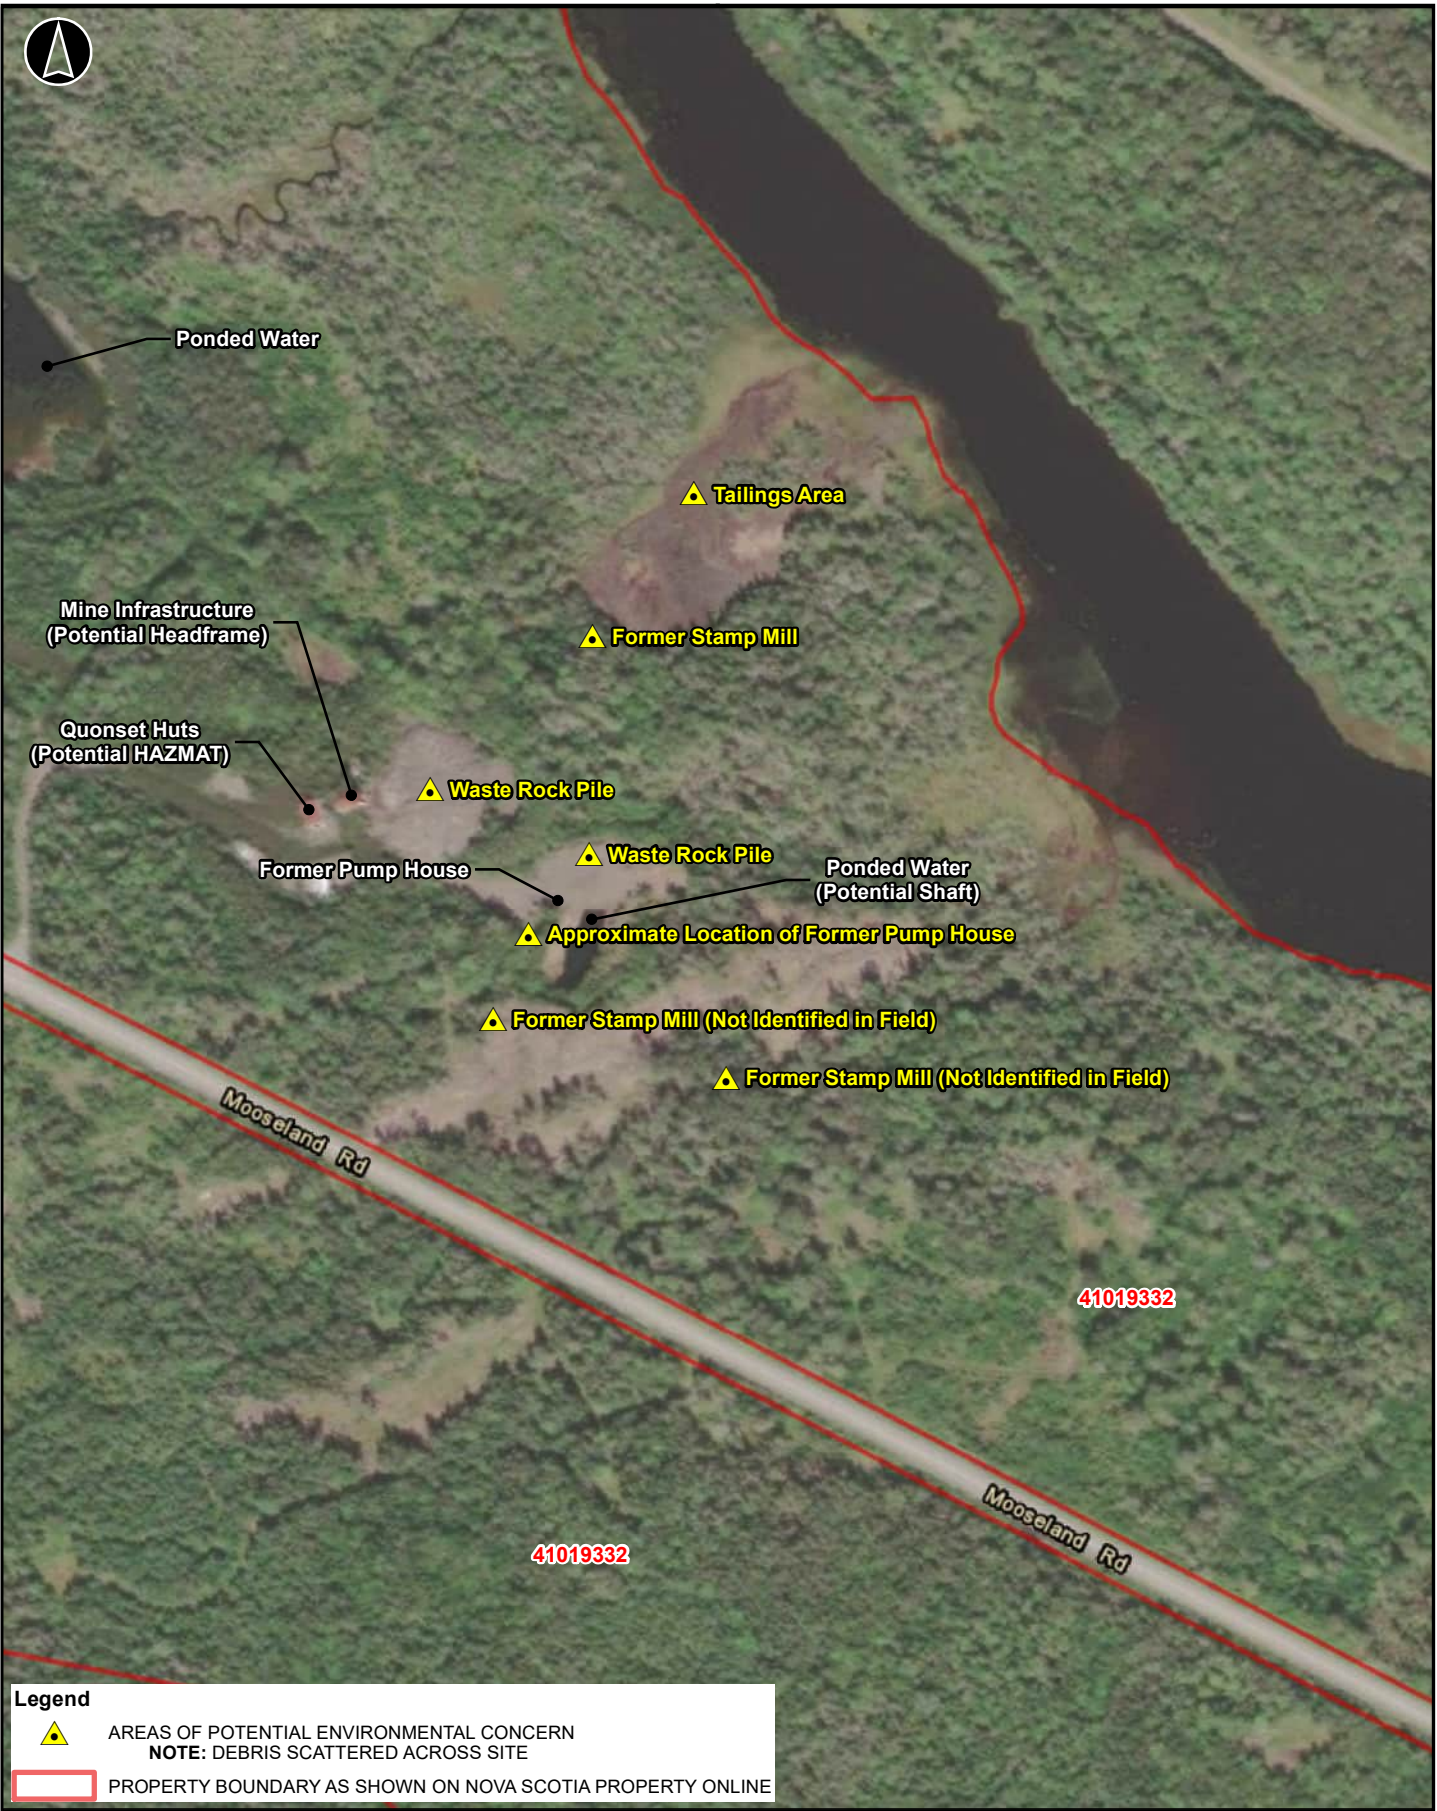
- AREAS OF POTENTIAL ENVIRONMENTAL CONCERN
NOTE: DEBRIS SCATTERED ACROSS SITE
- PROPERTY BOUNDARY AS SHOWN ON NOVA SCOTIA PROPERTY ONLINE

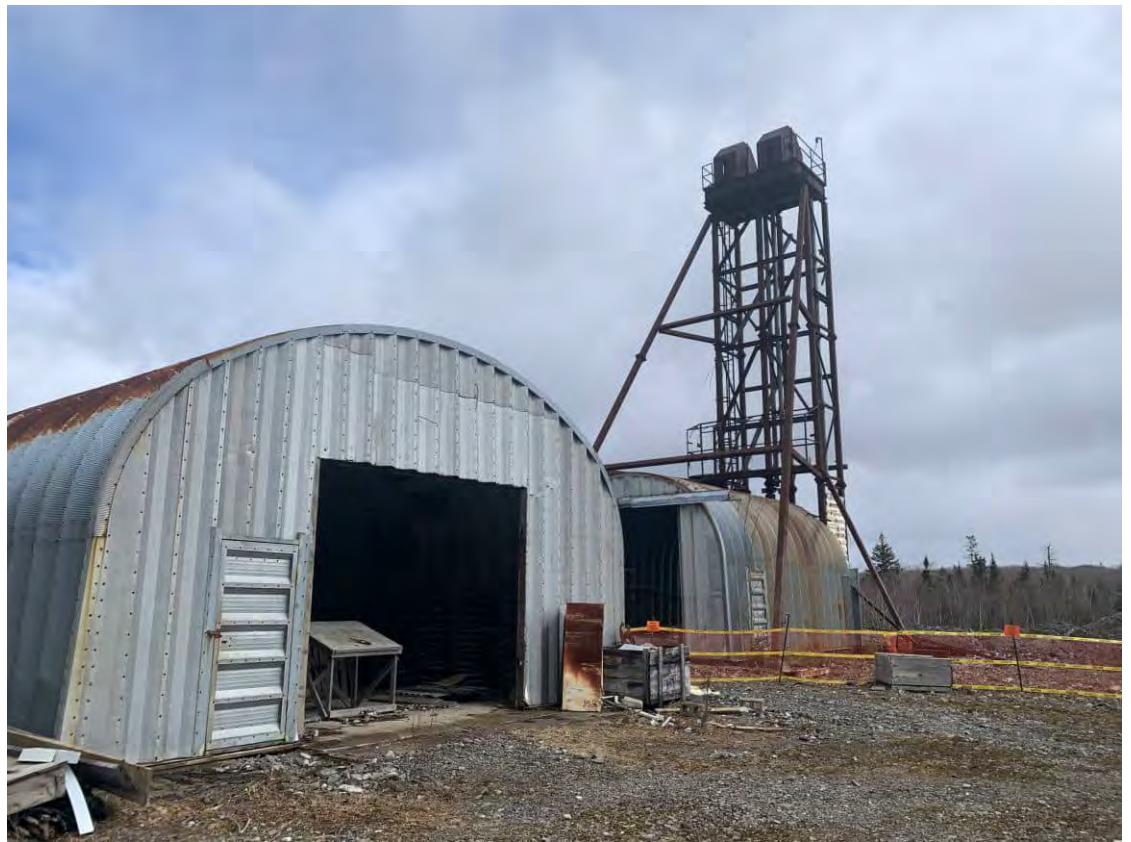
Photo No. 1	Date 3/21/2022
Direction Photo Taken North	
Description Existing structures on site – metal structure (potential headframe) and Quonset huts used to store drill cores and waste. Photo taken in cleared area at the end of the road off of 3630 Mooseland Road – adjacent to waste rock area.

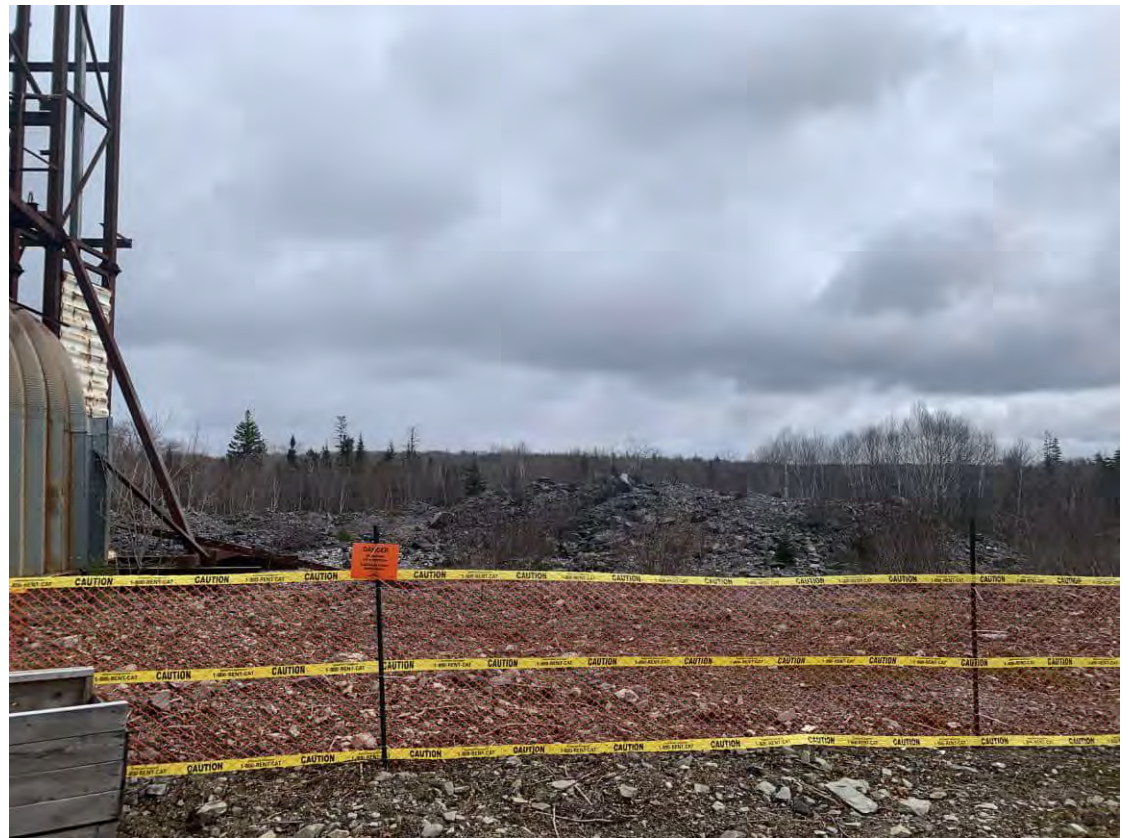
Photo No. 2	Date 3/21/2022
Direction Photo Taken East	
Description Caution fence demarking “Abandoned Mine openings”. Waste rock can be seen beyond the fences. This area is adjacent to Quonset huts and metal structure (potential headframe).

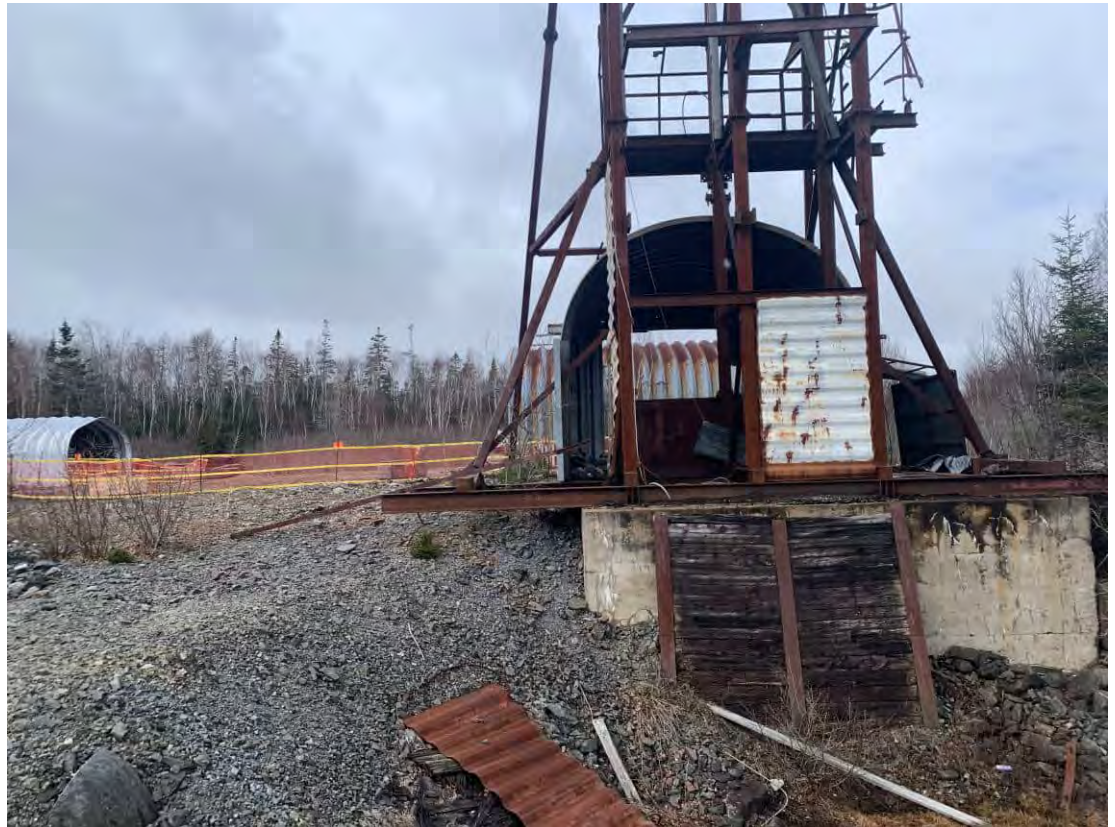
Photo No. 3	Date 3/21/2022
Direction Photo Taken West	
Description Existing structures on site –Quonset huts and metal structure. Photo taken from other side of the fence. Metal structure is potentially a former headframe over a mine shaft for two separate compartments. The houses at the top likely protected pulleys of hoists, the wire ropes appear to have been removed.

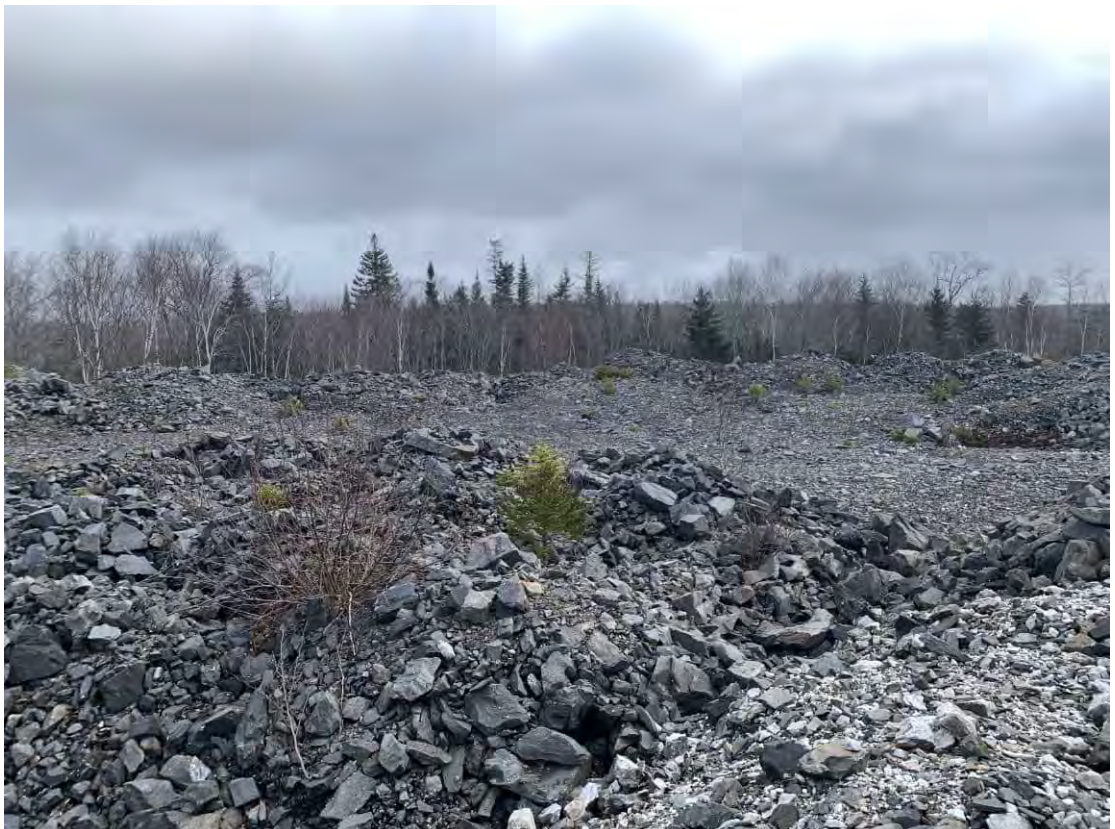
Photo No. 4	Date 3/21/2022
Direction Photo Taken North	
Description Waste rock piles. Metals and other waste were observed in the piles. Photo taken adjacent to Quonset huts.

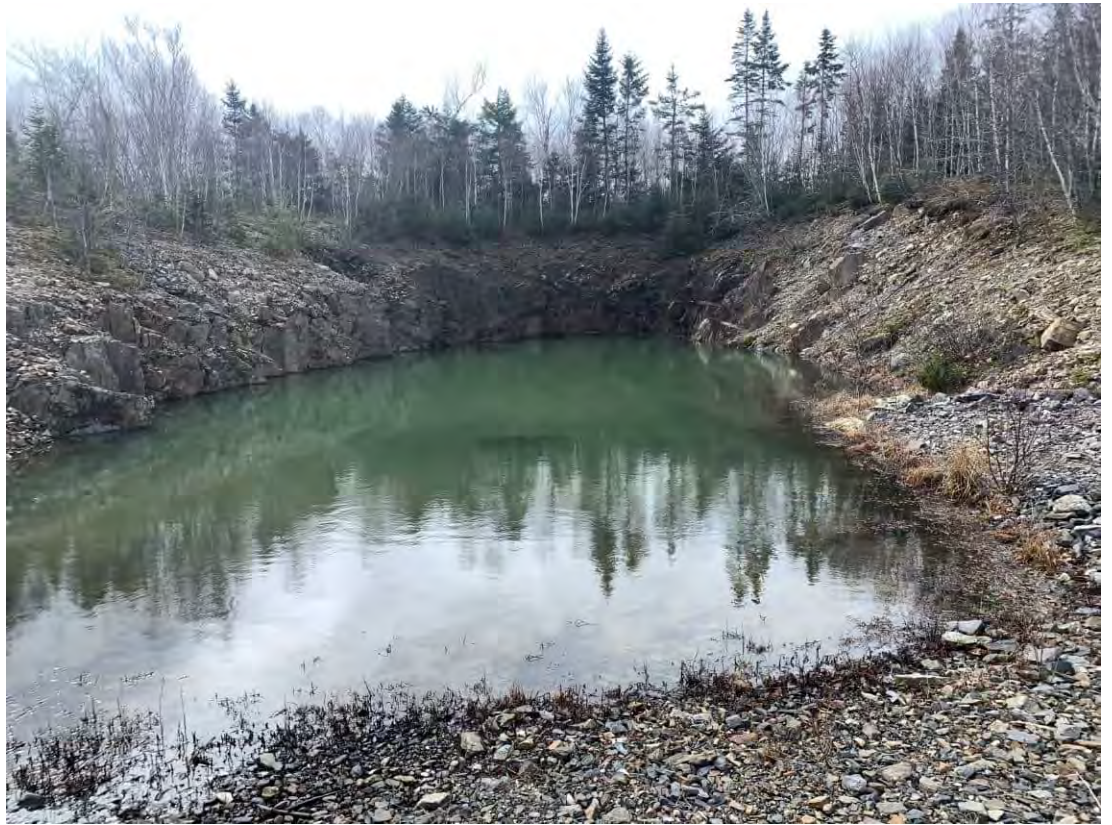
Photo No.	Date
5	3/21/2022
Direction Photo Taken	
Southwest	
Description	
<p>Ponded water within site area. Material on the far wall indicates area may have been excavated. Potential former Hecla mining shaft that was flooded.</p> <p>Area located to the southeast of the Quonset huts.</p>

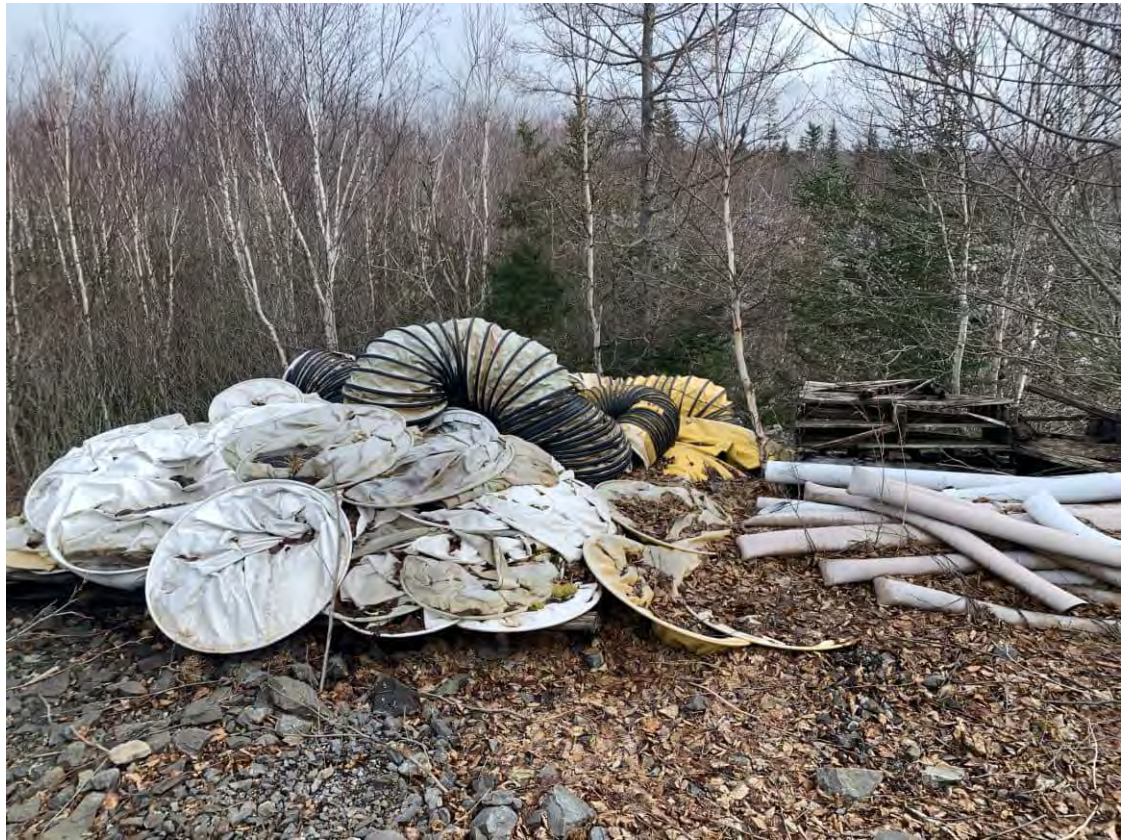
Photo No.	Date
6	3/21/2022
Direction Photo Taken	
North	
Description	
<p>Garbage and waste left outside the Quonset huts.</p> <p>Garbage is comprised of flexible ductwork (potential ventilation tubing).</p>

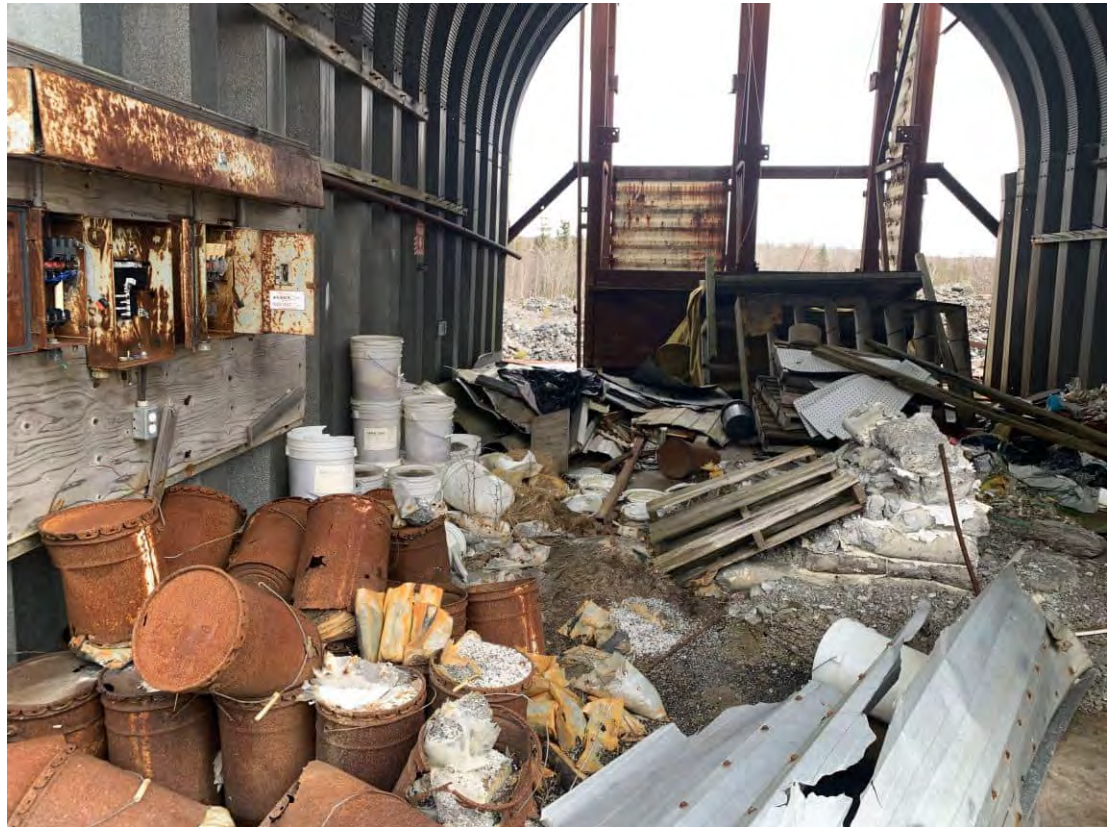
Photo No.	Date
7	3/21/2022
Direction Photo Taken	
Northeast	
Description	
<p>Garbage and waste left inside the Quonset hut.</p> <p>Garbage was made up or metal, woody materials, electrical components, and plastic / metal containers. Contents inside of metal / plastic containers was not confirmed.</p>

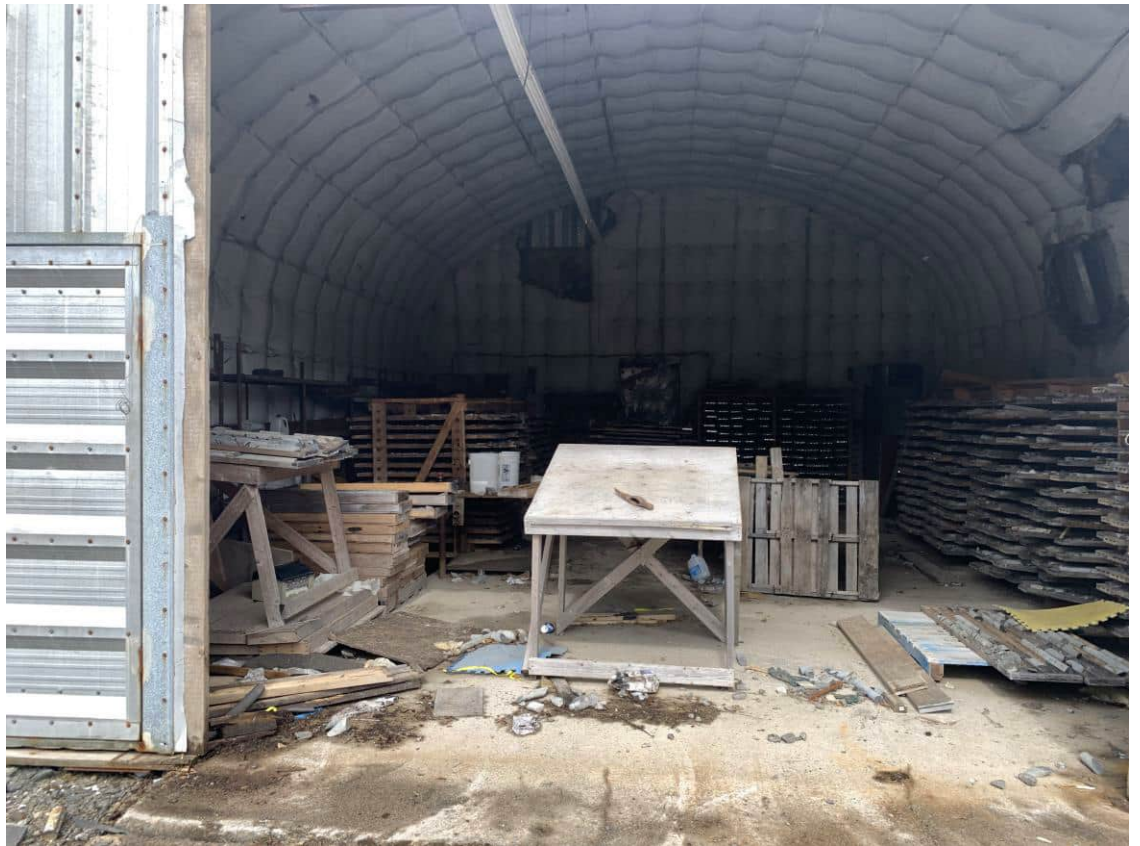
Photo No.	Date
8	3/21/2022
Direction Photo Taken	
North	
Description	
<p>Rock core storage left inside the Quonset hut. This Quonset hut is insulated.</p>

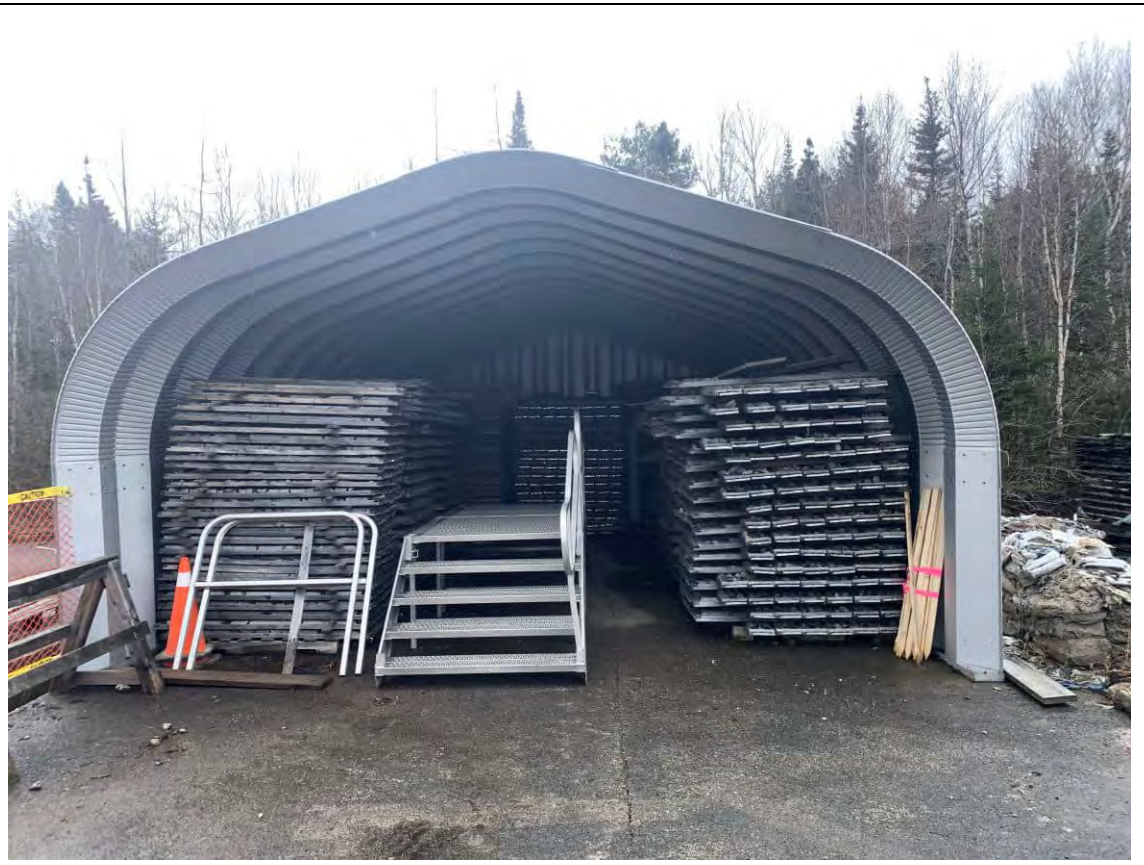
Photo No.	Date
9	3/21/2022
Direction Photo Taken	
South	
Description	
<p>Rock core storage. This Quonset hut is "new". This newer storage area may belong to Atlantic Gold.</p>

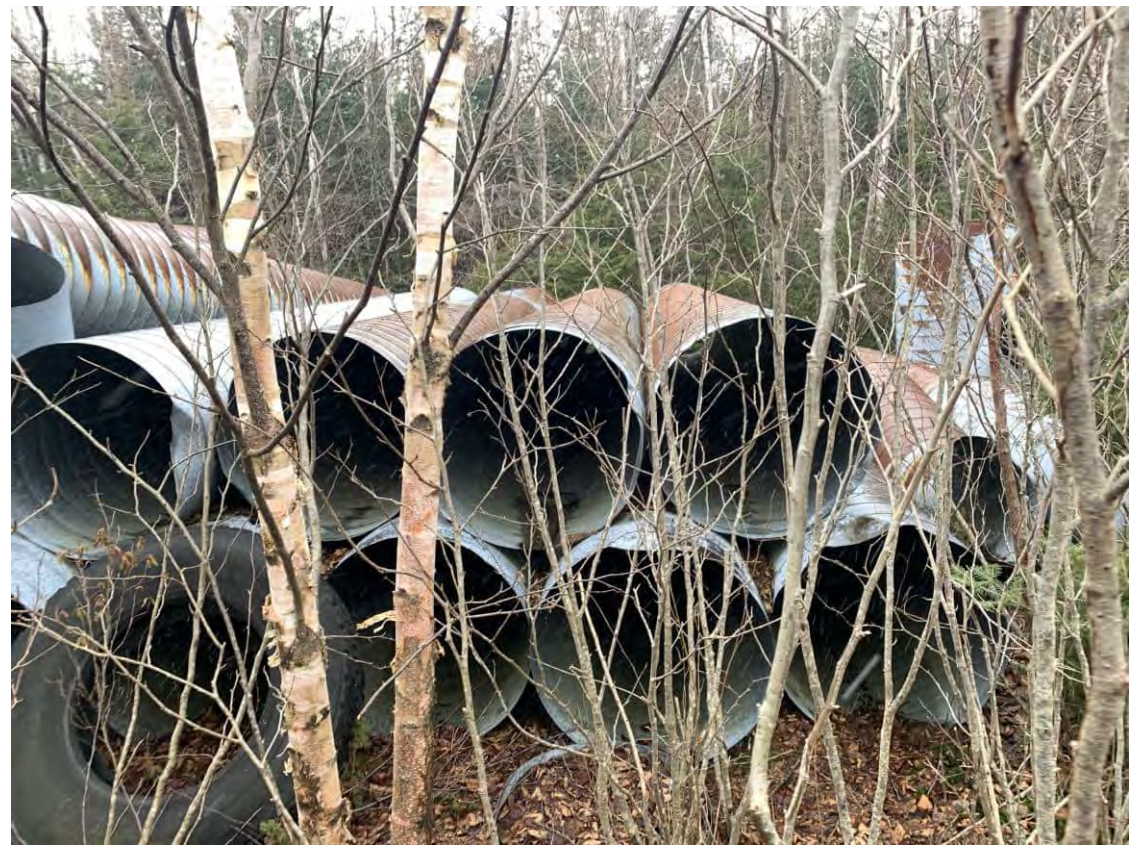
Photo No.	Date
10	3/21/2022
Direction Photo Taken	
Northeast	
Description	
<p>Corrugated metal piping and rock cores left outside exposed to elements.</p> <p>Photo taken along the road to the area where the Quonset huts are located.</p>

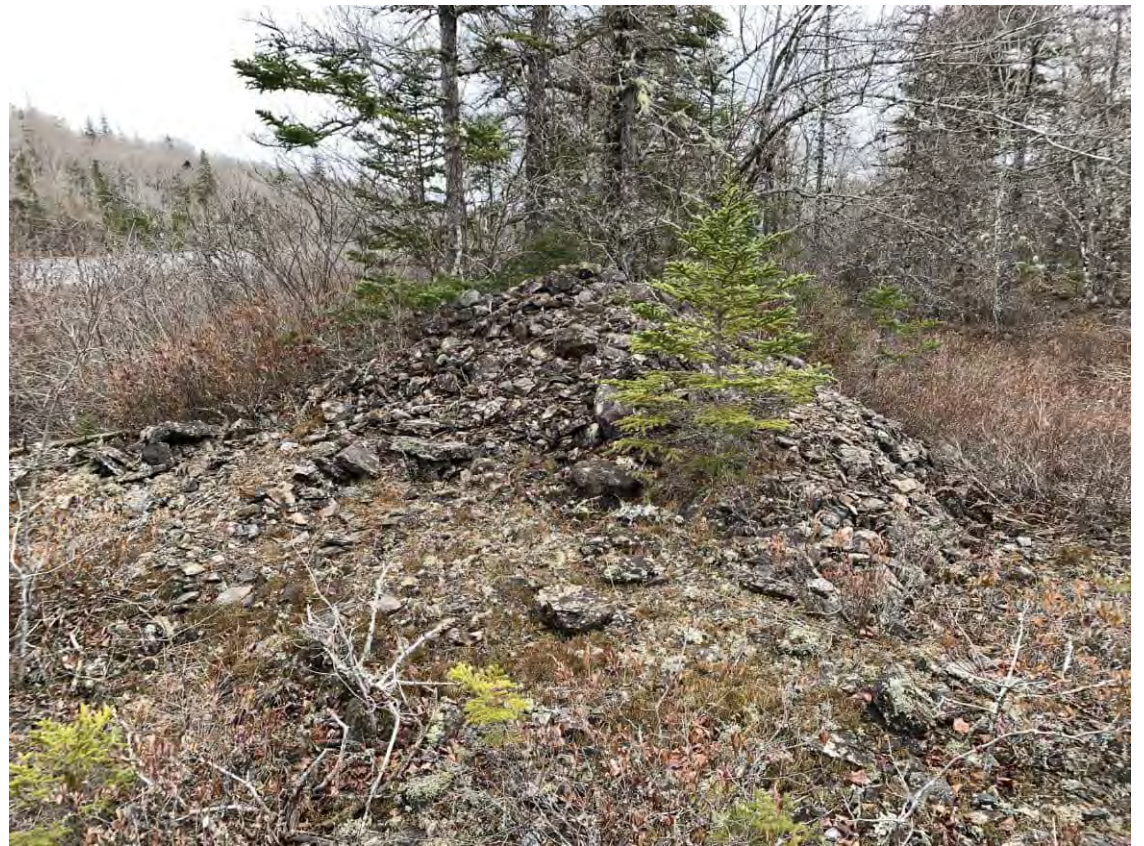
Photo No. 11	Date 3/21/2022
Direction Photo Taken Southeast	
Description Waste rock material found along the edge of Tangier River. Rock located next to tailings Photo taken to the northeast of where the former stamp mill would have been located.

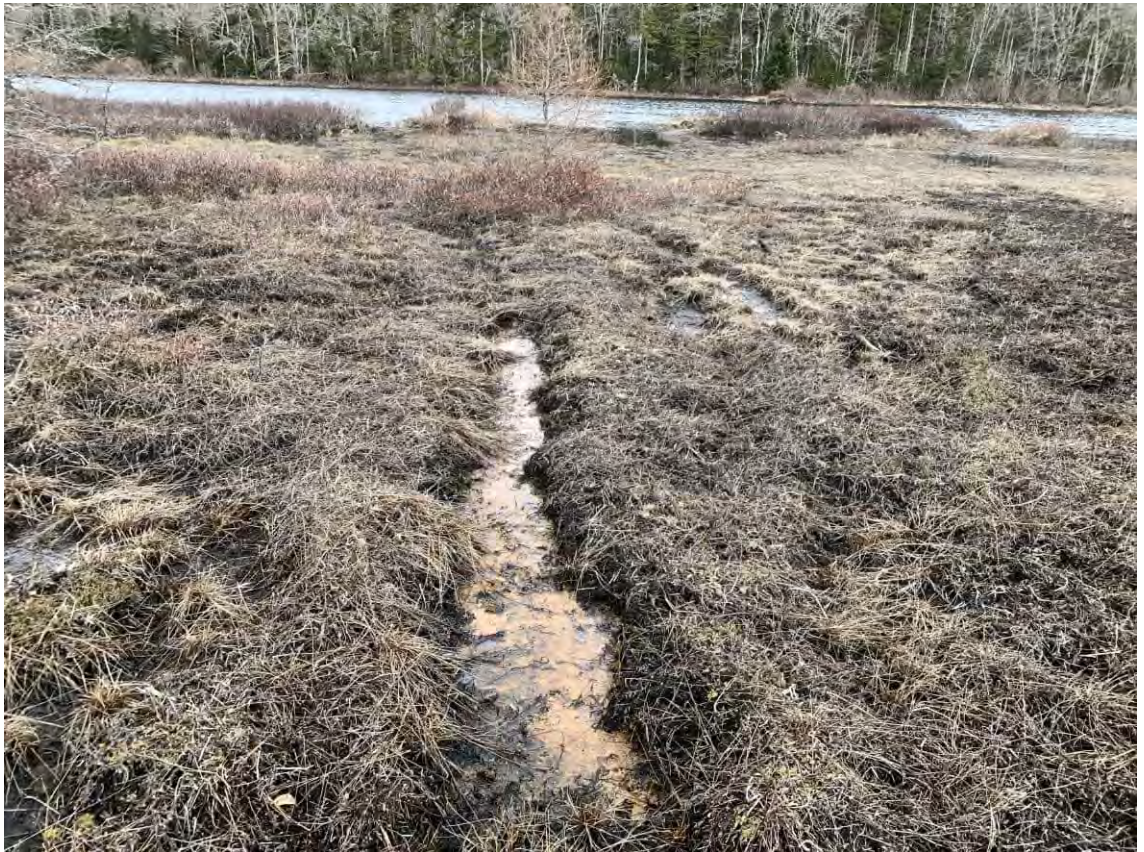
Photo No. 12	Date 3/21/2022
Direction Photo Taken East	
Description Well oxidized sandy tailings were noted along the edge of Tangier River. Photo taken to the northeast of where the former stamp mill would have been located.

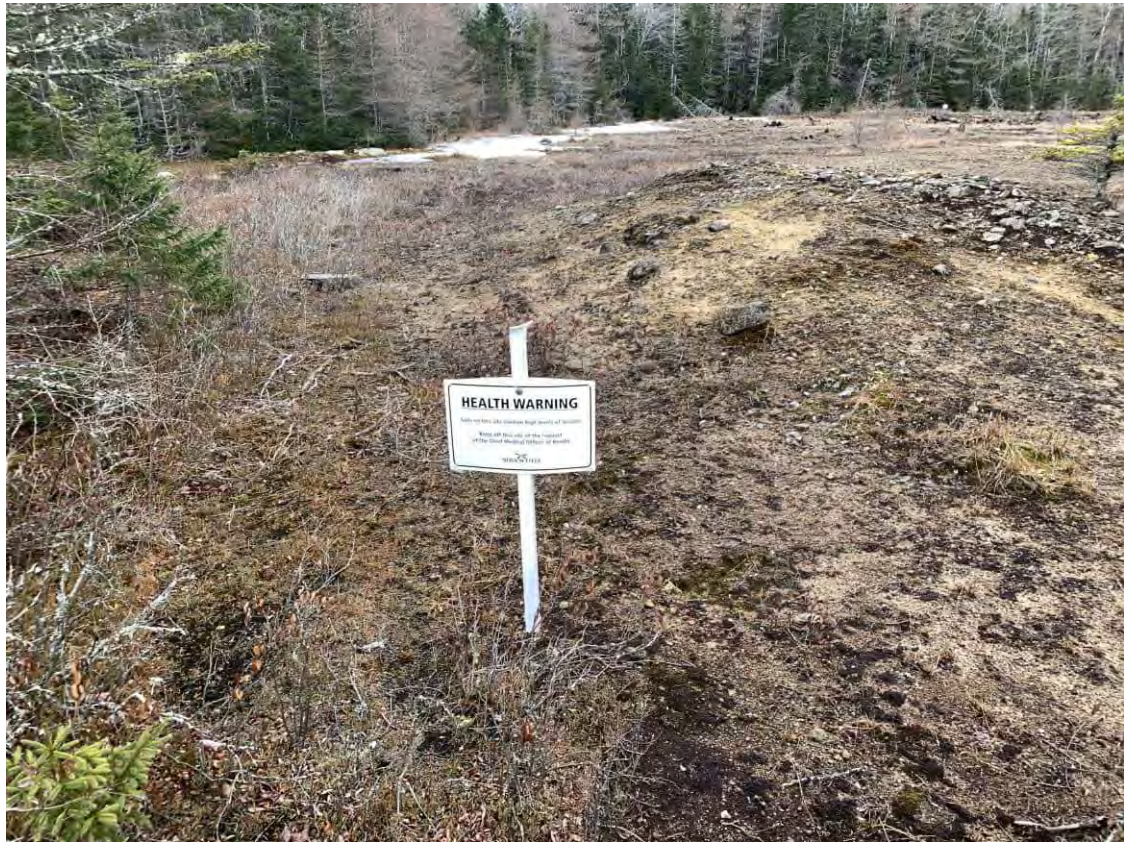
Photo No.	Date
13	3/21/2022
Direction Photo Taken	
South	
Description	
Vegetative tailings located next to the waste rock pile in photo 11.

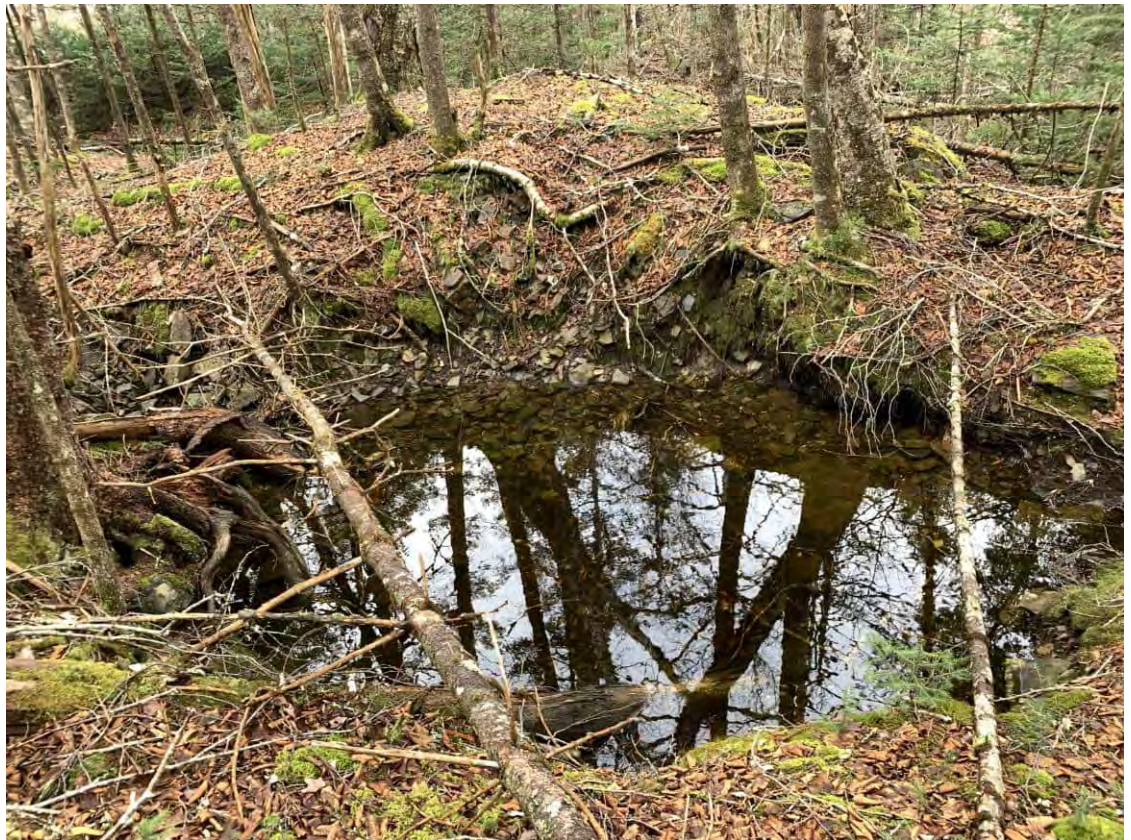
Photo No.	Date
14	3/21/2022
Direction Photo Taken	
South	
Description	
Open holes in the forest to the southeast of the area where the Quonset huts are located. Signs are throughout the woods cautioning the open holes.

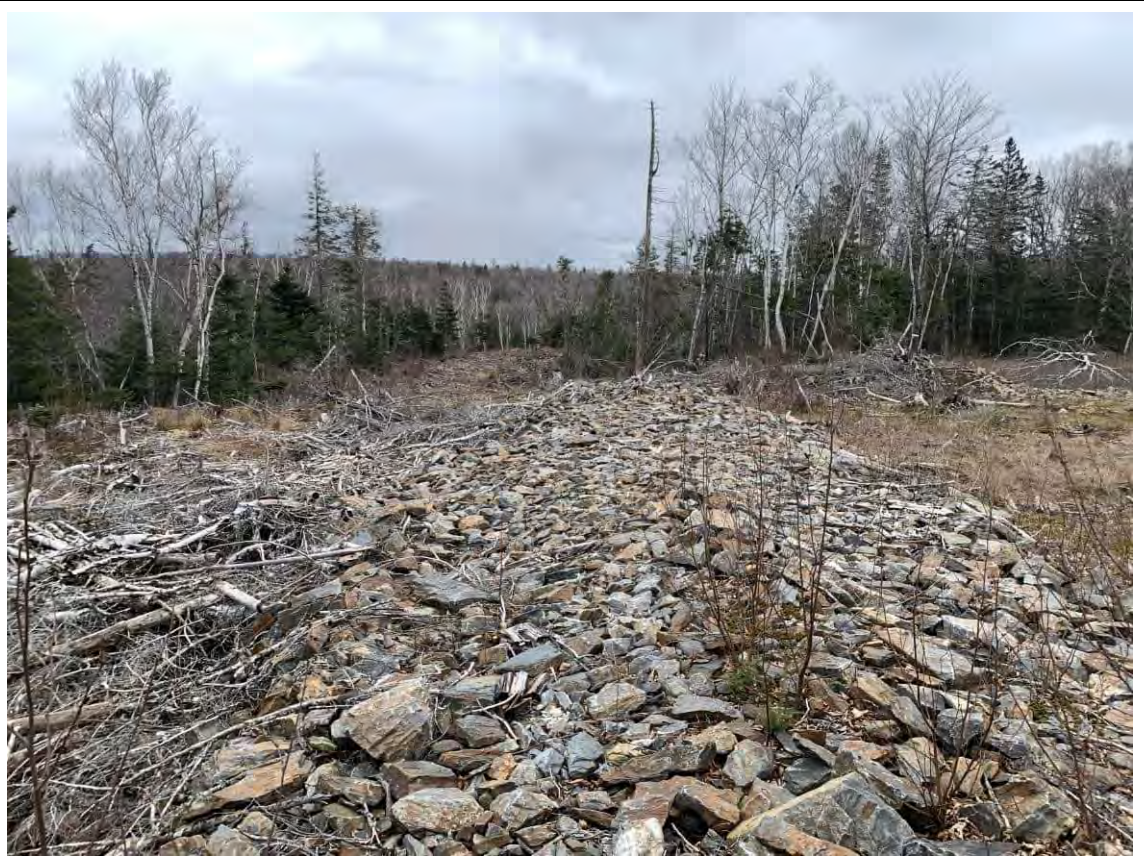
Photo No. 15	Date 3/21/2022
Direction Photo Taken East	
Description A clearing of oxidizing waste rock. Some vegetation present. Photo taken to the southeast of the area where the Quonset huts are located.

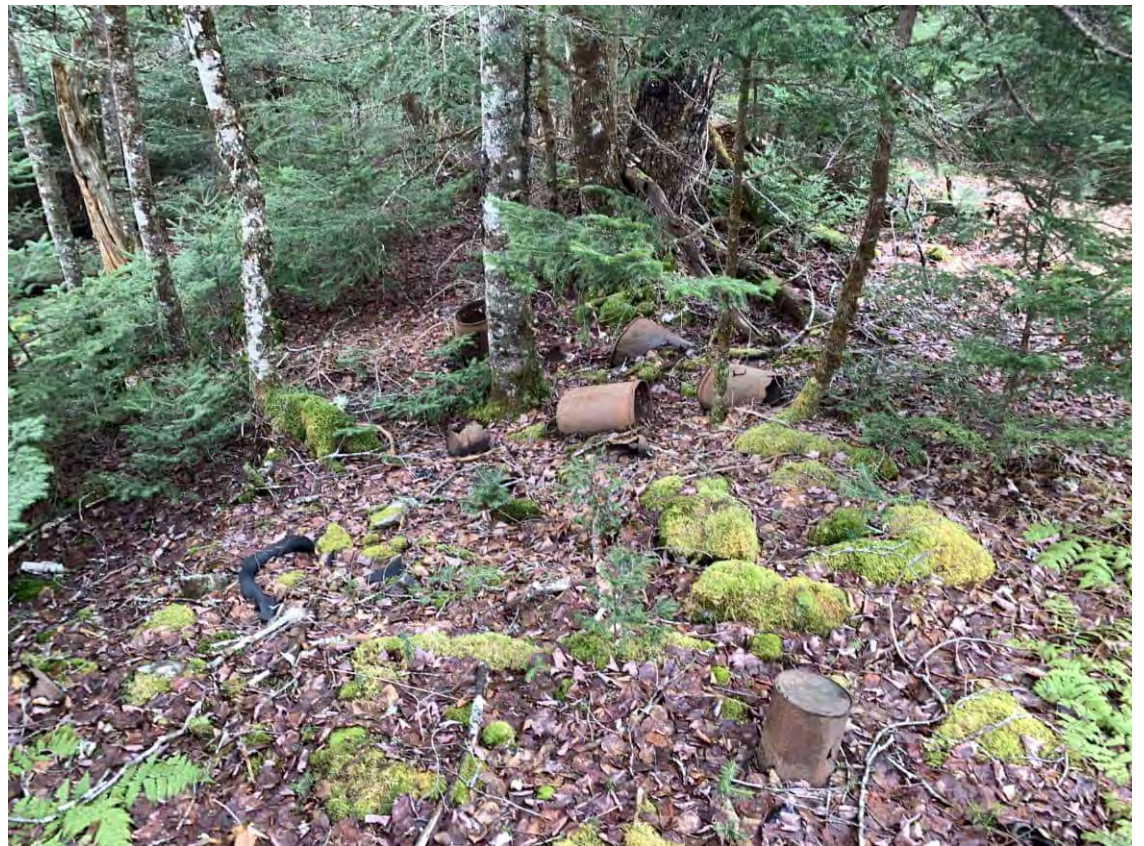
Photo No. 16	Date 3/21/2022
Direction Photo Taken West	
Description Metal bins left in the woods. Contents within the metal bins were not confirmed. Photo taken to the southeast of the area where the Quonset huts are located - further southeast than the waste rock plateau in photo 15.

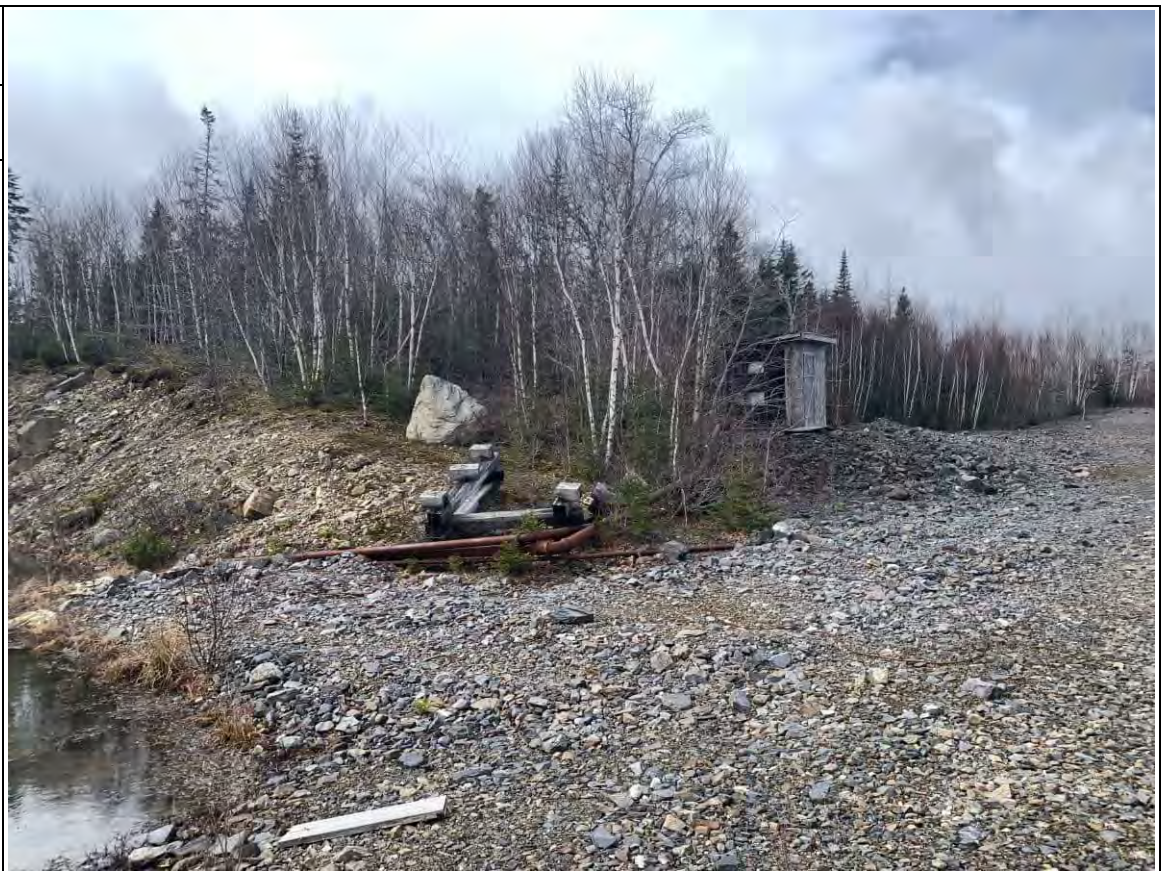
Photo No. 17	Date 3/21/2022
Direction Photo Taken Southwest	
Description Small plywood structure – possible former pump house (note piping entering the shed). Structure was empty. Notes - ponded water to the left – potential Hecla Mine Shaft Area located to the southeast of the area where the Quonset huts are located.
