Appendix B. Photo Log

Client Name:
Nova Scotia Lands Inc.

Report Name
Mooseland Mine Site

Project No.
60680169

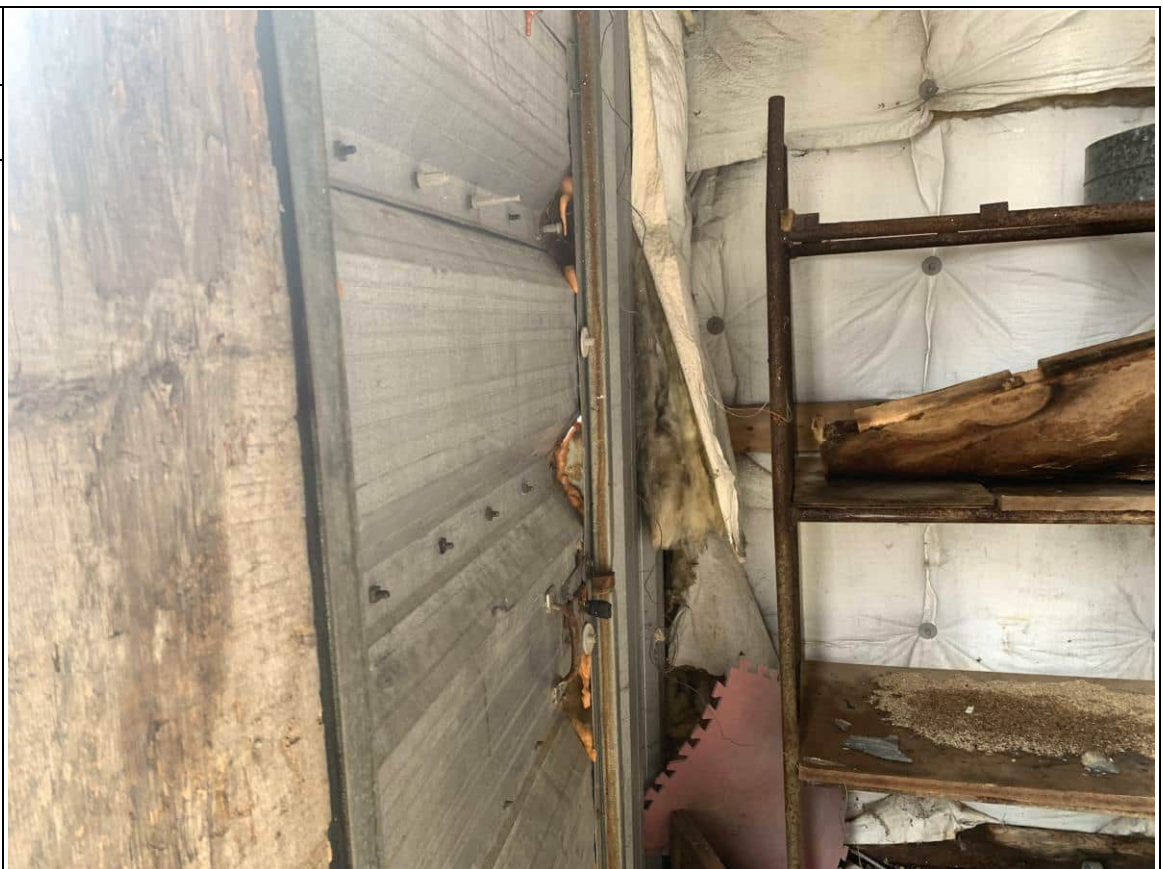
Photo No. 18	Date 3/21/2022
Direction Photo Taken East	
Description Photo of insulation present in Quonset hut that currently stores old core samples. Potential asbestos insulation.
