BUILD NOVA SCOTIA

Phase II Environmental Site Assessment (Final)

Former Frenchvale Mine Site, Frenchvale, Nova Scotia

Property Identification Designation Number: 15845167

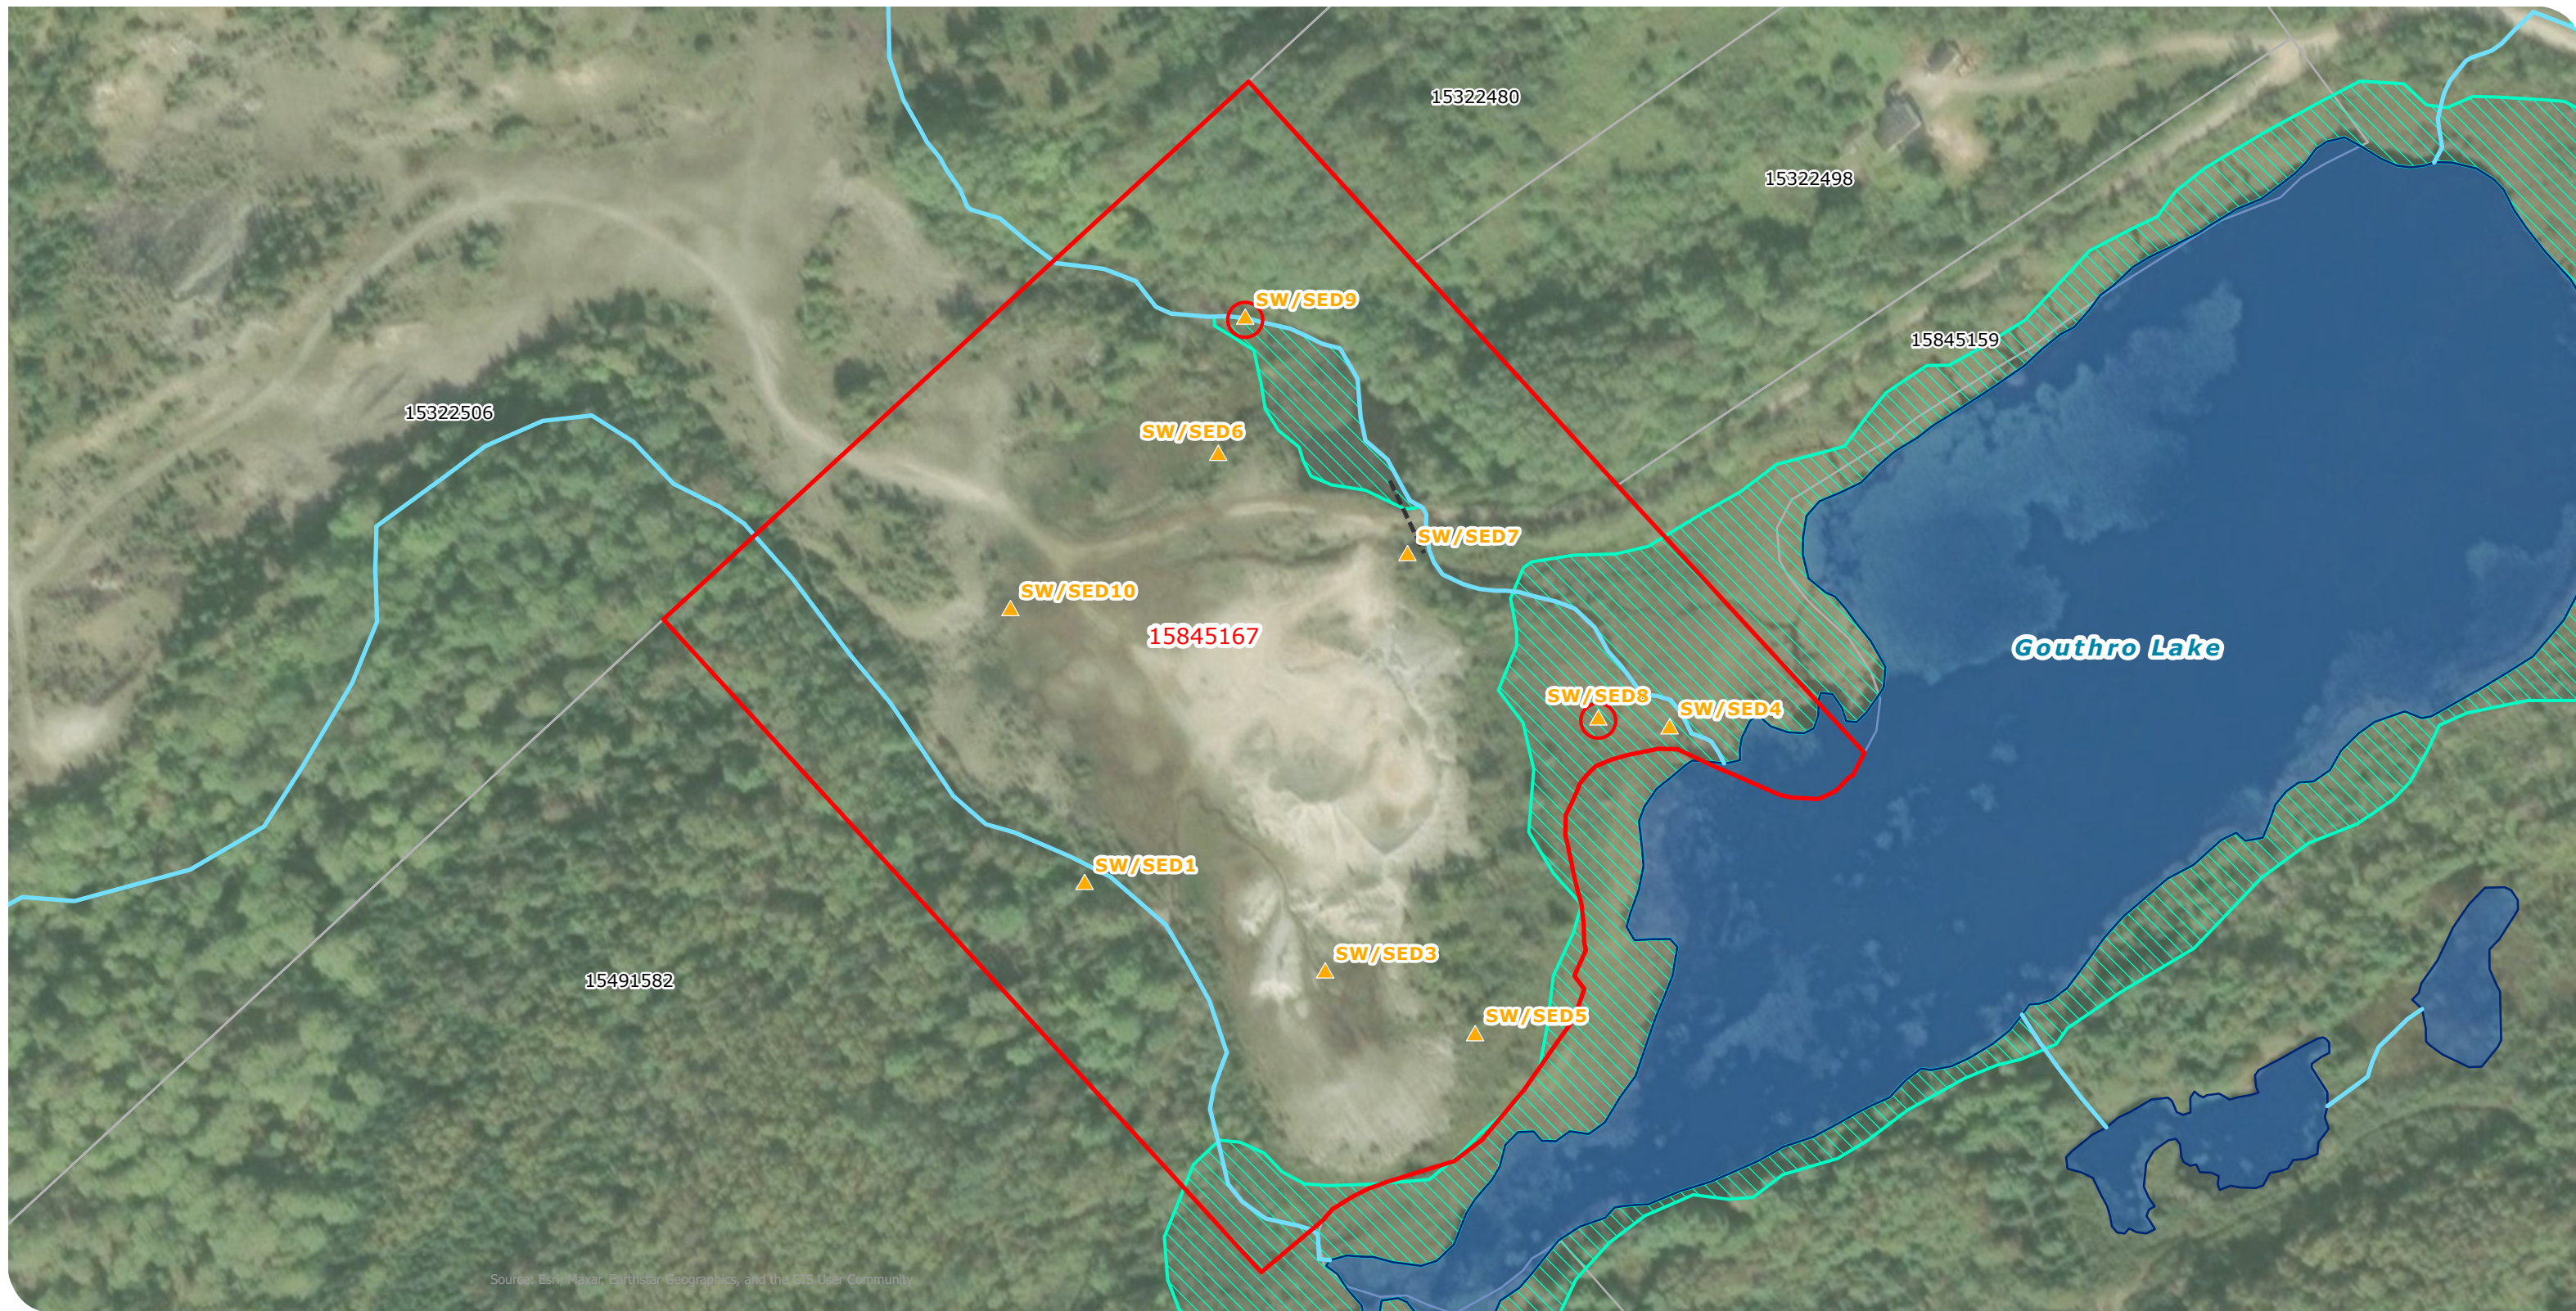
- Based on the analytical results, metals concentrations in sediment were within the applicable Tier I EQS, with the exception of lead, manganese and/or zinc at two sample locations (i.e., SED8 and SED9). It is noted that the highest arsenic and mercury concentrations were also reported at the SED8 location, although these were below the Tier I EQS. Further, the only detected sulphur
