NOVA SCOTIA LANDS INC.

## Phase I Environmental Site Assessment (Final)

Lake Enon Former Mill Site, Enon, Nova Scotia, PID Nos: 15551369,  
15340045, and 15340052

October 2022 – 22-3723

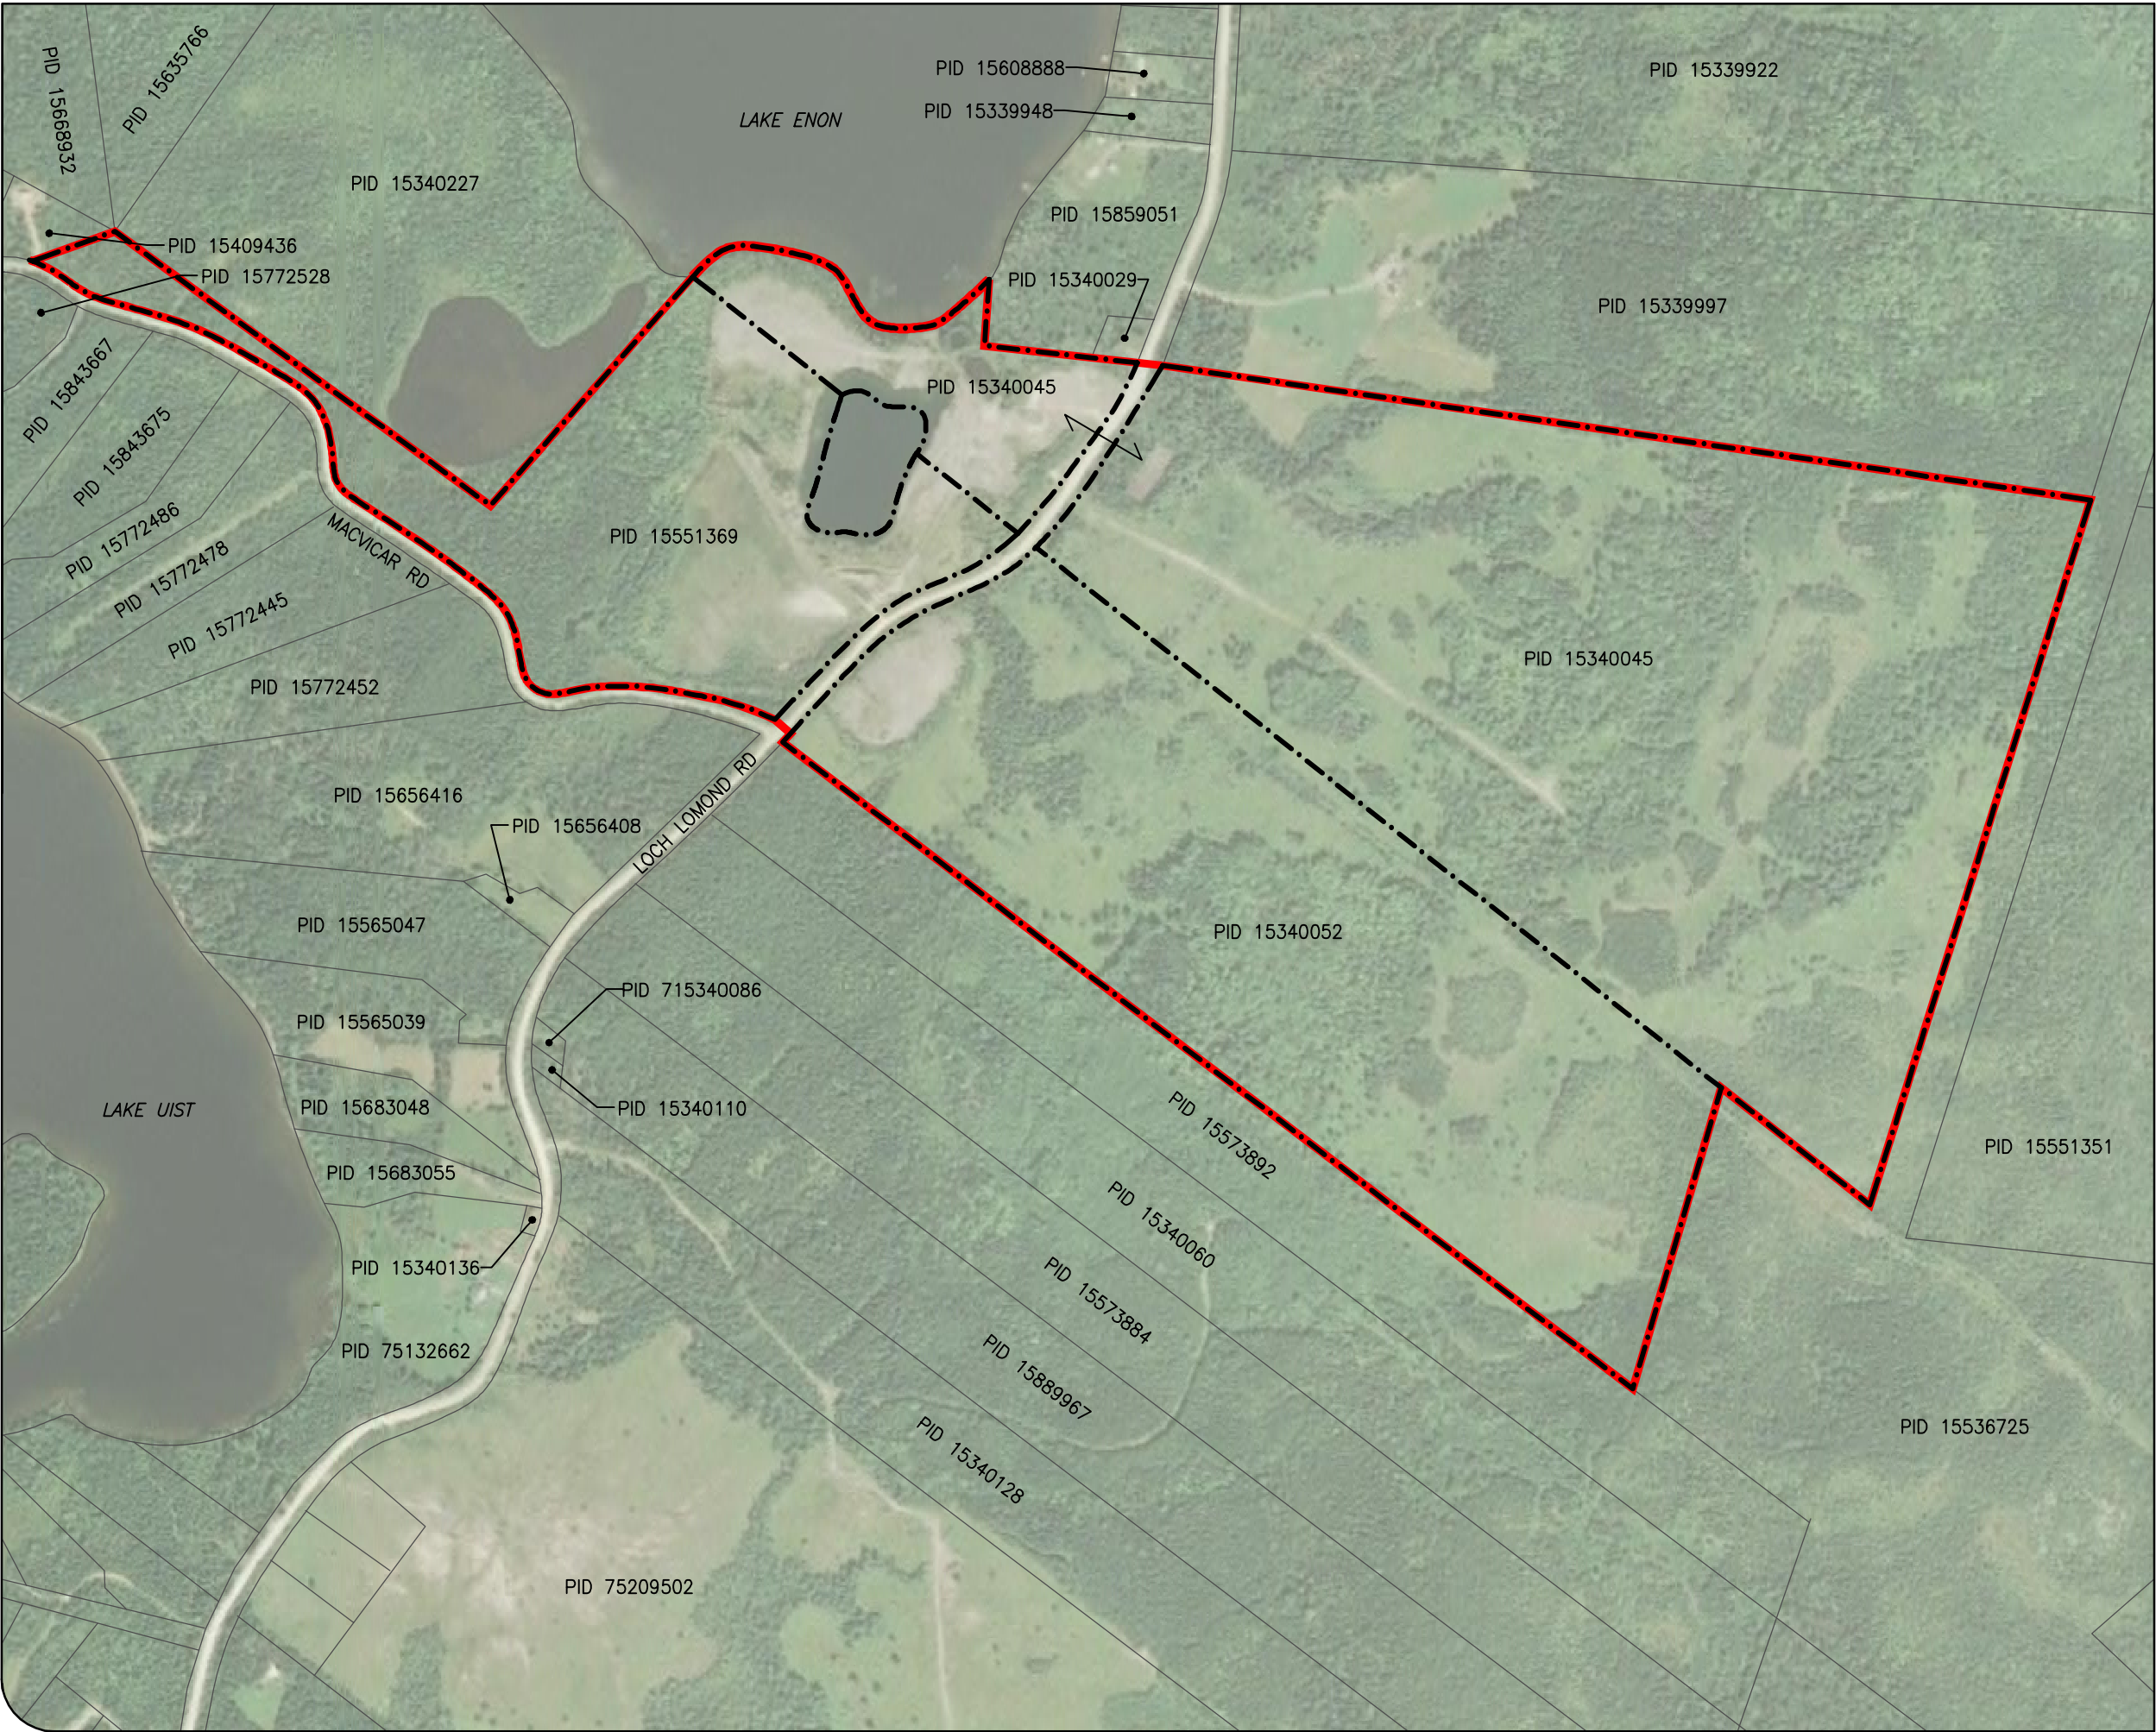
ASSESSMENT AREA AND  
SURROUNDING PROPERTIES  
FIGURE 2

The identified APECs are illustrated on Figure 2 and presented in Table 7, below:

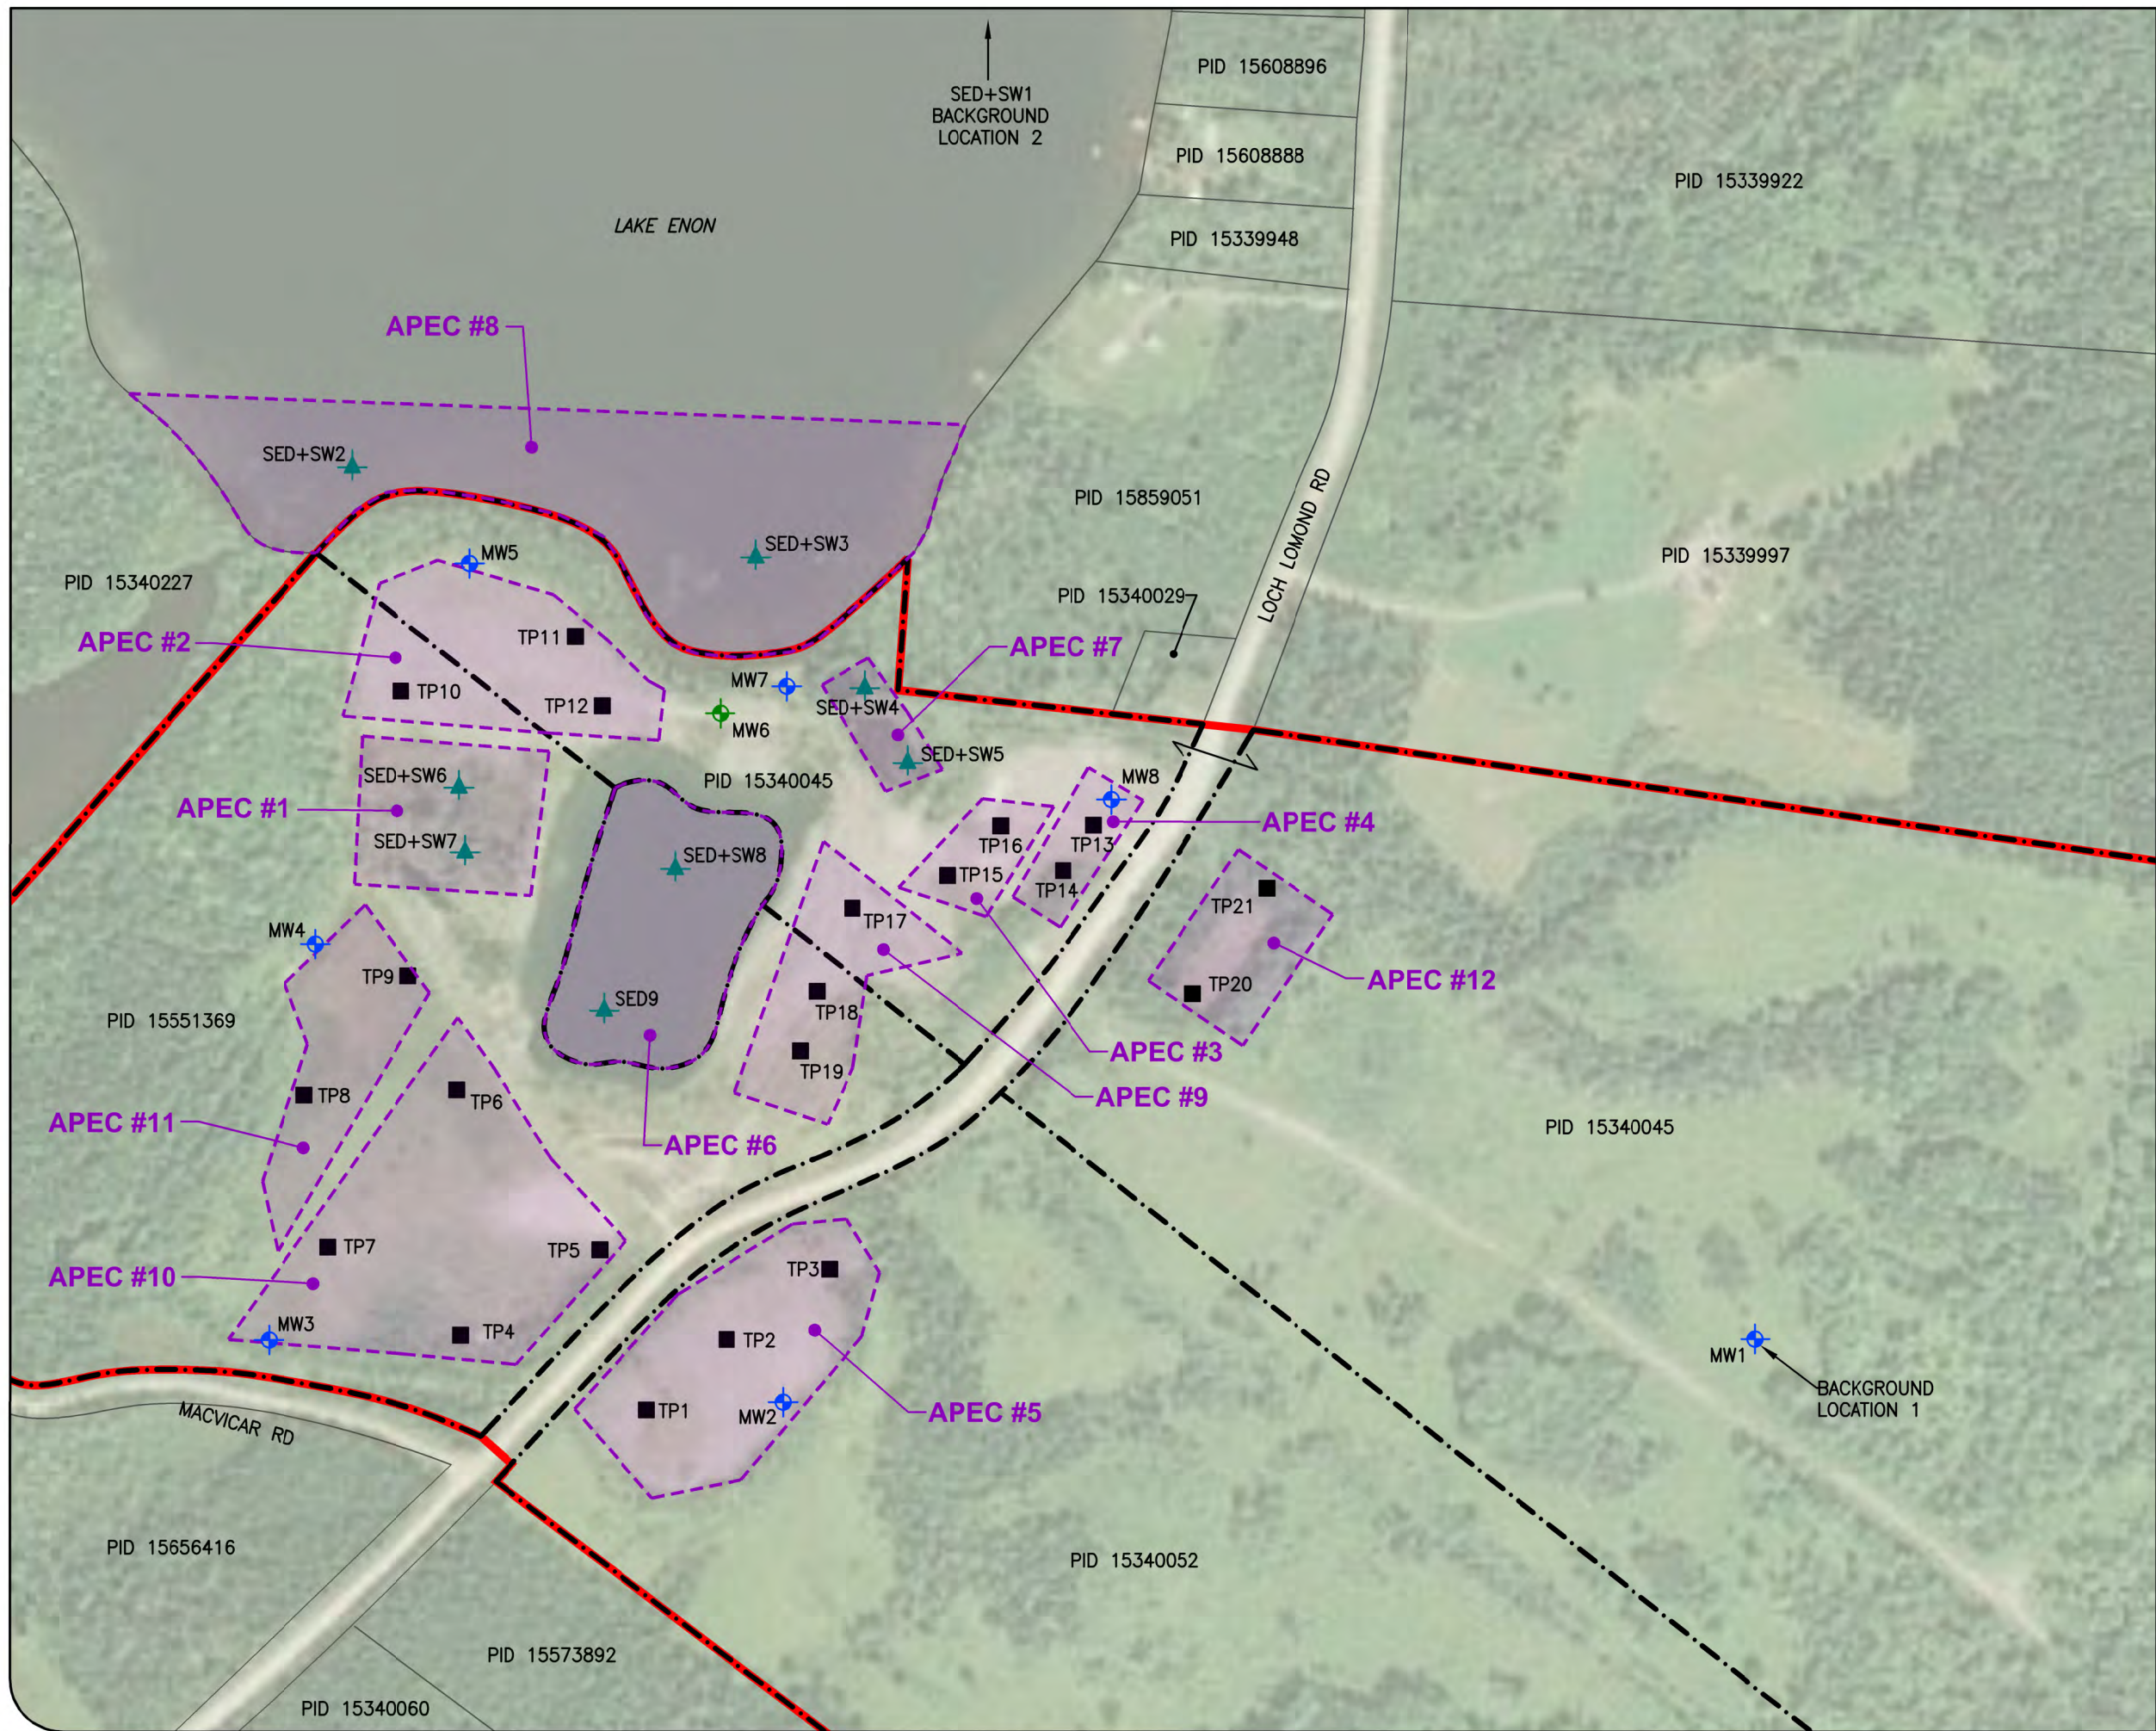
**IDENTIFIED APECS AND SAMPLING PLAN**  
FIGURE 3

In addition to the above noted APECs and COPCs, assessment for potential acid rock drainage (ARD) and potential presence of buried reagents from milling processes is recommended in areas where waste rock, waste, and tailings disposal have been identified (i.e., APEC #1, APEC #2, APEC #5, APEC #6, APEC #9, APEC #10, and APEC #11). In locations where surficial water is present, the feasibility of surface soil sample locations should be assessed on-site. In addition to the COPCs identified in these areas, surface soil samples are recommended to be analyzed for electrical conductivity (EC), sodium adsorption ratio (SAR), and chloride.
