**BNS MILLER LAKE
PHASE I ESA REPORT**

Site Visit Photo Log

Report Name
Miller Lake Mine Sites

Client:	Build Nova Scotia
Project:	Phase I Environmental Site Assessment of Miller Lake
Project Number:	60711967

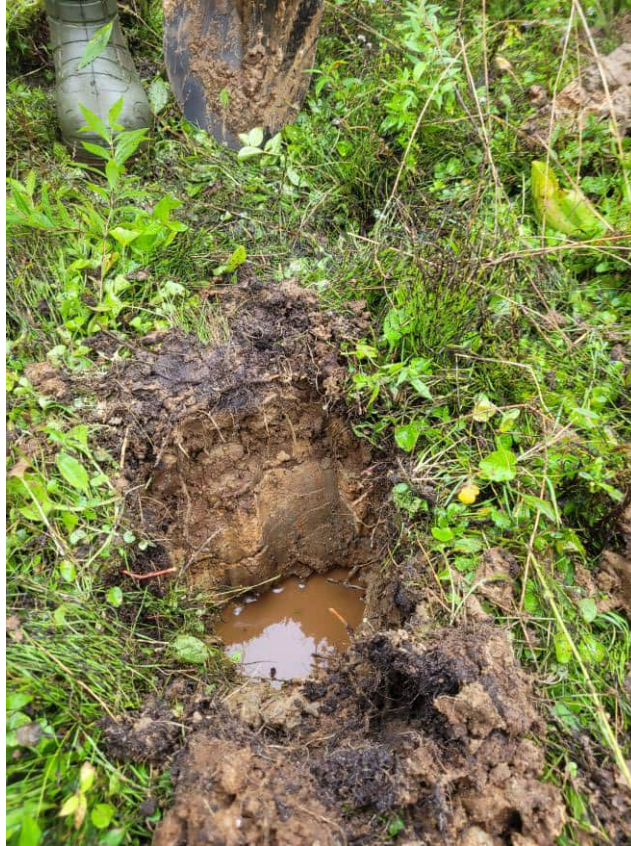
Photo No. 3-01	Date 9/7/2023
Subsite 03	
Description Tailings deposit Soil profile at the tailing sampling location at Subsite 03.

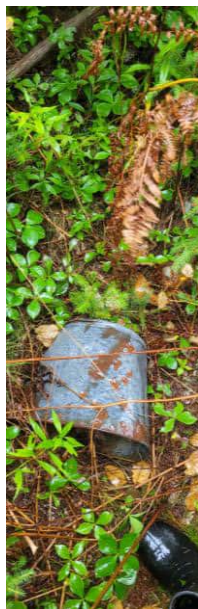
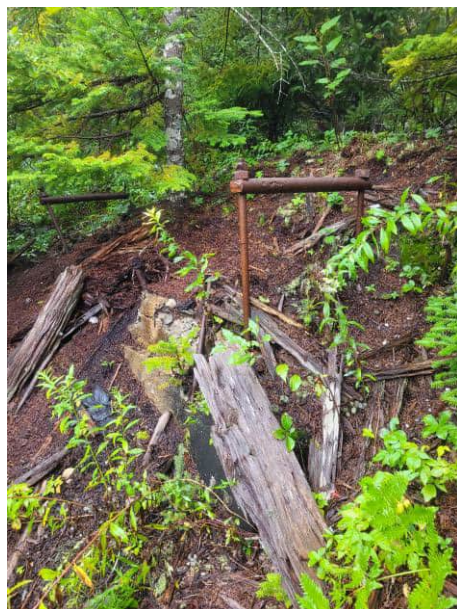
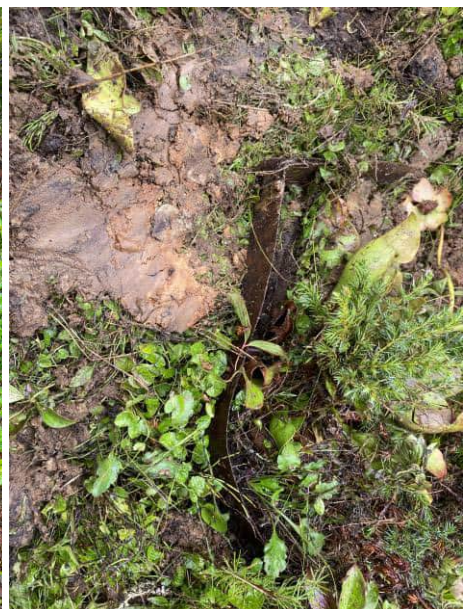
Photo No.	Date
3-08	9/7/2023
Subsite	
03	
Description	
Debris area: S03-DA-001	
Debris and remaining infrastructure. Leftover metal supports, metal and wood debris. Immediately south of waste rock pile and on top of waste rock
